COMMERCIAL BUILDING SURVEY

London

**Victorian
Two Storey
Public House**

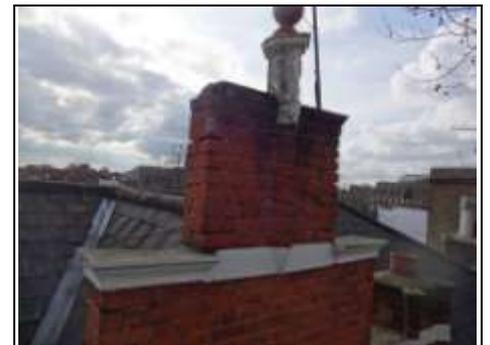
These are at high level and are formed in soft red brick. These are in a below average condition and from what we can see look as though they have not had any maintenance for some time.

External view of chimneys, Dutch gables and parapet walls
Aerial view – 360 photo

ACTION REQUIRED: Repair and repoint and possibly rebuild.

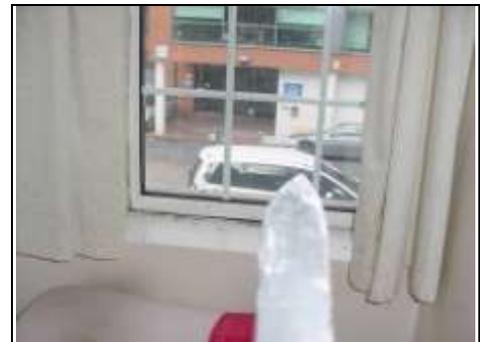
Window literally falling out

ACTION REQUIRED: We recommend new windows to the majority of the first floor.

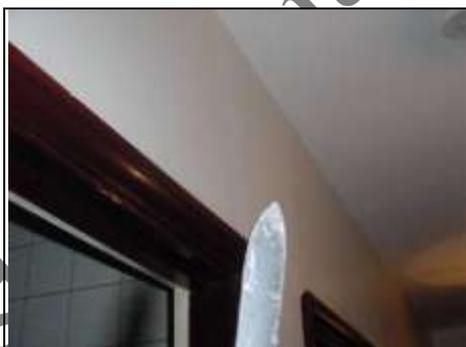
We can see there has been condensation to the first floor level which in turn has caused cracking to the plaster within the property and black mould (please see our article on black mould).

Hairline cracking in corridor to right side between first and second toilets

ACTION REQUIRED: The problem will effectively be resolved when these rooms are no longer used for bed and breakfast, washing, etc. You will need to repair any cosmetic defects to the plaster. As it is a modern plaster it may be replastering and redecorating.

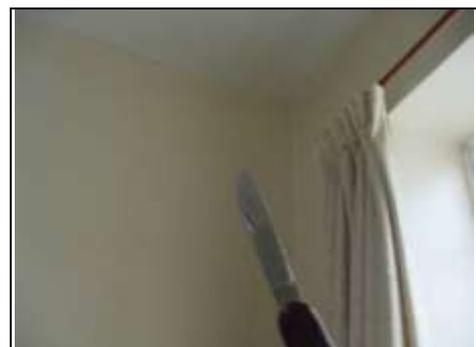
Hairline cracking in rear right bedroom

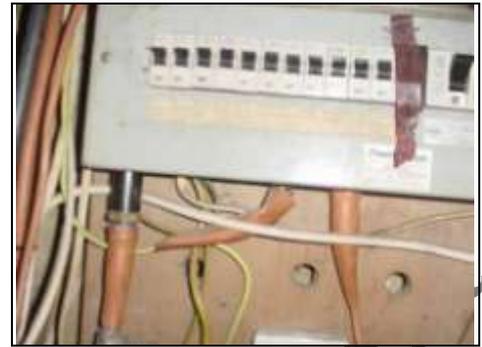
Older fuseboard

We recommend an Institution of Engineering and Technology (IET) test and report to be carried out by an NICEIC registered and approved electrical contractor or equivalent.

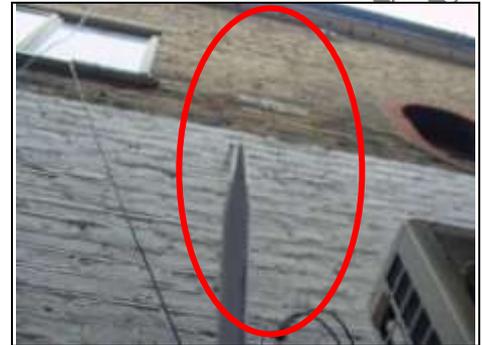
We can see cracked lines running vertically through the joint and brickwork to the left side of the property. It looks to have had repairs over the years which have re-opened up. This is approximately in line with the cellar and could relate to this or it could relate to the extra weight added on the original property by the extensions, or to the clay soil in the area and water table level problems.

High level vertical cracking to left hand wall in passageway

The movement may be acceptable, it may not, but it needs to be monitored and we cannot be 100% from a one-off inspection.

ACTION REQUIRED: Ideally we would recommend the existing owners take out an insurance claim, advising that the cracking has been noted by a structural surveyor (this should cost them nothing other than time to write the letter).

This usually means that the insurance company will carry out a monitoring exercise (the Building Research Establishment recommends monitoring any cracks for a minimum of one year) to establish if there is any progressive movement.

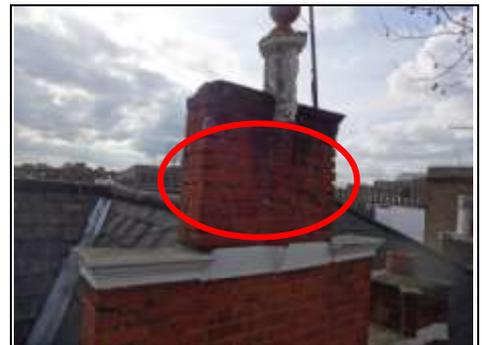
Deteriorating brickwork on the chimney
Aerial view -360 photo

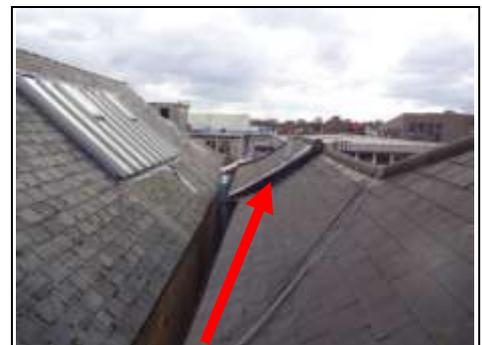
Flashband repairs on step in left side of roof
Aerial view -360 photo

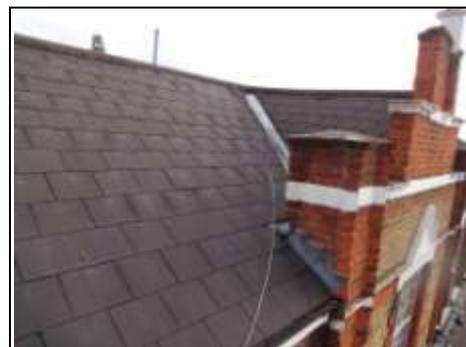
Chimney to right side
Aerial view – 360 photo

This chimney is also built with a soft red brick and again is in below average condition for its age, type and style.

ACTION REQUIRED: Please see our comments in the Executive Summary.

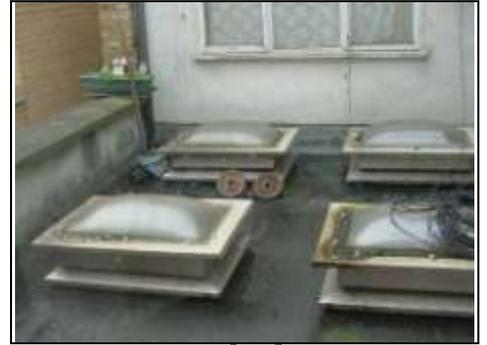
Roof windows / sky lights

There are roof windows/sky lights on the rear single storey flat roof. This is a flat, flat roof and as such think water will sit on it which can lead to leaks around roof windows/skylights.

There looked to be a felt flashing around it which is not ideal.

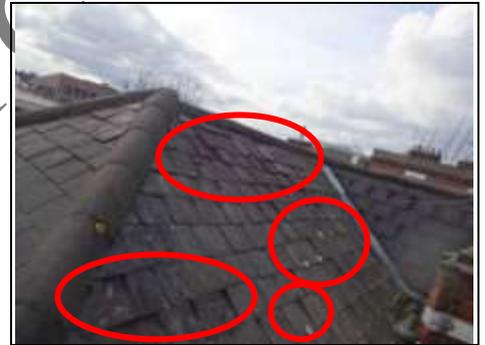
The main roof is a shallow pitched, hipped roof, clad with slates. From ground level and aerial photography this looks in below average condition considering the roof's age type and style.

Slipped slates and lead tingles

ACTION REQUIRED: Please see our comments in the Executive Summary.

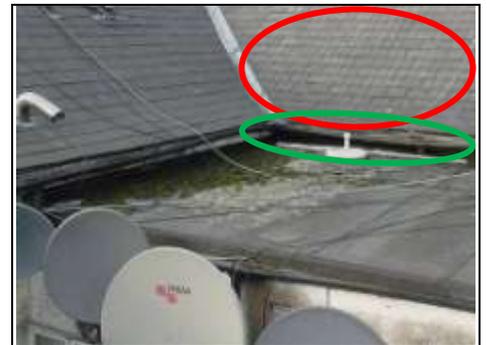
Dip in roof (red oval)
with Flashband repairs below
(green oval)

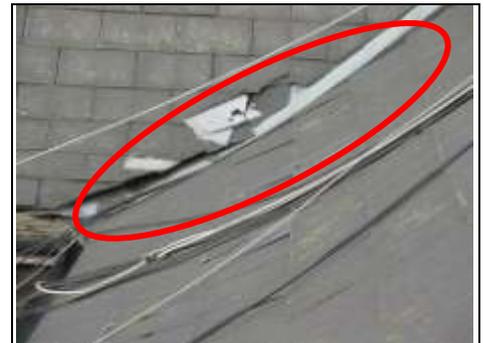
Rear valley gutter with damaged and slipped slates

ACTION REQUIRED: Check and clean valley gutters when the roof work is being carried out.

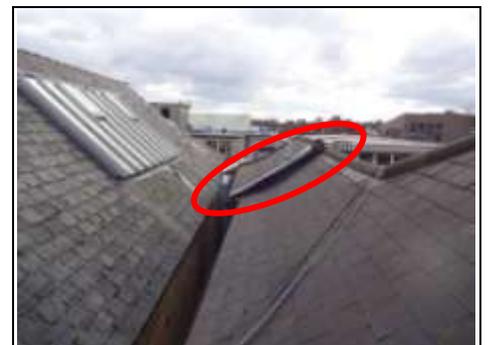
There is a step in the roof on the left side which has Flashband repairs. We consider this a temporary material and recommend it is replaced with lead.

Flashband repairs on step in left side of roof

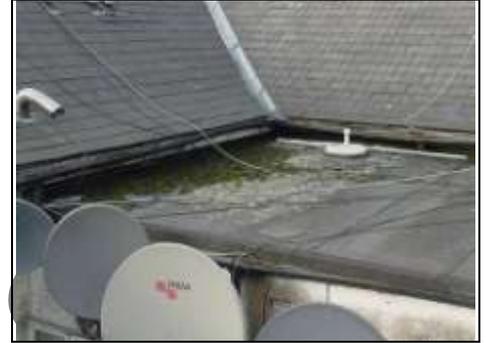
Rear two storey flat roof

There is a high level flat roof covered with felt. We can see an area of moss on it indicating it is a flat, flat roof, by this we mean without any fall on the roof.

ACTION REQUIRED: No doubt there is life left in this roof and it can be patch repaired for a while, particularly if you are looking to develop this area.

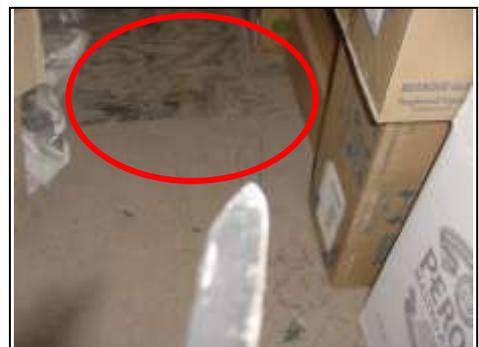
Staining to floor indicating rainwater coming in

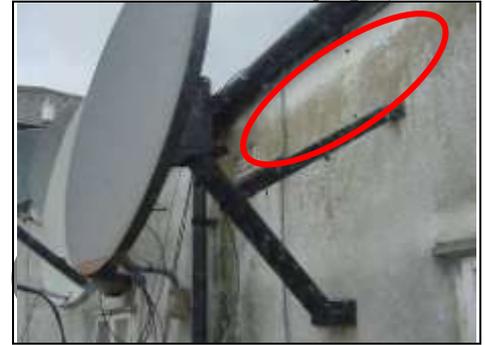
The gutters and downpipes are plastic. They are in below average condition for their age, type and style. They are overflowing and discharging against the walls which can lead to dampness.

Paint worn away from gutter and downpipe discharging down wall

We would always recommend that the gutters and downpipes are cleaned out, the joints are checked and the alignment checked to ensure that the gutters fall towards the downpipes.

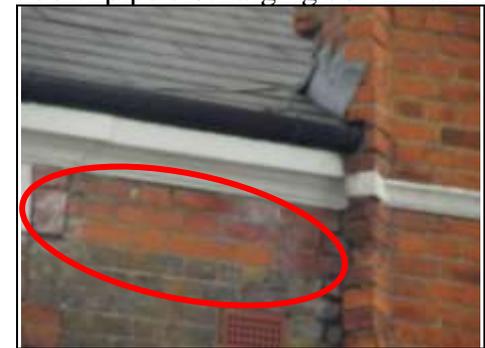
Some of the gutters are sit on gutters. They are leaking and causing efflorescence to the brickwork below.

Dampness in the form of efflorescence on brickwork from overflowing gutter

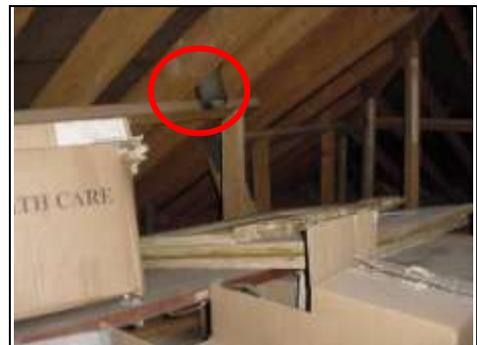
Although we can see vents at roof level we can also see within the roof space they are not connected.

Vent not connected in roof space

ACTION REQUIRED: If you wish to carry on using it as guest accommodation then we recommend all soil and vent pipes and extract systems are connected.

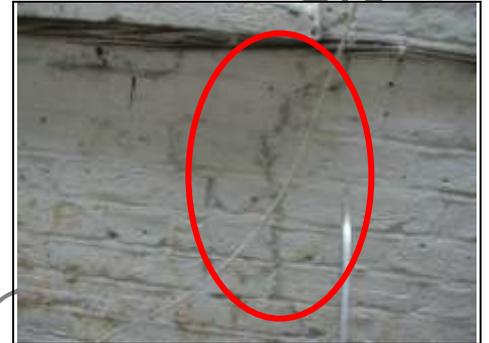
There is a long vertical crack running all the way down the left side of the property. It looks to be historic as we can see that it has been sealed in some areas, however from a one-off inspection we cannot be certain.

ACTION REQUIRED: Please see our comments in the Executive Summary about monitoring the cracks and an insurance claim by the existing owners.

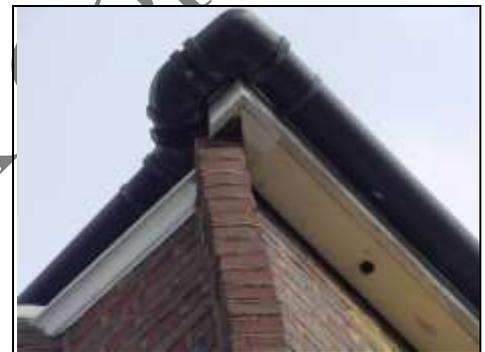
Fascias and soffits need redecoration

Make sure gutters and downpipes are watertight before carrying out any work on fascias and soffits.

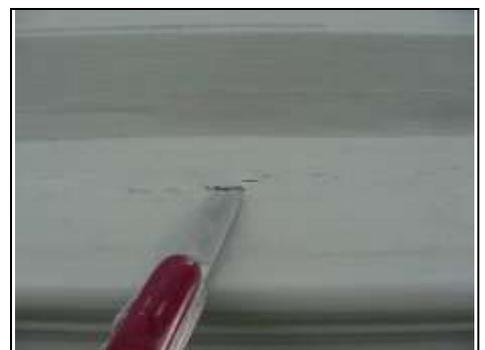
The timber windows are starting to deteriorate. There are signs of wet rot in the timbers when we carried out our knife test.

Signs of wet rot in timber windows

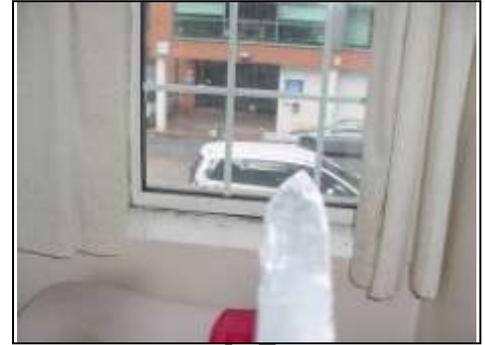
In this case they look in poor condition. We noted one window literally about to fall out.

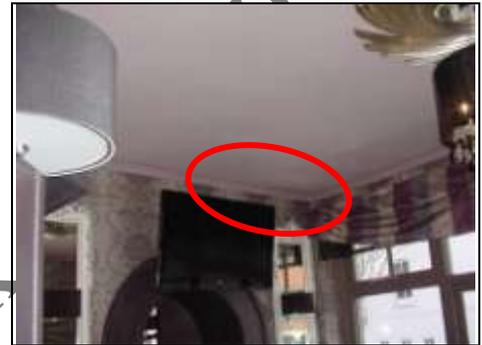
Straight crack in ceiling to right side (Middle Row side)

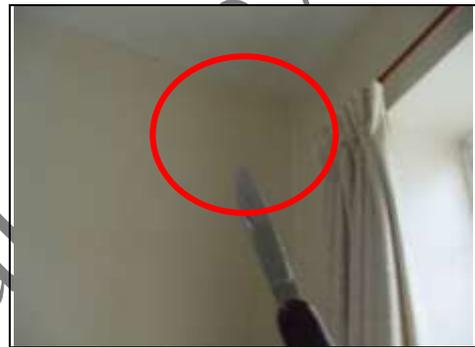
Hairline cracking in rear right bedroom

ACTION REQUIRED: Please see our comments in the Executive Summary.

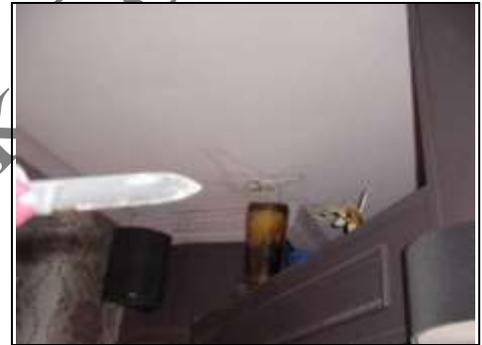
Leak from one of the shower rooms above
