PROPERTY REPORT AND NEGOTIATION DOCUMENT

We have been instructed to inspect and prepare a Property Report and Schedule of Condition for:

The XXXX
XXXX Hertfordshire, HP23 XXX

Property Report

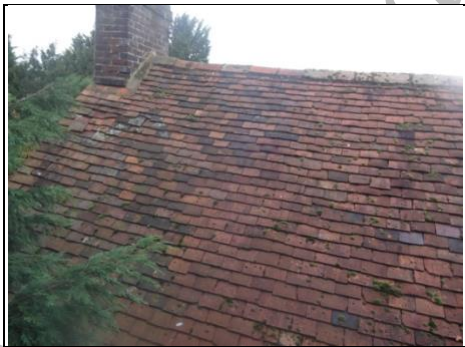
The clay tile roof is deteriorating, there are literally holes in it, slipped tiles, spalling tiles and broken tiles allowing dampness into the property as well as around the chimneys.

Deterioration to tiles

ACTION REQUIRED: Exclude roofs from lease. However the roofs will need work to make them watertight.

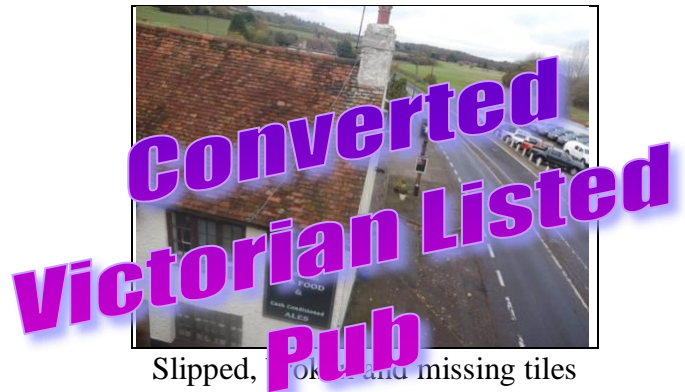
Slipped, broken and missing tiles including holes in the roof for example to front left

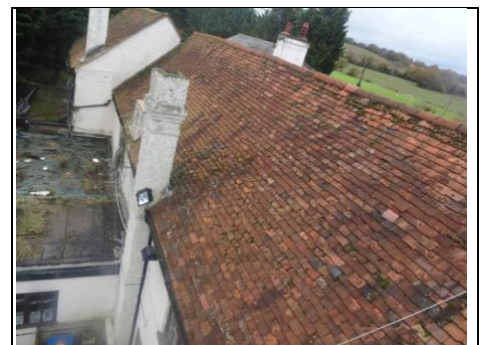
Dip to rear left roof

We would recommend further investigation by forming access hatches to each of the roofs (rear left and right roof), ideally before you purchase the lease or take on a new lease to carry out investigations in these areas.

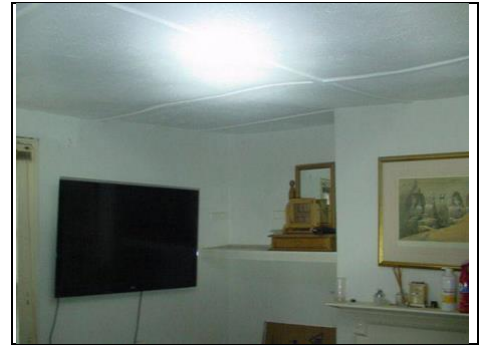
Undulating ceiling

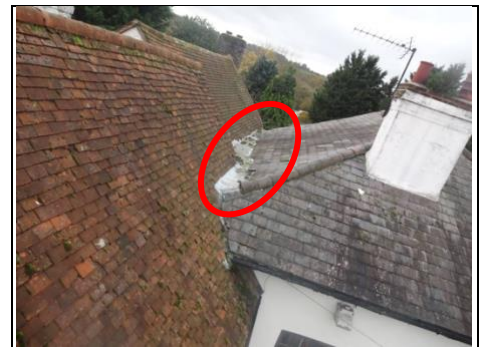
Valley gutter

This property has valley gutters which are generally problematic. Water appears to be sitting in this. We could not access either of the roofs that it would affect and it can cause rot to the common rafter feet. Valley gutters are often problematic particularly where different ages of roofs meet. There does not look to be sufficient fall on this valley gutter.

It is likely that the valley gutter will need replacing with some repairs to the roof as well. A good fall is always recommended on a valley gutter, there may be limited possibilities to do this.

ANTICIPATED COST: In the region of £7,500 - £15,000 depending upon what is found within the roof; please obtain quotations. As it is high level work you may also need scaffolding.

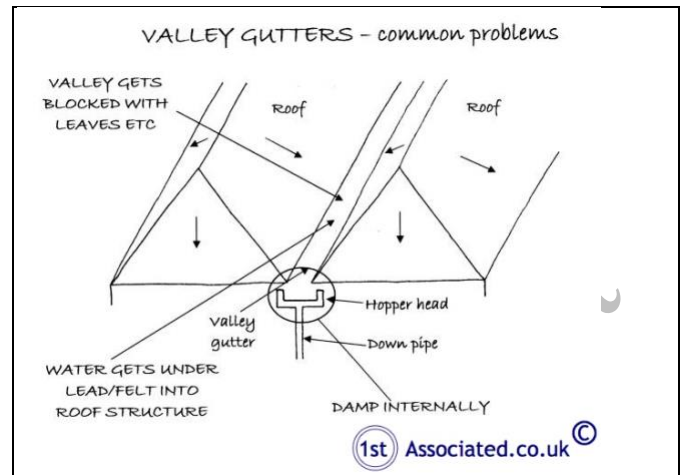
Valley gutter problems

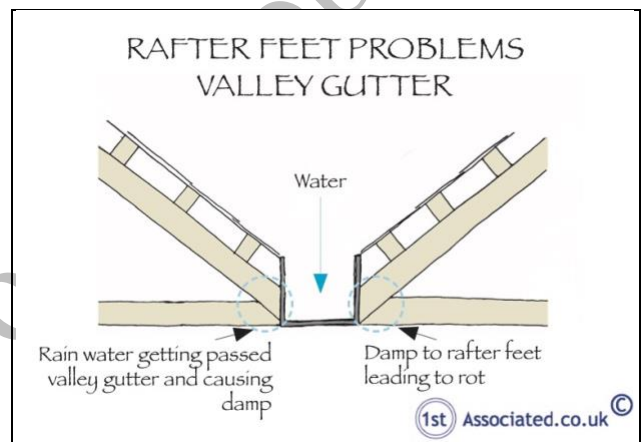
Rafter feet problems

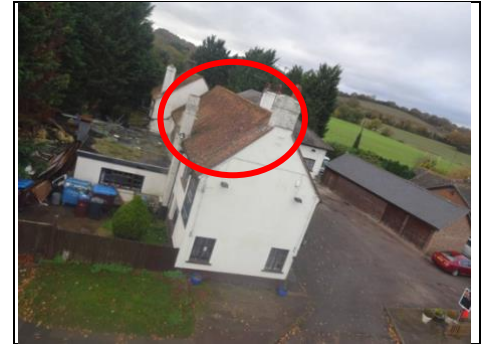
Main central roof

There are cracked and split common rafters in the main roof and also woodworm. The roof is in poor condition.

ACTION REQUIRED: Exclude all roof structures from the lease as we believe there are hidden and latent defects present.

Further investigation. We recommend access hatches are added to all the roofs.

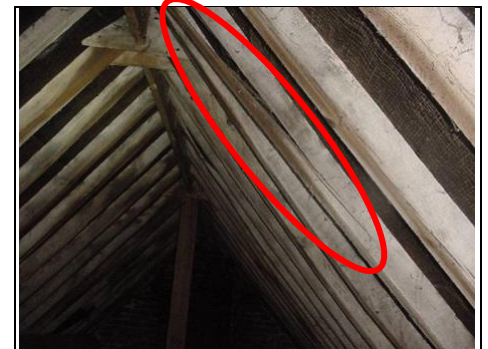
Cracking in common rafters

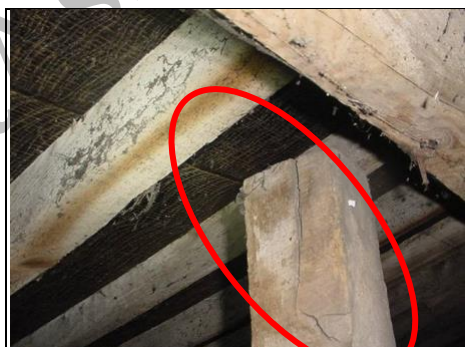
Prop/strut no longer securing purlin

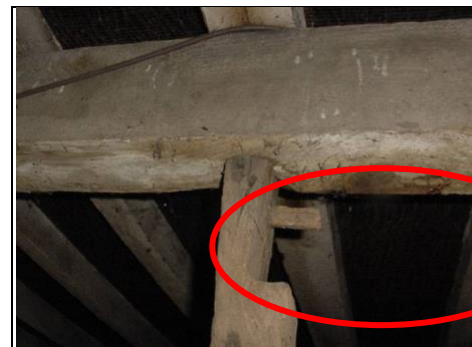
Struts giving support to purlin have been cut

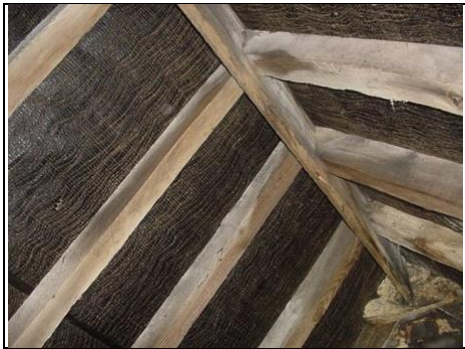
Dampness

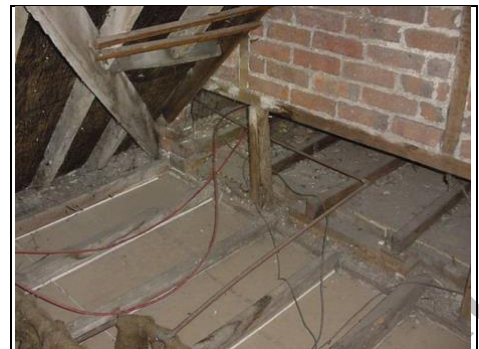
Dampness particularly to roadside end

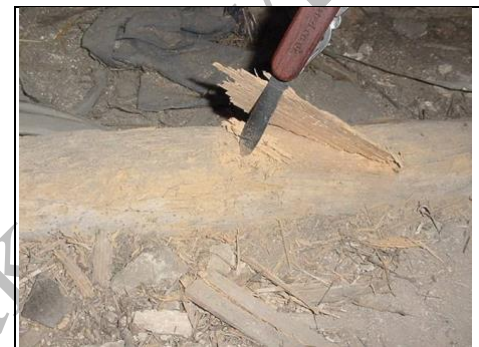
Woodworm

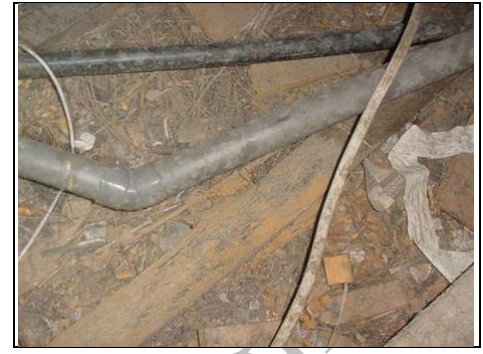
Woodworm near entrance to roof

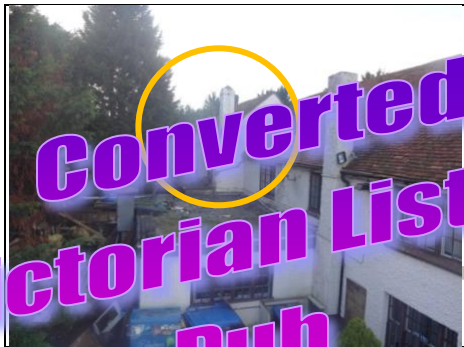
Rear Left Roof

No access to this area readily available. We noted dampness is getting in at the step in the roof and causing deterioration to support timbers.

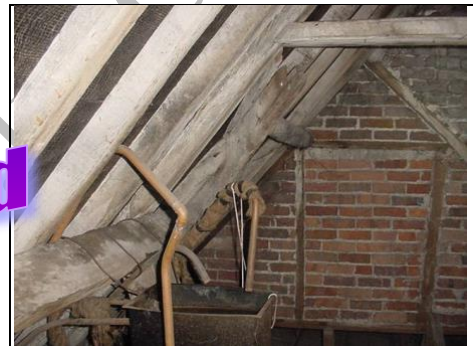
Dampness to wall between front and rear roof

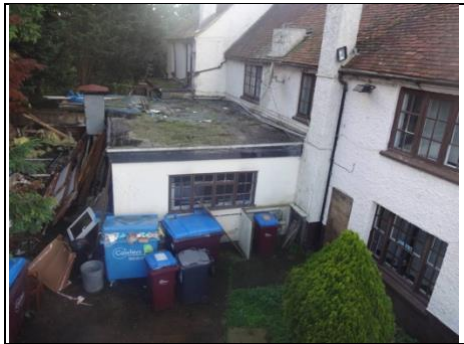
Dampness is noted within the catering kitchen due we believe to a leaking flat roof.

Tarpaulin on square roof, moss on rectangle roof

ACTION REQUIRED: Exclude from lease. Patch repair required.

ANTICIPATED COST: £2,500 - £5,000 for patch repairs.

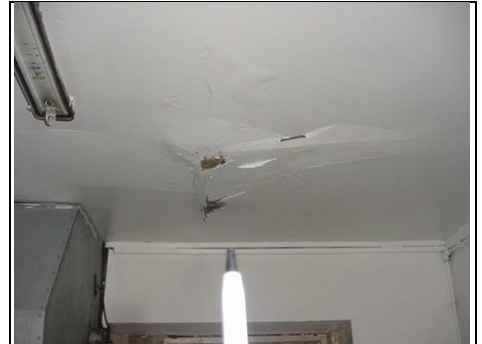
Staining and undulating ceiling in catering kitchen

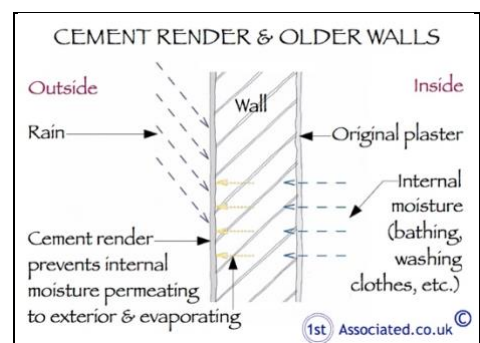
Cement mortar stops the building from breathing, this should be a lime based render. It also causes accelerated deterioration to the timber frame.

Cement render

At some point sections of the render need to be opened up near where the timber frame is to check the condition of the timber frame and carry out appropriate repair.

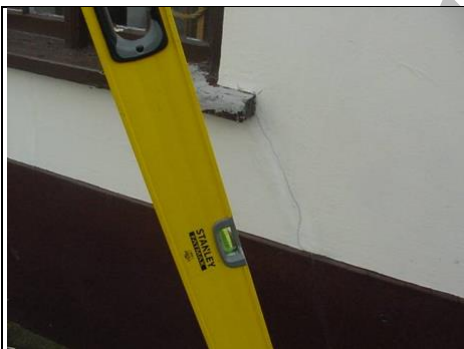
Throughout the render to the central part of the building we can see cracks. There is movement occurring in the structure which is probably due to the timber frame having differential movement to the cement render.

Cracking below window

ACTION REQUIRED: Exclude all cracking and associated damage from the lease.

We would also recommend that the landlord places an insurance claim, advising that the cracking has been noted by a chartered building surveyor (this should cost them nothing other than time to write the letter/email). We would recommend monitoring for one year as recommended by the Building Research Establishment to establish if there is any progressive movement.

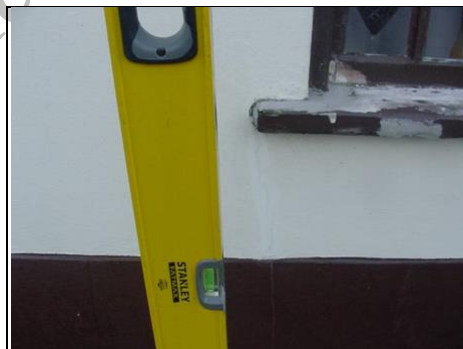
Cracking below window

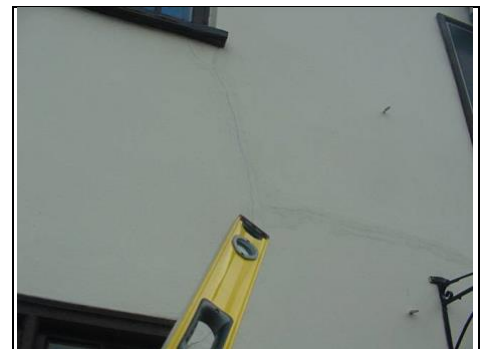
Cracking

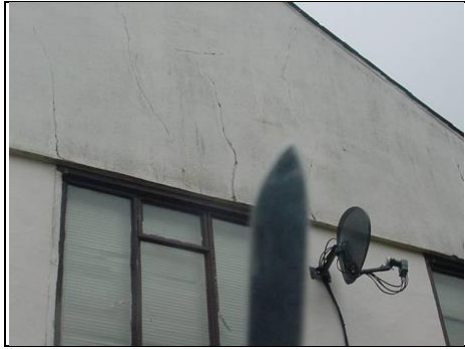
Cracking above metal window to rear of building

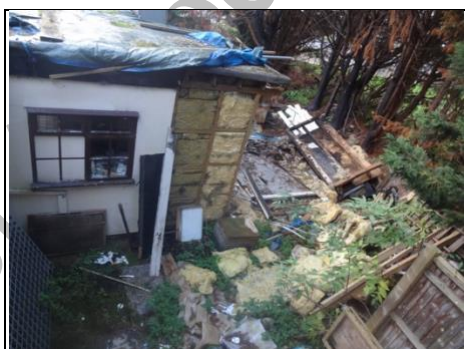
Generally, the left side of the building where the fire damage is, is in a dilapidated condition. There are parts of the walls exposed and it needs general repair.

Walls exposed

ACTION REQUIRED: We do not know if this is subject to an insurance claim however it needs to be made watertight.

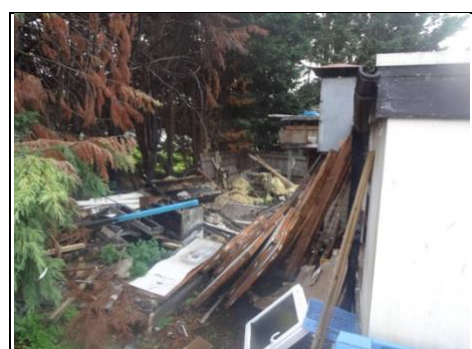
Fire damage

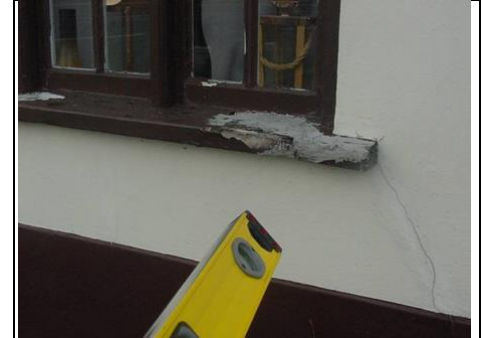
Window in poor condition

The windows are in a poor condition. There have been various poor quality repairs carried out.

ACTION REQUIRED: Exclude from lease.

ANTICIPATED COST: In the region of £10,000 - £20,000, possibly more depending upon the amount of timber repairs; quotations required.

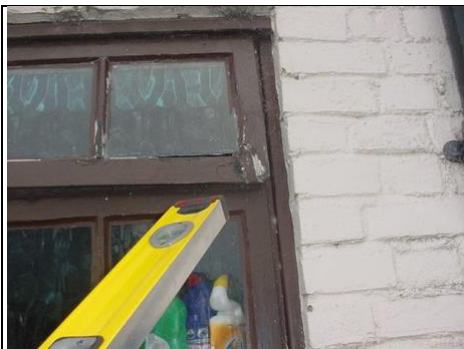
Joints opened up and window falling apart to right

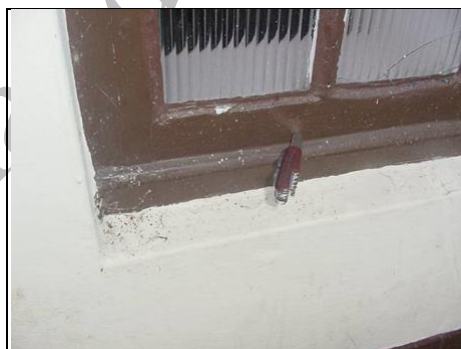
Rot to windows

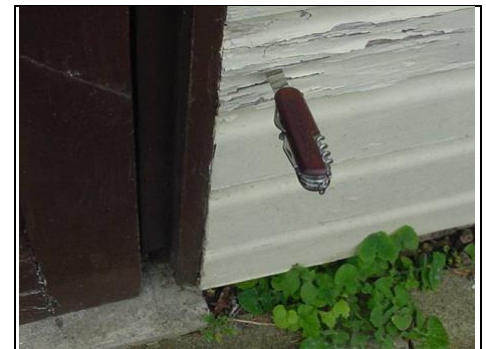
Wet rot to horizontal cladding to rear

ACTION REQUIRED: Replace horizontal cladding.

ANTICIPATED COST: Set aside the sum of £500 - £1,000 to replace. The wall will then need time to dry out; please obtain quotations.

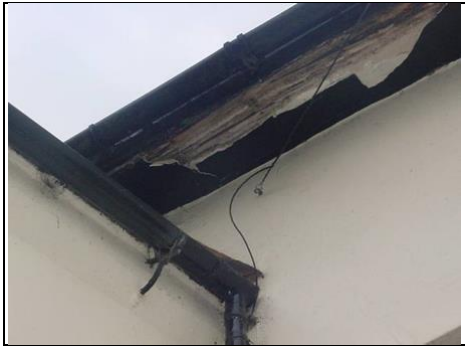
From ground level there are a few particularly bad areas to the fascias and soffits. Until the roof problems are sorted it is almost pointless repairing the fascias and soffits because the problem will just reoccur.

Fascias and soffits in poor condition front right building

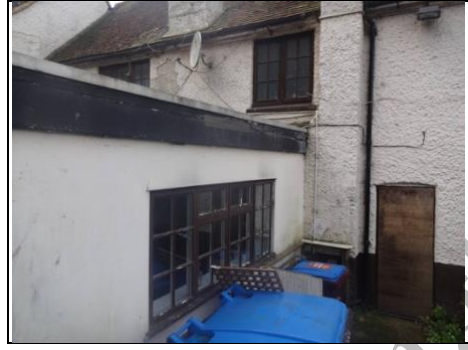
Flat roof fascias and soffits in poor condition

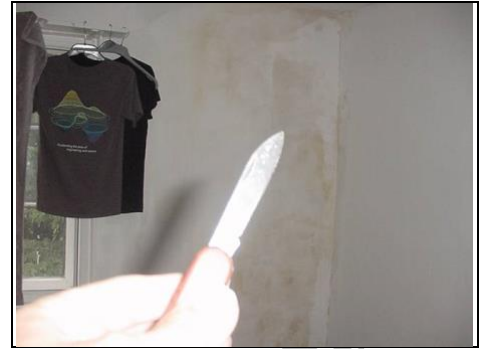
There is dampness visible to the left side of the property which includes the bathroom, lounge, etc and also to the rear dining room area of the pub. This dampness we believe relates to gutters.

Dampness to reception room one

ACTION REQUIRED: Gutters need to be cleared to the entirety of the property. We also believe there will be some gutter repairs.

ANTICIPATED COST: In the region of £1,000 - £2,000; please obtain quotations

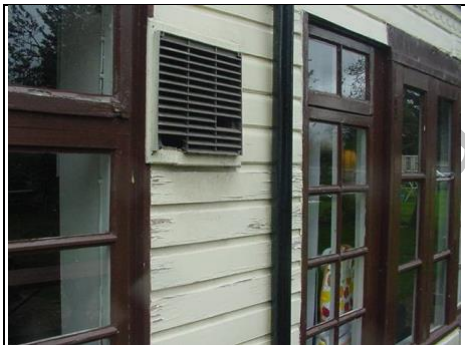
There is also dampness to the rear of the property in the dining area. The rear timber cladding is rotten and we recommend replacing.

Dampness to rear behind horizontal cladding

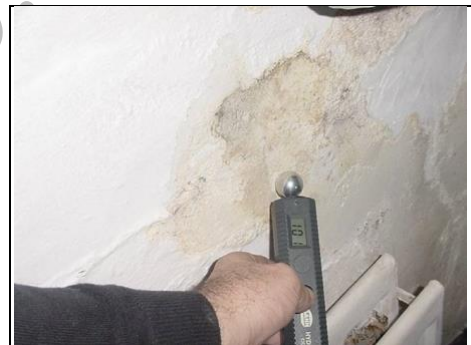
Dampness to rear

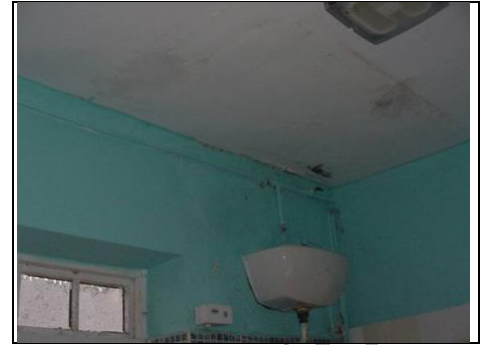
We noted dampness to the toilet area which could relate to condensation.

Dampness to toilet

ACTION REQUIRED: Add extract fans and heat in the area as well as refurbishing the toilets of course.

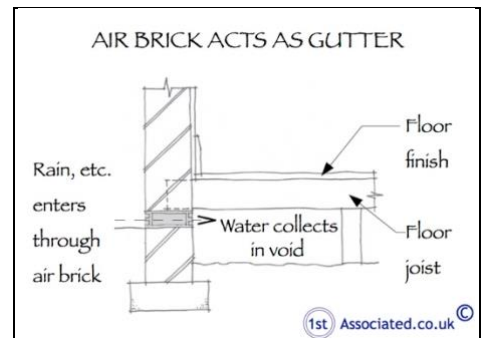
The property has a suspended timber floor to the front which needs an airflow underneath it to help reduce the chances of wet rot, dry rot and woodworm. The airbricks which should ventilate the floor unfortunately are so low they are acting as gutters. There is also general dampness where the cement surround to the pub is sitting against the property.

Airbrick acting as gutter

ACTION REQUIRED: Add a French drain linked into the drainage system.

ANTICIPATED COST: In the region of £1,000 - £2,000; quotations required.

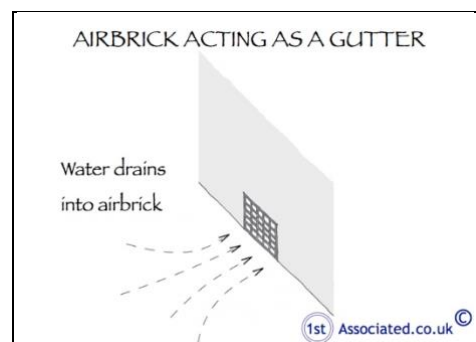
Airbrick acts as gutter

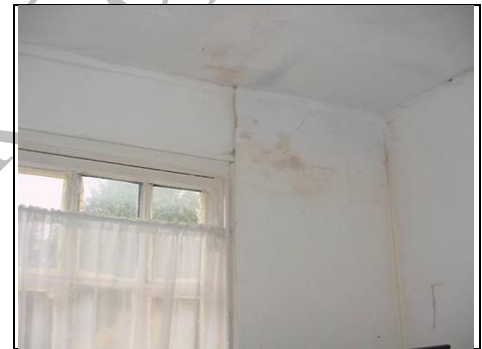
Dampness to rear right room

ACTION REQUIRED: Once the dampness is resolved we would recommend redecorating throughout. You need to remember under a Full Repairing and Insuring lease you will normally be required to leave the property freshly decorated when you leave. We suggest this is excluded from the lease.

ANTICIPATED COST: In the region of £5,000 - £10,000. You can spend as much or as little as you like; please obtain quotations.

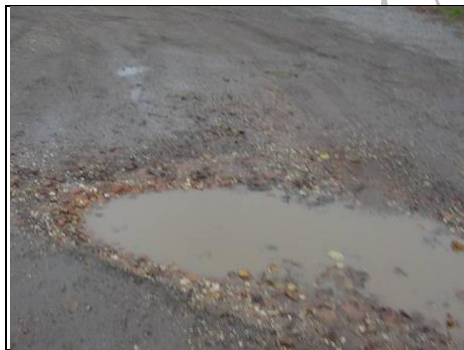
The car park has pot holes and is in need of repair and general tidying up of the vegetation and plant life around it.

Pot hole

ACTION REQUIRED: Fill all pot holes and re-tarmac where currently tarmacked and shingle unmade car park areas.

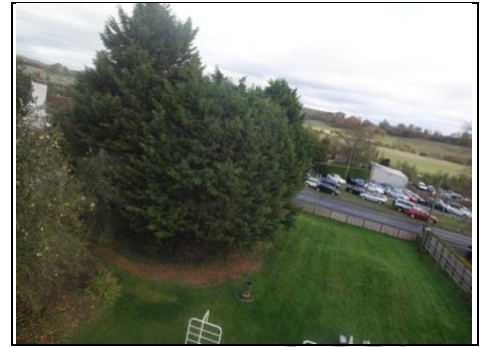
Overgrown conifers

ACTION REQUIRED: Cut back and maintain.

We would recommend an arboriculturalist (not a tree surgeon) is asked to view the property and give a ten year plan for maintenance.

ANTICIPATED COST: £500 - £1,000 for an arboriculturalist report. £2,500 - £5,000 to cut back trees depending upon how much they need cutting back; please obtain quotations.

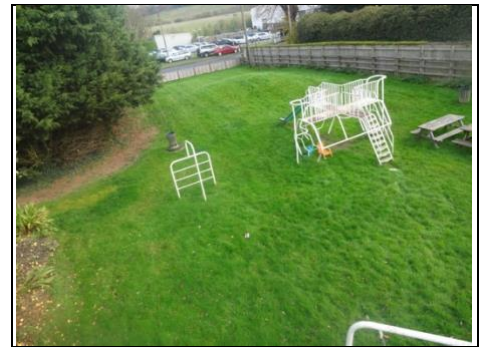
There is some metal play equipment which is rusting. It may not be safe to use.

Play equipment

ACTION REQUIRED: RoSPA safety check on play equipment required. You may need to replace it and/or fence it off or add signage regarding supervision and who should use it.
