# PHOTOGRAPHIC RECORD - PUB

## EXTERNAL - PUB

# PHOTOGRAPHIC RECORD - BARNS

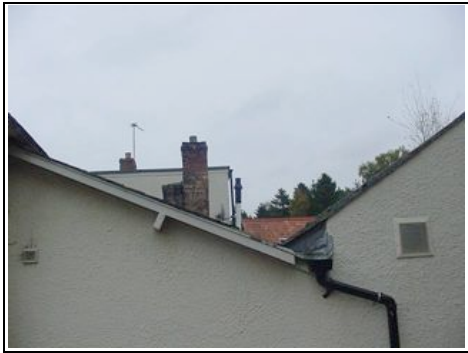
Defect to valley gutter to pub

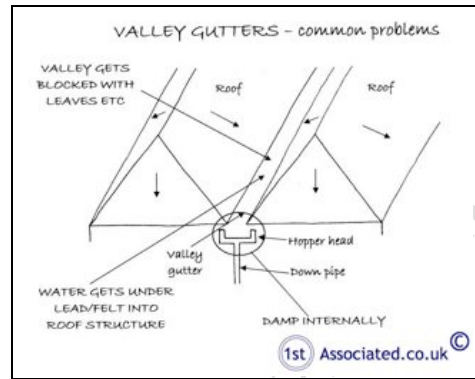
Valley gutter

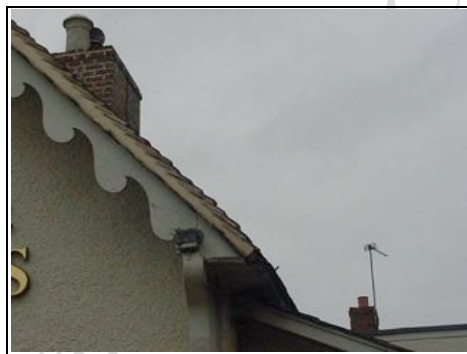
Cement repair to tiles rather than lime

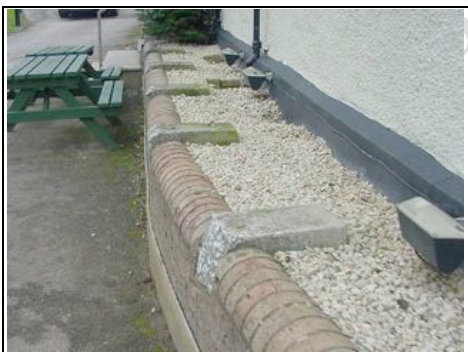
High ground level rather than French drain

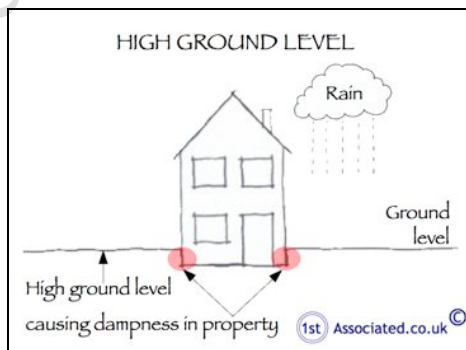
High ground level

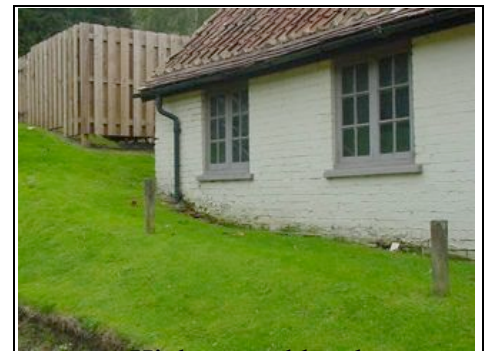
High ground level

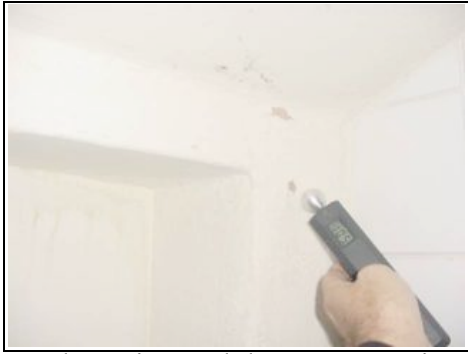
Condensation and dampness getting in relating to valley gutter on right side

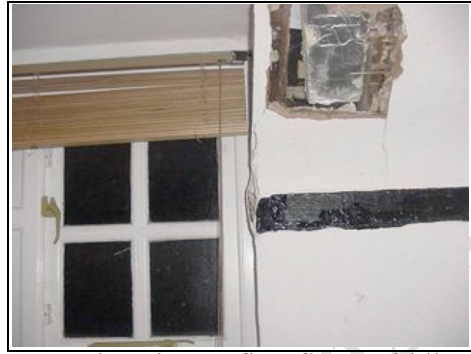
Deterioration to first floor middle room caused by work to roof

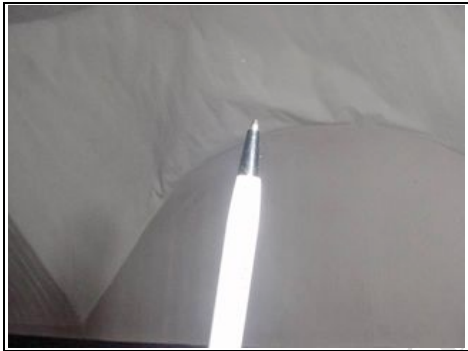
Dampness coming into eyebrow section of front right room

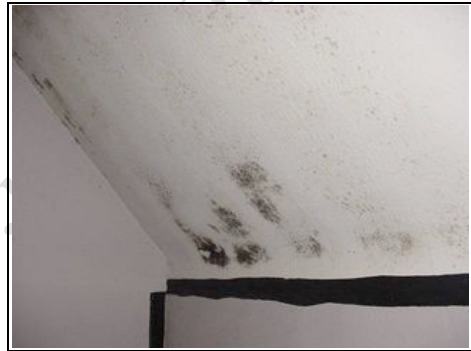
Cold bridging to left hand room

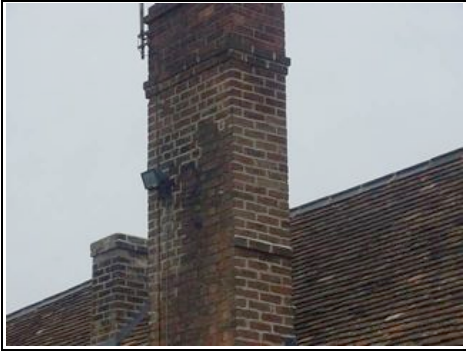
Weathering to chimney

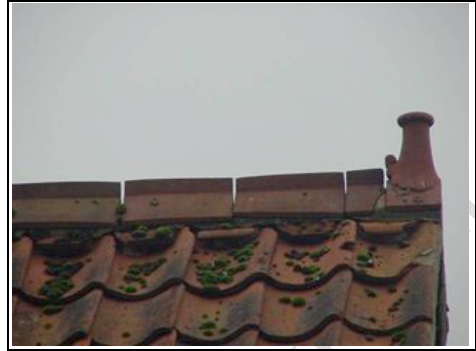
Weathered ridge tiles

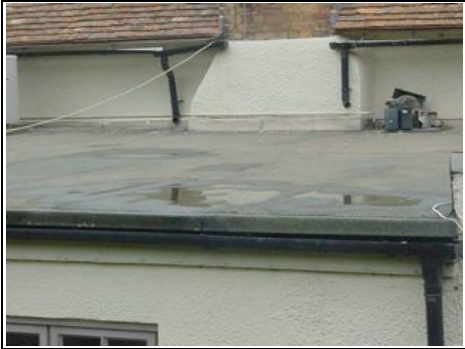
Ponding to flat roof

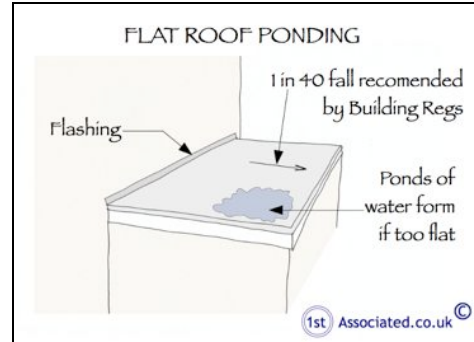
Flat roof ponding

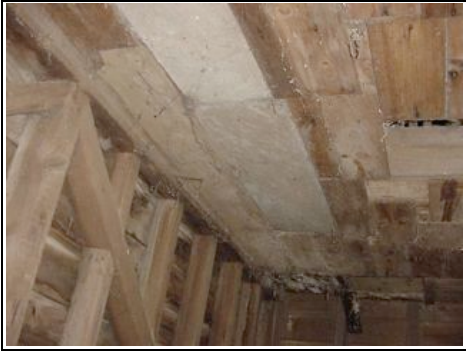
Asbestos

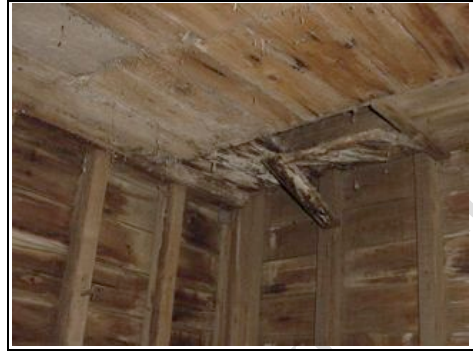
Wet rot, possibly dry rot to floor and walls

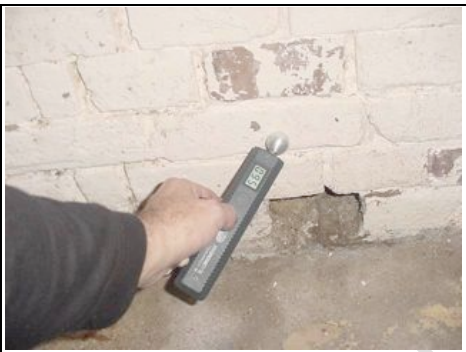
Very high damp meter readings generally and particularly to left side

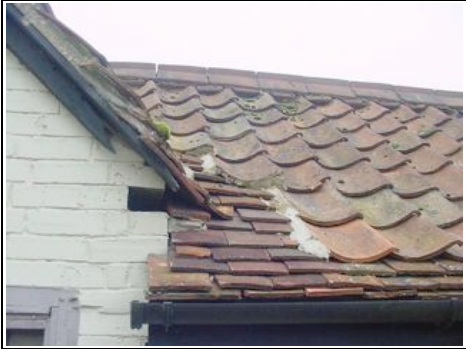
**You advised the tile repairs had been carried out by the brewer/property owner**

Cement mortar repairs to tiles

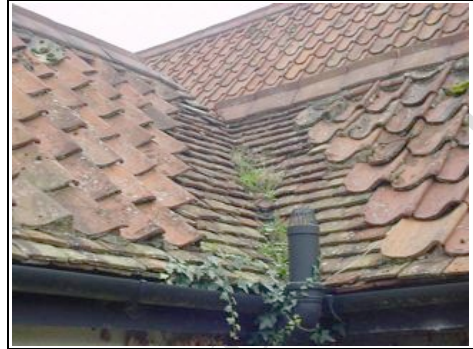
Vegetation growing from barn roof

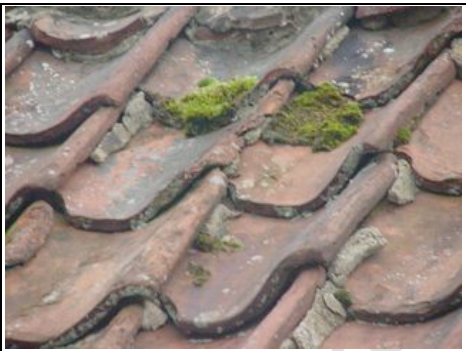
Vegetation

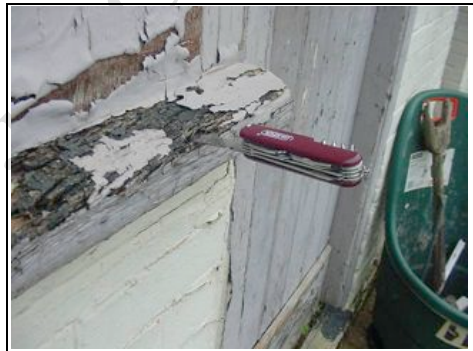
Lack of external painting

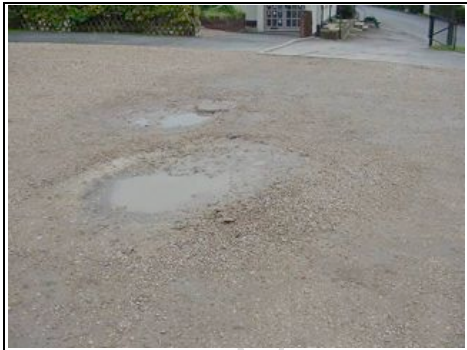
Deterioration to car park

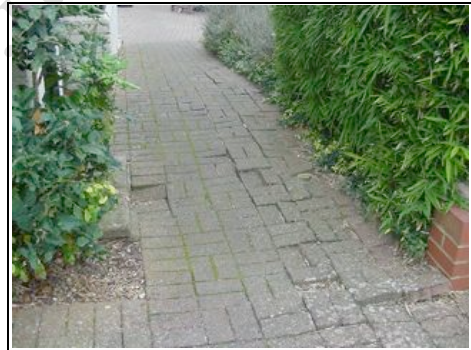
Areas of deterioration
