COMMERCIAL BUILDING SURVEY

**XXXXXXXXXX,
XXXXXXXXX, Lower Lydbrook,
Gloucestershire,
GL17 xxx**

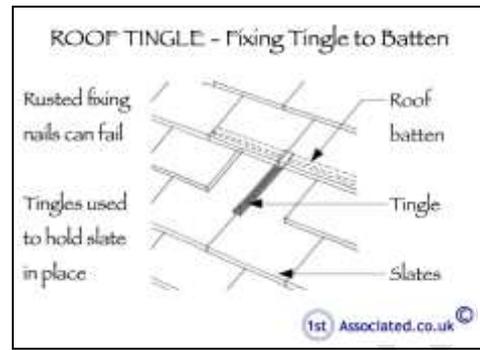
Main roof with some lead tingles

There is a possibility that the property has what is known as nail sickness. This is where the nail fixings have rusted and when you try to repair one section the entirety of that section will come away. We would base this on the fact that we can see lead tingles (please see our earlier photo and sketch).

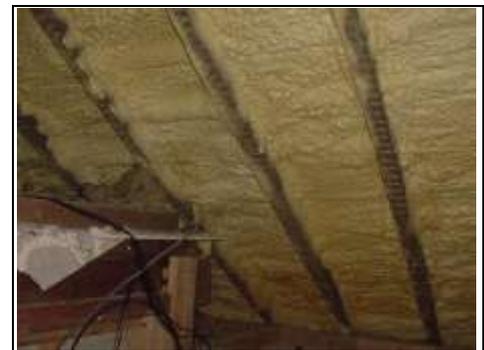
We can see the older style turnerising has been applied which is a liquid bitumen and helps resolve any dampness coming into the property. Internally the more modern spray foam has been added. Whilst there are various discussions over the usefulness of spray foam we would say the jury is still out, but we tend to be erring on the side of caution with this product. From what we can see it does promote dampness within the roof structure.

Spray foam in roof

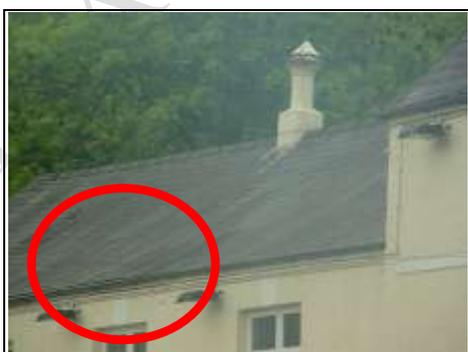
Our main concern is that the rafter feet have rotted on the left hand side to such an extent that the roof trusses will need replacing. We can see from within the roof there are areas of darker colour spray foam indicating to us that there is dampness. Whilst this isn't that big a job relatively speaking it will need scaffolding.

Common rafter feet have deteriorated in the area circled.

ACTION REQUIRED: The purchase of a tower scaffold as soon as possible together with replacement slates for your roof. We would recommend that you repair the roof as and when necessary. At the start of the summer of 2013 you need to open up sections of the roof for a closer inspection. By then after having repaired the roof for a year you will have got to know and understand it a lot better.

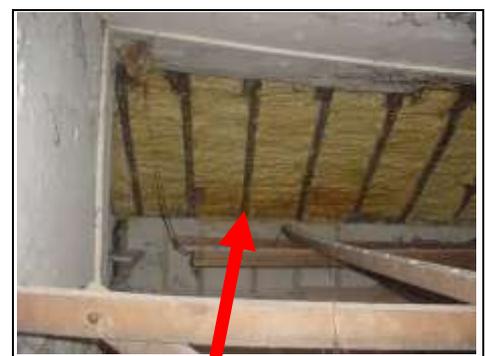
Discolouring could be due to dampness getting in

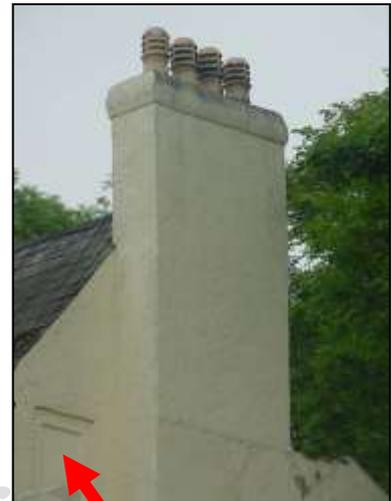
Lean in chimney and door blocked off

ACTION REQUIRED: Check the lining to this chimney and any chimneys you intend to use in the summer of 2012 and ventilate the ones that you will not be using.

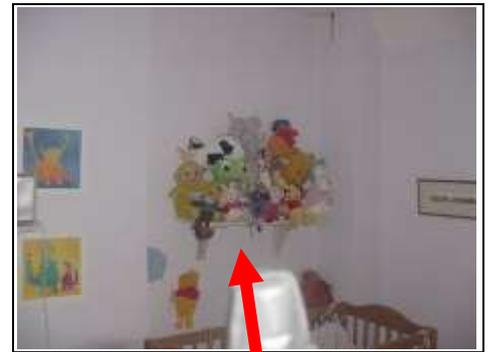
Door blocked off

ACTION REQUIRED: When carrying out the roof repair work/replacement also check the chimneys and repair as necessary.

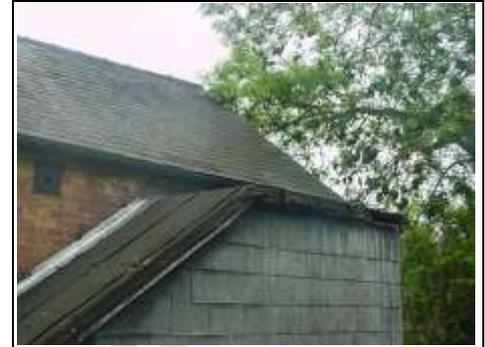
We feel priority has to be given to the worst roof first which from our visual inspection is the flat roof over the function room stairs. We can also see the flashings are in poor condition with a product used known as Flashband which we would say is a temporary repair material.

ACTION REQUIRED: Re-roof.

ANTICIPATED COST: £5,000 - £10,000 (five thousand to ten thousand pounds) depending upon the decking. We would always recommend with any of these re-roofs that you have insulation added as it makes sense to stop trying to heat the outside areas; please obtain quotations.

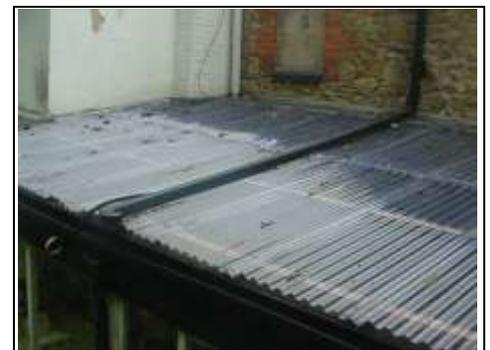
We can only imagine that the temporary fix of putting the plastic corrugated roof over the top of the felt roof was because of troublesome leaks over a period of time that the owners simply did not have the money to resolve.

Kitchen roof

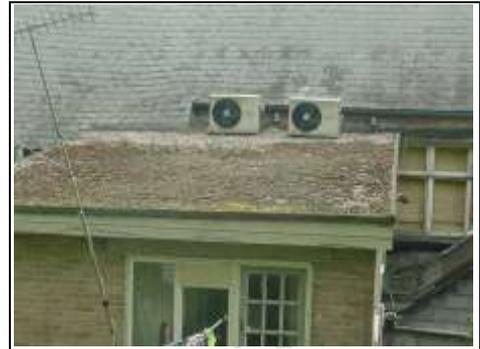
We are advised by the Chef that this is currently not leaking. However it is a very flat roof with a lot of moss on it indicating that water is sitting on it.

Chefs accommodation roof

ACTION REQUIRED: We would carry on a process of patch repair until the summer of 2014 when we recommend it is re-roofed with an insulation added. Insulation can be cut to falls to ensure there is a fall on the flat roof. New gutters and downpipes also need to be added.

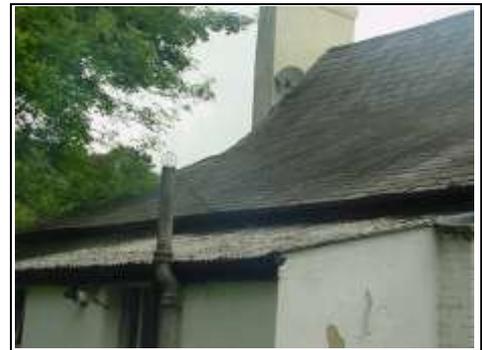
Asbestos roof

ACTION REQUIRED: Remove the asbestos remembering that you need to use asbestos approved contractors. The Local Authority can give you a list of these. Also you are liable for where the asbestos is tipped if it is not tipped correctly.

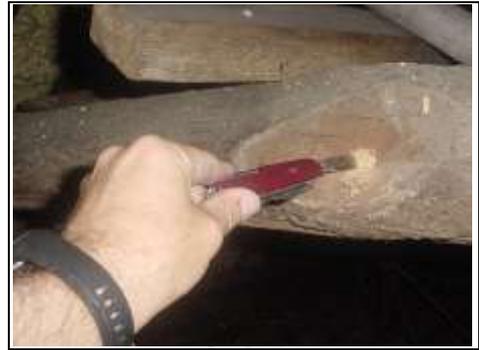
We can see active woodworm to the right hand side roof. We very rarely see active woodworm and we would comment that we feel that many of the woodworm companies blow woodworm out of all proportion regarding the problems it can cause. It takes a lot of woodworm holes to cause damage to a timber that we would term as significant structural damage.

Finding active woodworm

ACTION REQUIRED: In this roof we can see there is woodworm present. A chemical spray to the roof will be the best way forward. Although we don't normally recommend this it looks to be the best

course of action. We would also recommend the roof is vented. However this is very difficult where the roof has been spray foam insulated such as this one has. You will need to add this to the gable end of the roof.

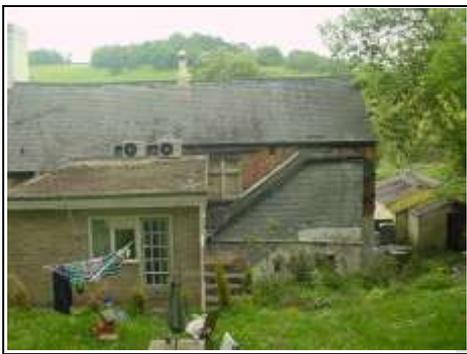
You appear to have a structural frame forming the rear extension that is used as the Chefs accommodation. The concrete looks to be deteriorating and requires repair.

Chefs Private Living
Accommodation

ACTION REQUIRED: The metal and the concrete needs to be inspected. We feel it is likely to need repair. Your Legal Advisor to obtain any information they can from the Local Authority with regard to this and forward it to us.

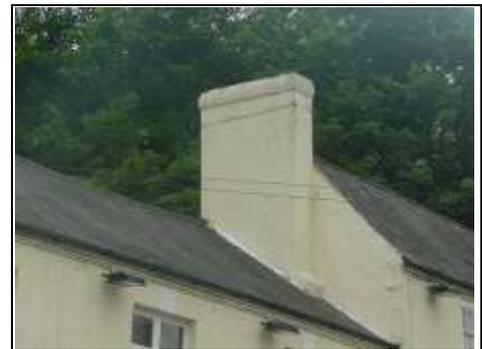
This chimney has a paint finish. From what we could see from ground level it looked in average condition considering its age, type and style with the exception of the base where there is a Flashband flashing. We would expect water to be getting in this area.

Middle Chimney

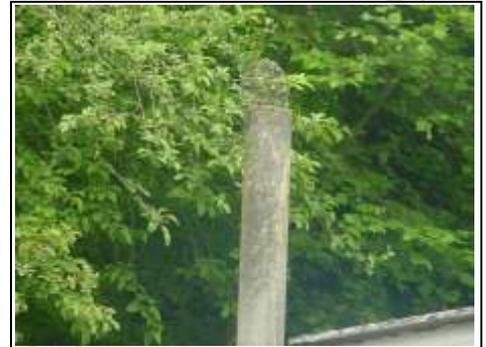
Asbestos Flue

ACTION REQUIRED: Please see our comments within the Executive Summary about removing asbestos.

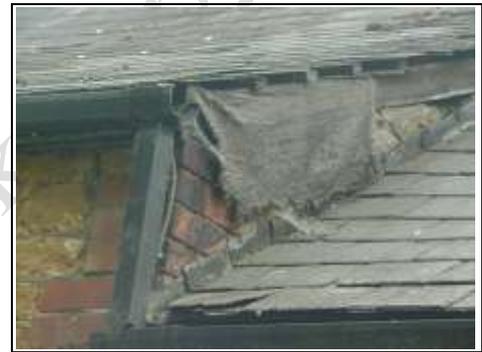
We do need to point out the detailing to the rear left hand side of the main roof where we can see that the battens are open and exposed and also that there is a slate flashing. This area is exposed to rain and wind and needs to be sealed as soon as possible.

Rear roof where battens are exposed.

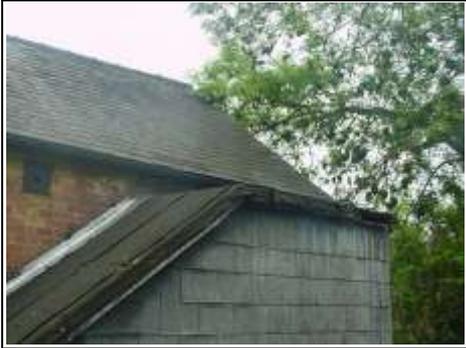
Flashband where the felt roof meets the main building.

ACTION REQUIRED: Please see our comments in the Executive Summary.

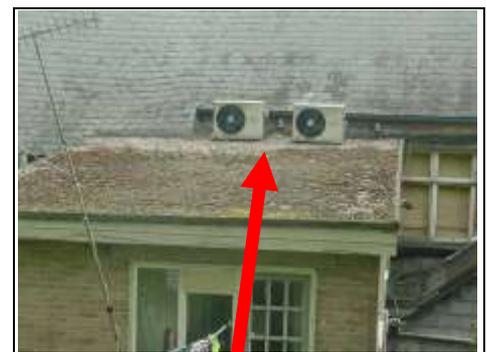
Chefs accommodation roof. Arrow indicates where the leak was.

ACTION REQUIRED: Please see our comments in the Executive Summary.

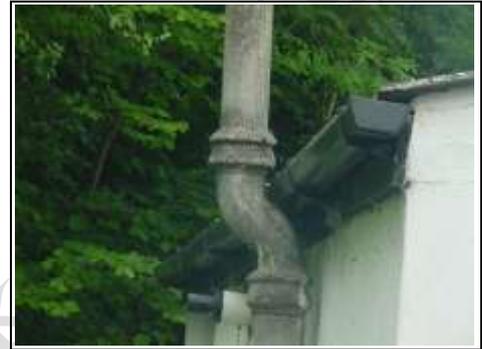
The property has cast iron, plastic and asbestos soil and vent pipes. The asbestos soil and vent pipe should be removed and the remaining soil and vent pipes should be checked.

Asbestos soil and vent pipe

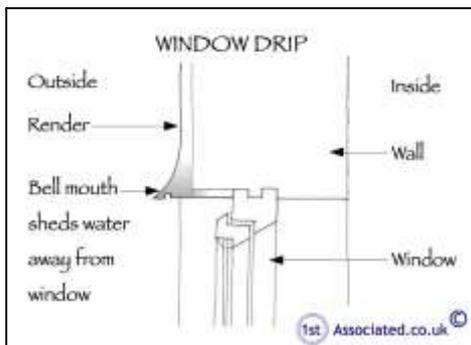
In this case we would comment that there are no drips to the render indicating that it is from the cheaper end of the market. There is also no bell mouth to the render. The render goes down to the ground meaning that capillary attraction will cause dampness at ground level and will bridge any damp proof course if there is one (which we doubt).

Drip detail

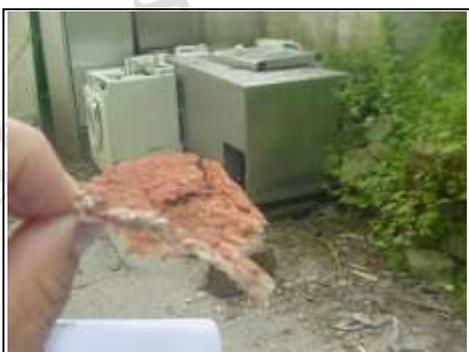
Piece of painted brick that came away

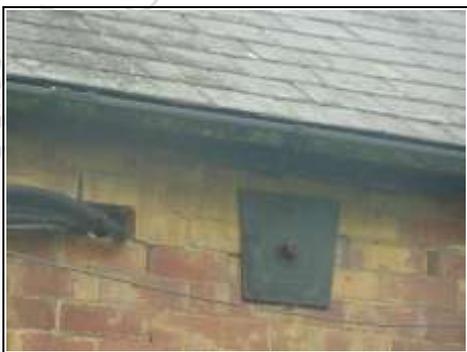
We can see the tie bar to the function room indicates that there has been movement in the walls which has been restrained by the tie bars. This has been hidden to the front of the property. There may be other areas of hidden structural repairs such as this which you will only be able to truly see once the property has been opened up. As mentioned earlier this tie bar may well have been put in place due to the roof defects that have perhaps caused roof spread.

Tie Bar on the back of the function room

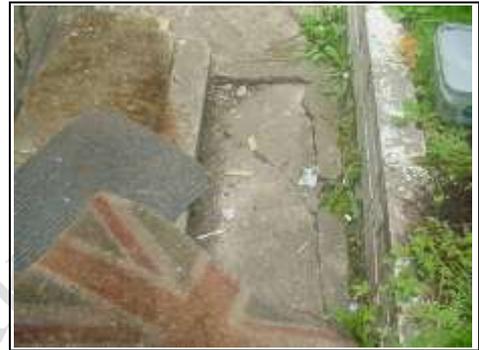
Movement next to Chefs private living accommodation

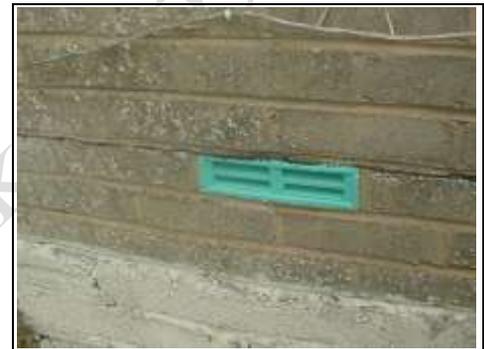
Airbricks are present to the Chefs private living accommodation and have been painted a turquoise/aqua colour. We have no idea why? This does indicate to us that there is a timber floor that needs ventilation and access to the floor. Unusually the floor had wood blocks similar to the ones that were found in the function room.

Air brick in chefs private living accommodation

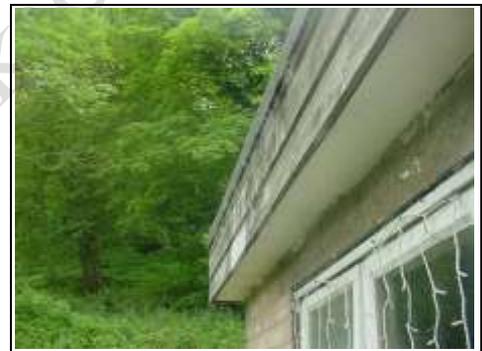
Fascia and soffit to the chefs private living accommodation

ACTION REQUIRED: You need to budget in your redecoration work to repair, replace and redecorate the fascia and soffit boards. Make sure gutters and downpipes are watertight before carrying out any work on fascias and soffits.

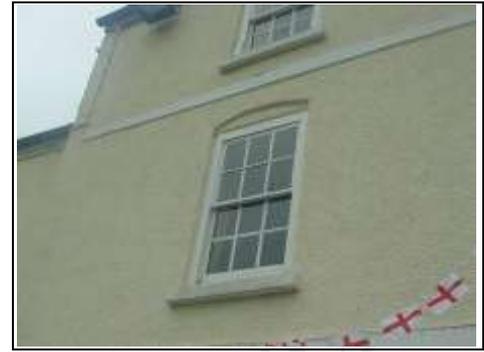
The property has predominantly single glazed timber sliding sash windows to the right hand side of the property, casement windows to the left hand side and a mixture of windows to the rear. We would specifically comment that all of them are in generally below average condition

Sliding sash window

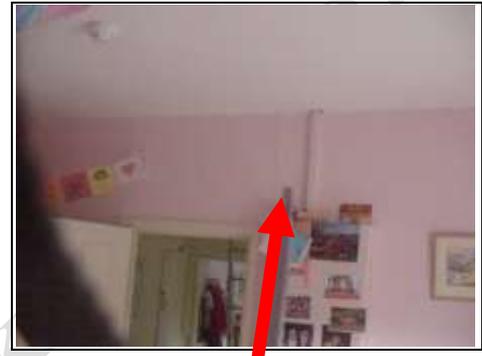
Hairline cracking in second floor left hand bedroom

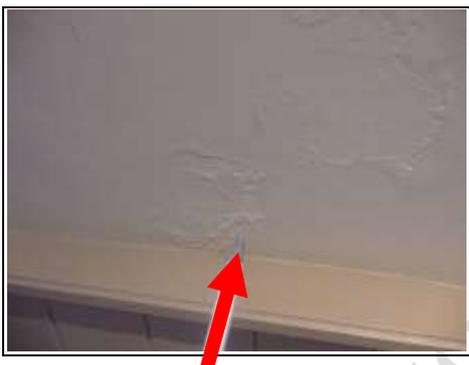
Dampness in front wall in left hand bar

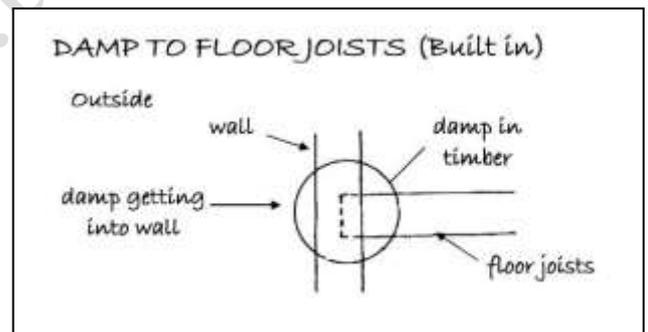
Damp to floor joists

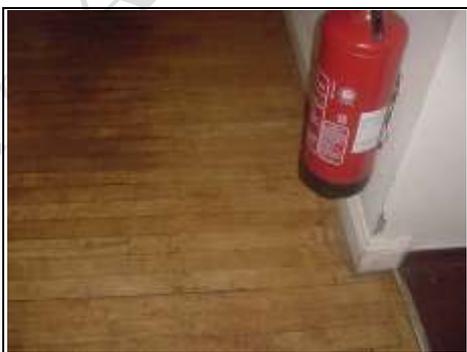
Condition of suspended floor in the function room

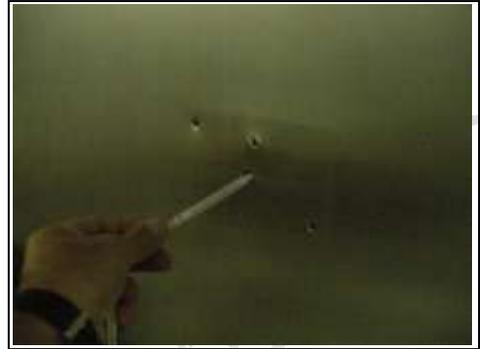
Holes in the stainless steel

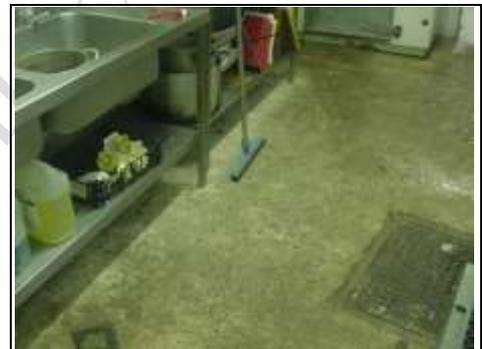
Floor that will not meet environmental health standards

ACTION REQUIRED: You advise us that you have spoken to the Environmental Health Officer. We would recommend that you actually meet with them.

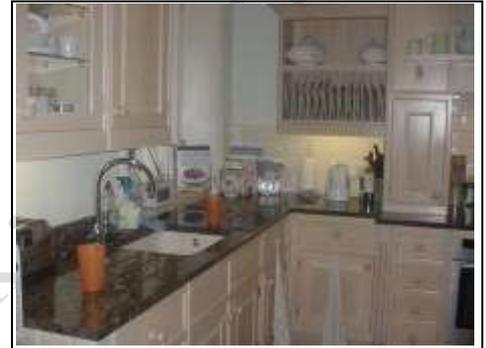
Wood exposed in kitchen

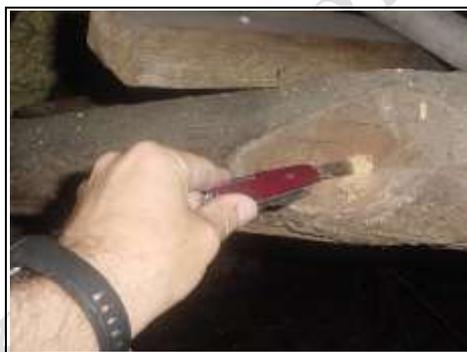
Active Woodworm in the roof

ACTION REQUIRED: Please see our comments within the Executive Summary. The only way to be 100 per cent certain with regard to woodworm is to have all areas emptied of fixtures and fittings and then have a re-check which we would be happy to carry out. Please contact us to discuss this.

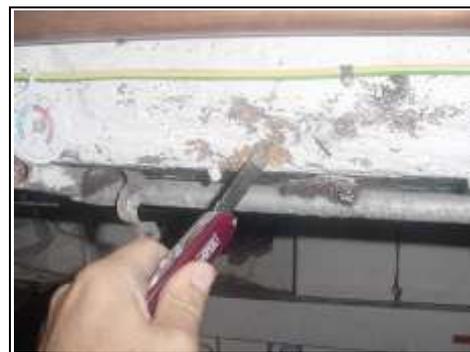
Active Woodworm in the cellar

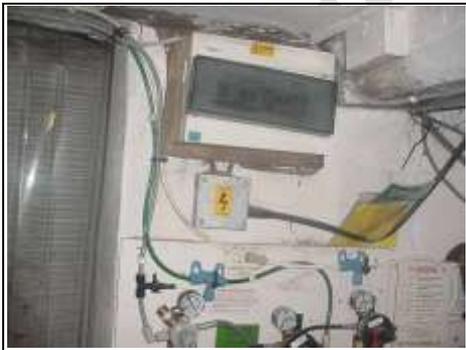
We do not usually see so many fuse boards even on a property of this size. It looks like the electrics have been added to over the years.

Electrics in the cellar

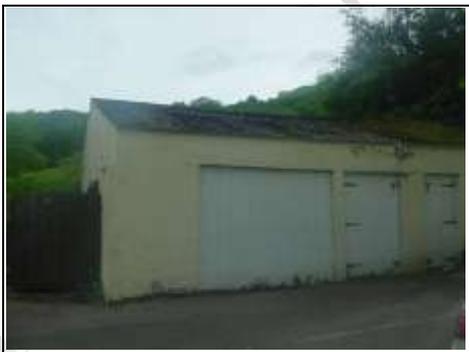
The outbuildings to the left hand side are generally in a dilapidated condition and they also have asbestos roofs. To the rear of the building which is close to the trees there is a large amount of cracking. We have classified this roof as being in a deteriorated condition.

Outbuilding with cracked asbestos roof

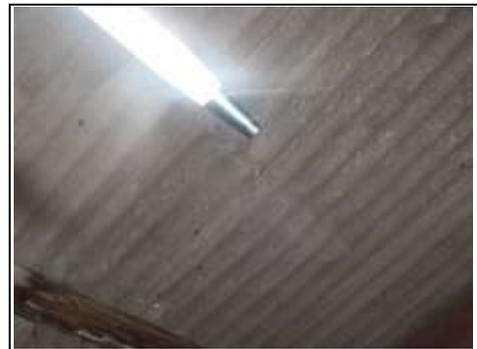
Asbestos roof – the pen identifies cracking in the roof

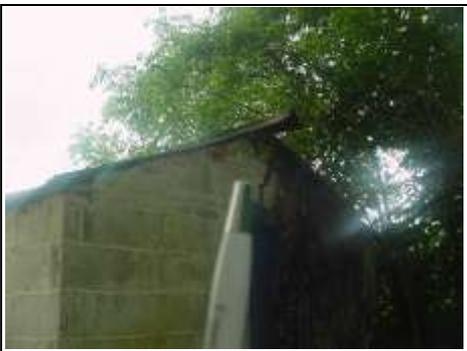
Huge crack to the rear of outbuilding because of the tree

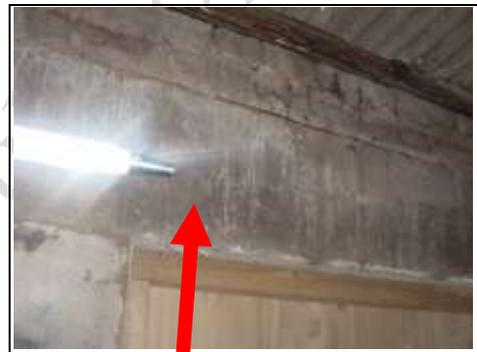
Crack to the lintel in the outbuilding
