# COMMERCIAL BUILDING SURVEY

XXX

Worcestershire  
WR8 XXX

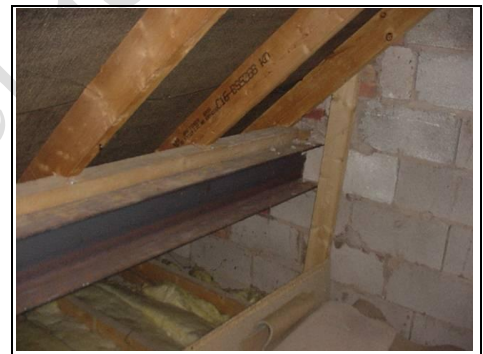
The roof with metal purlins has been added changing the roof from being a uniform distributed load (common in this type of building) to a point load roof without, as far as we could see, thought being given as to how the weight transfers through the structure as a whole.

Metal frame roof

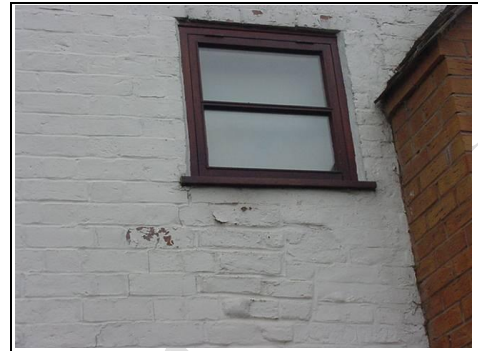
Point loading (from the structural frame type alteration) has been cracking both externally and internally.

Externally this is around the weaker areas which are to the windows and internally not directly this is below the metal "I" beam which is visible in the form of hairline cracks with the exception of the walls where it is hidden by dry lining covering (sometimes known as false walls) or plaster or similar.

Cracking to corner of window

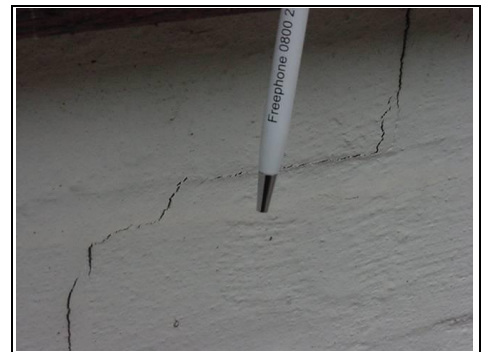
Cracking to right hand side

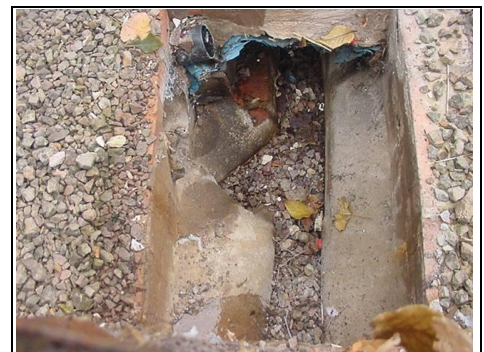
We believe that the drains may be leaking and contributing to the movement of the structure.

Rainwater drains to left hand side

**ACTION REQUIRED:** We would recommend a closed circuit TV camera report is carried out to establish if there are any problems with the drains, this could relate to cracking from the drains to open joints.

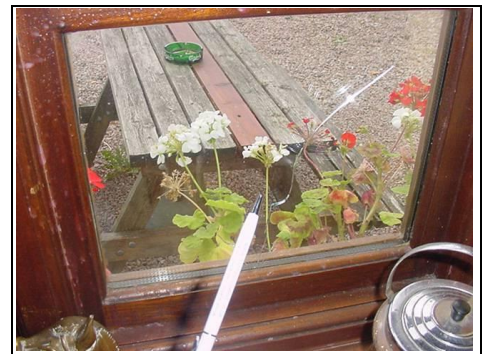
Cracked glass could indicate movement is still occurring

We can also see signs that it is still moving such as the cracked glass pane to the front of the property which whilst it could have occurred from an accident could also have occurred from movement in the structure (as well as movement in the timber window itself). The way it has cracked would indicate movement to the left hand wall.

We would add from a one off inspection it is impossible to be one hundred per cent certain and most insurance companies and the Building Research Establishment (commonly known as BRE) recommend monitoring for at least a year which is what we would recommend in this case.

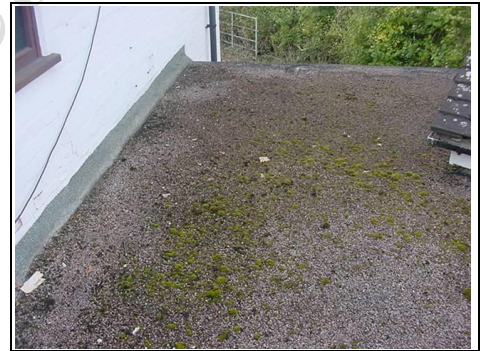
To the rear of the property is a large flat roof. The main problem with this flat roof is that it is flat without a typical fall of fifteen degrees. This means that water sits on the roof and causes the moss that you can see as well as reducing the life of the roof which will of course cause problems with leaks coming in as can be seen in the corridor downstairs (although the temporary management company advised that as far as they were aware it was not a problem when it rains anymore).

We would also add with this older style roof probably from the 1960s/1970s that usually there is next to no insulation in the roof which is not ideal in the ever increasing energy costs.

Flat roof with moss

**ACTION REQUIRED:** Ideally we would recommend a pitched roof is added however we also find flat roofs that have insulation cut to falls added and then a high performance felt have an increased thermal efficiency level and of course an extended life. We would also look at the detailing which currently has felt flashings and replace these with lead flashings. We would add that patch repair will no doubt continue the life of the roof for some years to come however it is an ever increasing problem.

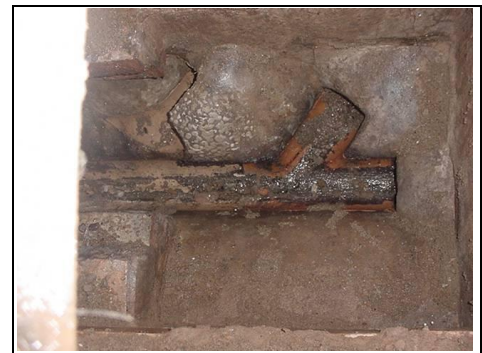
We also noted that there was no grease trap present. With a food based public house we believe this is essential as it stops not only you blocking your own drains but other people's drains.

No grease trap present in drains

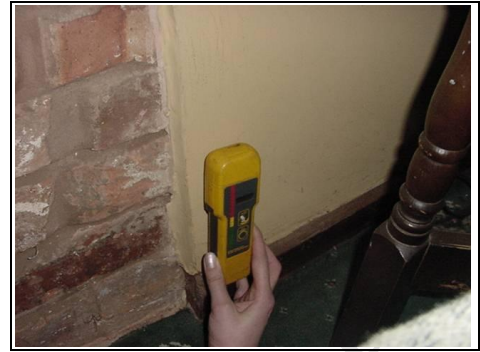
We found rising damp to the property on external and internal walls. We believe that predominately this relates to a combination of issues:-

- 5.1) The high ground level particularly to the right hand side (all directions given as you face the property) of the property. Please see further information regarding French drains in the Appendices

Rising damp detected

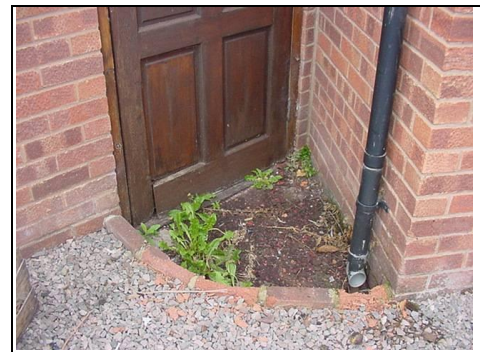
- 5.2) The rainwater pipes as you correctly noted discharge to the rear of the property and into the property itself.

Rainwater discharges and goes through door to cellar

**ACTION REQUIRED:** We would recommend a view of all the rainwater drains and this combined with your new drainage system should alleviate the problem of the rainwater being discharged into your cellar!

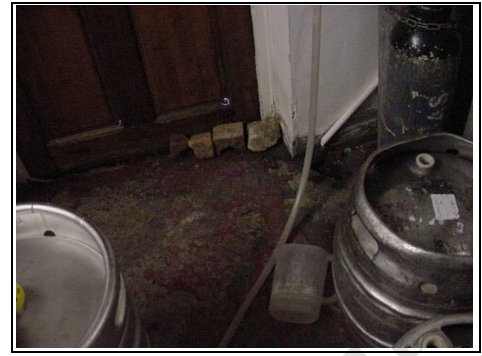
Cellar area behind door where rainwater can get in.

We would always recommend that the rainwater goods are cleaned out the joints are checked and the alignment checked to ensure that the gutters fall towards the downpipes.

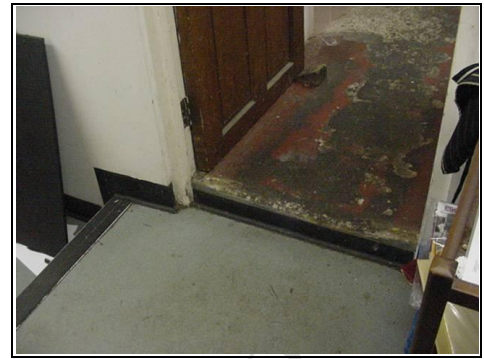
Degrading cellar floor

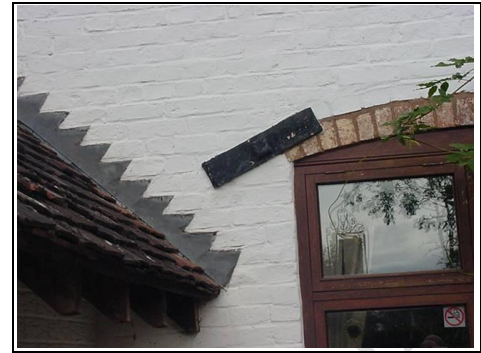
The floor deflects more than we would expect at first floor level. This again points us to there being problems with the structure as mentioned elsewhere in this section. We believe that some of these problems are long term as we can see a tie bar externally (as well as cracking and movement and re-building).

Tie bars have normally been added where lateral restraint from the floor joists has deteriorated or failed for some reason or other. This can mean that the floor joists have rotted or may have been attacked by woodworm or that walls have been removed having their resistance reduced/removed. In this case there is no way of knowing without opening up the structure.

Tie bar

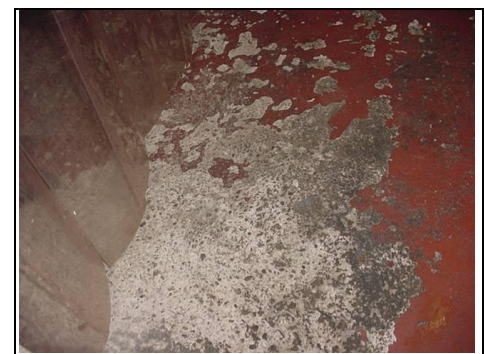
Cellar floor degrading

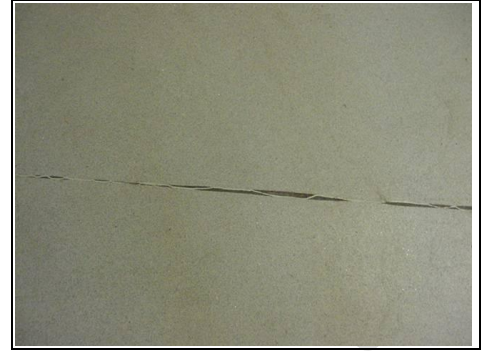
Altro style flooring in kitchen deteriorating

**ACTION REQUIRED:** We would recommend a “cup of tea meeting” with Environmental Health officers before you purchase the property to establish a list of work to be completed.

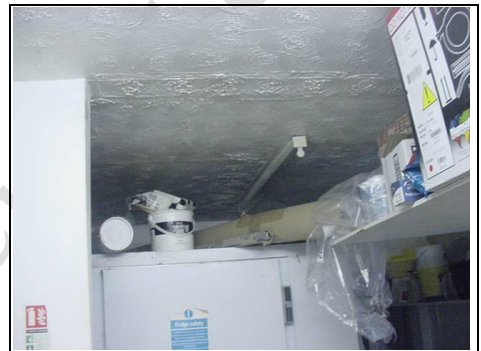
Textured ceiling to kitchen (often known by its trade name Artex)

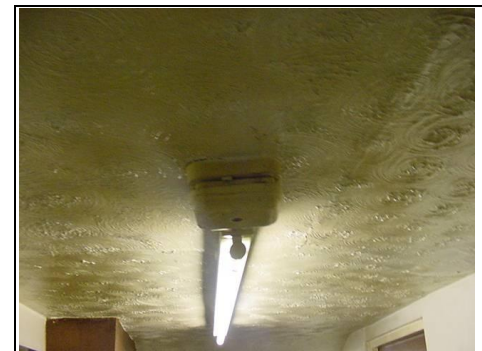
As far as we could see the property only has battery operated fire alarms which we do not feel it acceptable for a public house. We would recommend a hard wired fire alarm system is installed ideally with indicators to exactly where the fire is.

Battery operated fire alarms

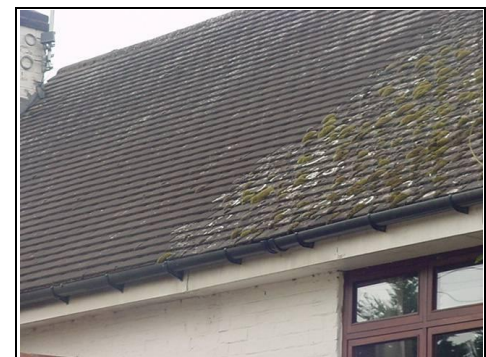
There is quite a lot of moss to the rear roof indicating that it does not get much sunlight and we find that it is best to remove the moss as it can cause deterioration to the roof tiles.

Moss to main roof

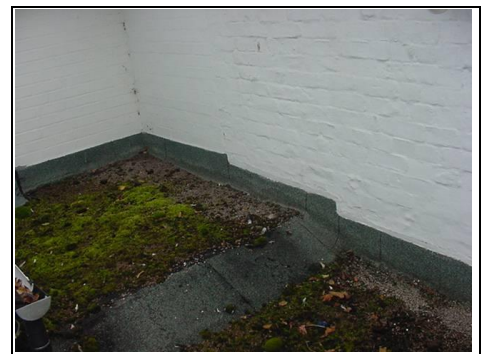
Moss to flat roof

**ACTION REQUIRED:** Please see our comments in the Executive Summary.

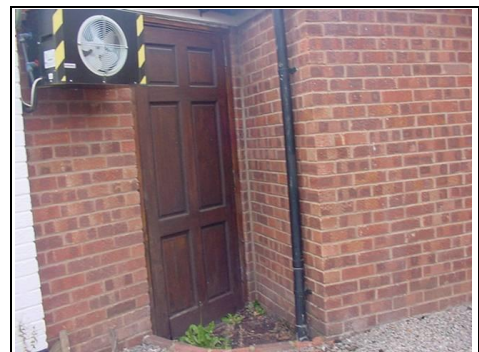
From ground level the gutters and downpipes looked to be plastic. There is a terrible detail to the rear where all of the rainwater from the rear roof is discharging onto and around the flat roof areas and then down a downpipe and into the cellar area as far as we can see, as you rightly drew to our attention.

Downpipe allowing rainwater to discharge into cellar

**ACTION REQUIRED:** We would always recommend that the gutters and downpipes are cleaned out, the joints are checked and the alignment checked to ensure that the gutters fall towards the downpipes. Please see our comments in the Executive Summary.

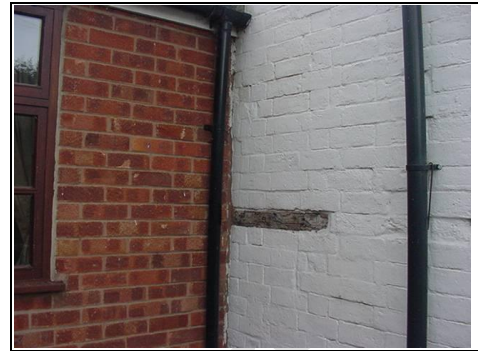
Before the 19th Century, the practice of building timbers into external walls was almost universal. These were known as bonding timbers. They are of course prone to rot as solid walls allow dampness through. Unfortunately, without opening up the structure, we are unable to confirm if this is the case.

Bonding timber

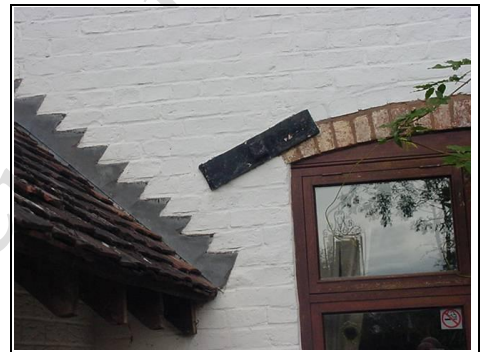
Tie bar

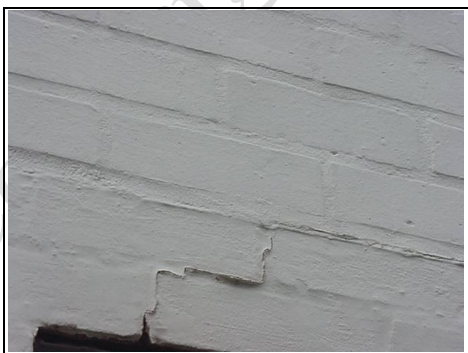
Cracking to Stretcher Bond  
brickwork

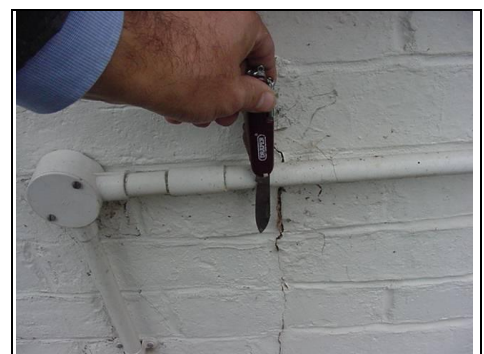
Cracking to rear

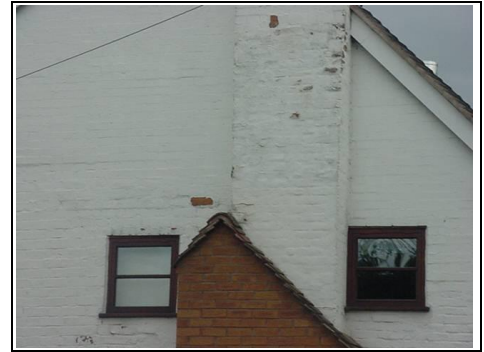
Spalling brickwork is occurring, this typically occurs on this type of property a softer red brick where dampness is getting into it. In this particular case we believe that a plastic paint has been used which is stopping the building breathing causing spalling. Often we would comment about this sort of problem within the Executive Summary however you have more basic problems to deal with.

Spalling brickwork

**ACTION REQUIRED:** Gradually remove the plastic based paint and replace it with a breathable paint.

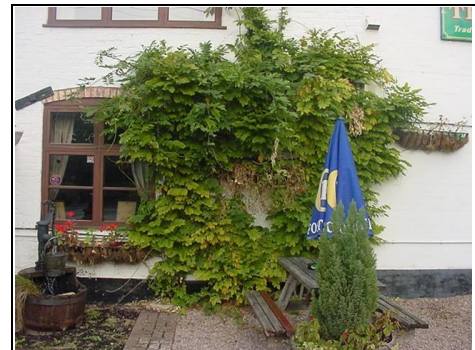
There is vegetation to the front of the property which needs to be cut back to ensure that rainwater and snow does not sit on it and cause dampness to get into the property. It was actually damp behind this area at the time of our survey.

Vegetation to the front of the property.

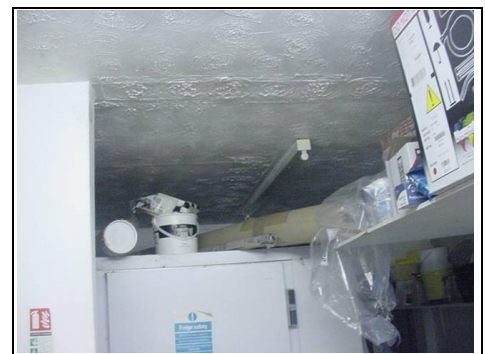
Textured ceiling in kitchen and cellar

**ACTION REQUIRED:** We would recommend a skim coat of plaster and paint finish.

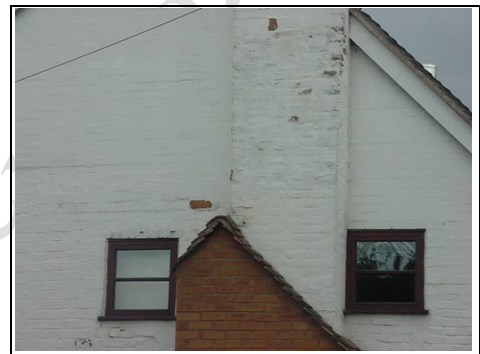
Spalling brickwork

**ACTION REQUIRED:** Please see our comments in the Executive Summary and in External decorations.

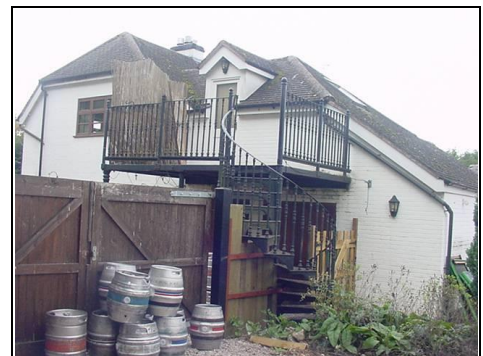
Rusting to spiral staircase

**ACTION REQUIRED:** Redecorate in the summer of 2012.
