COMMERCIAL BUILDING SURVEY

xxxxxxxxxx,
xxxxxxxx, Lower Lydbrook,
Gloucestershire,
GL17 xxx

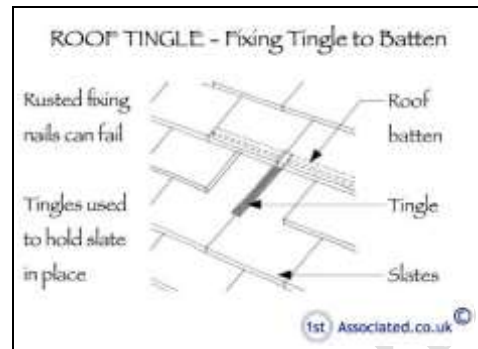
Main roof with some lead tingles

Roof tingles

There is a possibility that the property has what is known as nail sickness. This is where the nail fixings have rusted and when you try to repair one section the entirety of that section will come away. We would base this on the fact that we can see lead tingles (please see our earlier photo and sketch).

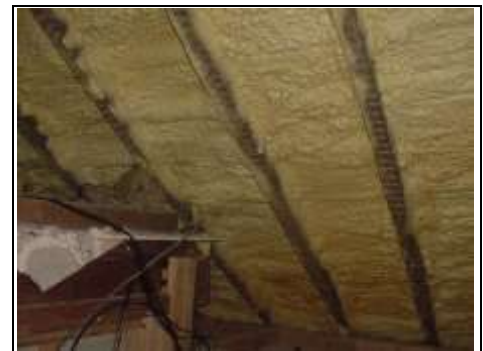
We can see the older style turnerising has been applied which is a liquid bitumen and helps resolve any dampness coming into the property. Internally the more modern spray foam has been added. Whilst there are various discussions over the usefulness of spray foam we would say the jury is still out, but we tend to be erring on the side of caution with this product. From what we can see it does promote dampness within the roof structure.

Spray foam in roof

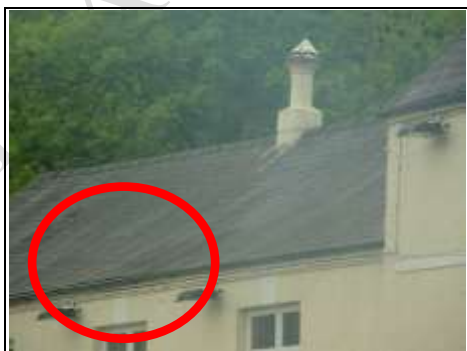
Our main concern is that the rafter feet have rotted on the left hand side to such an extent that the roof trusses will need replacing. We can see from within the roof there are areas of darker colour spray foam indicating to us that there is dampness. Whilst this isn't that big a job relatively speaking it will need scaffolding.

Common rafter feet have deteriorated in the area circled.

ACTION REQUIRED: The purchase of a tower scaffold as soon as possible together with replacement slates for your roof. We would recommend that you repair the roof as and when necessary. At the start of the summer of 2013 you need to open up sections of the roof for a closer inspection. By then after having repaired the roof for a year you will have got to know and understand it a lot better.

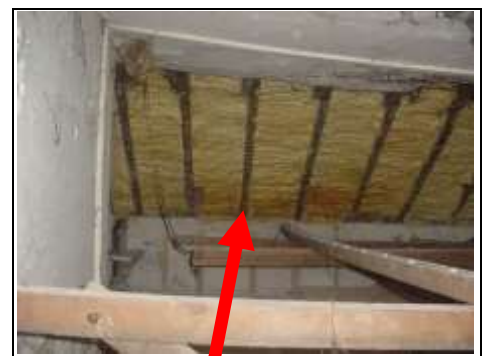
Discolouring could be due to dampness getting in

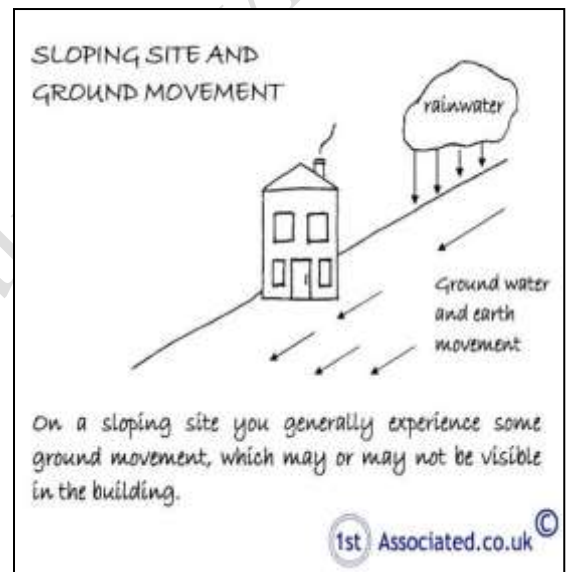
Sloping site

Medium Priority

With regard to this we feel a definite path should be built around the property to minimise deterioration. We draw your attention to section eight of the report in particular.

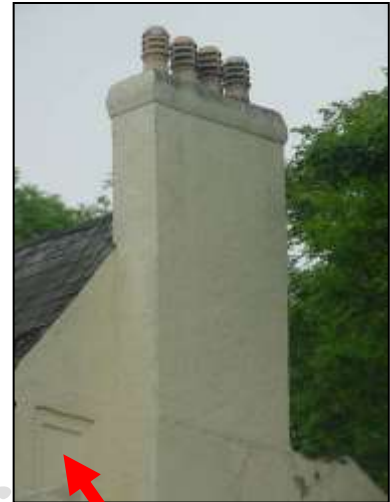
Lean in chimney and door blocked off

ACTION REQUIRED: Check the lining to this chimney and any chimneys you intend to use in the summer of 2012 and ventilate the ones that you will not be using.

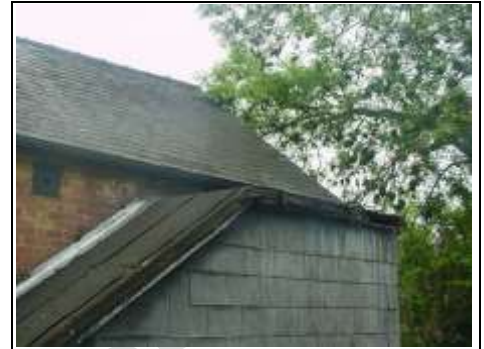
We feel priority has to be given to the worst roof first which from our visual inspection is the flat roof over the function room stairs. We can also see the flashings are in poor condition with a product used known as Flashband which we would say is a temporary repair material.

ACTION REQUIRED: Re-roof.

ANTICIPATED COST: £5,000 - £10,000 (five thousand to ten thousand pounds) depending upon the decking. We would always recommend with any of these re-roofs that you have insulation added as it makes sense to stop trying to heat the outside areas; please obtain quotations.

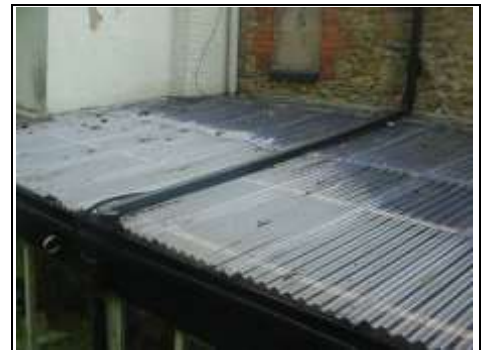
We can only imagine that the temporary fix of putting the plastic corrugated roof over the top of the felt roof was because of troublesome leaks over a period of time that the owners simply did not have the money to resolve.

Kitchen roof

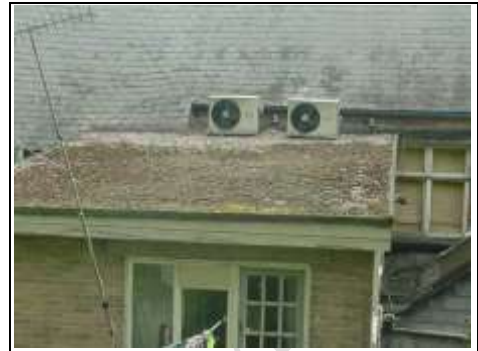
We are advised by the Chef that this is currently not leaking. However it is a very flat roof with a lot of moss on it indicating that water is sitting on it.

Chefs accommodation roof

ACTION REQUIRED: We would carry on a process of patch repair until the summer of 2014 when we recommend it is re-roofed with an insulation added. Insulation can be cut to falls to ensure there is a fall on the flat roof. New gutters and downpipes also need to be added.

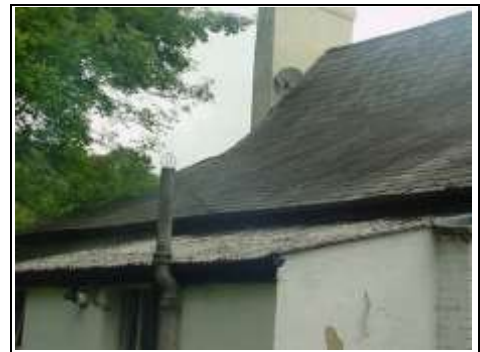
Asbestos roof

This really depends upon the asbestos report. We would generally recommend to get rid of all asbestos as soon as possible.

ACTION REQUIRED: Remove the asbestos remembering that you need to use asbestos approved contractors. The Local Authority can give you a list of these. Also you are liable for where the asbestos is tipped if it is not tipped correctly.

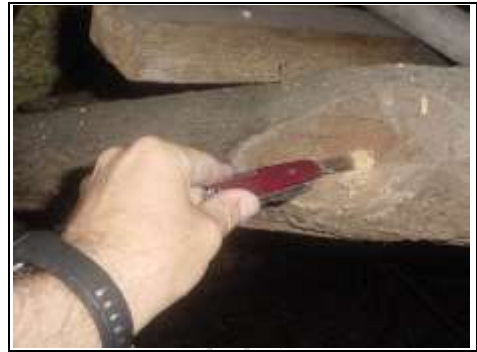
We can see active woodworm to the right hand side roof. We very rarely see active woodworm and we would comment that we feel that many of the woodworm companies blow woodworm out of all proportion regarding the problems it can cause. It takes a lot of woodworm holes to cause damage to a timber that we would term as significant structural damage.

Finding active woodworm

ACTION REQUIRED: In this roof we can see there is woodworm present. A chemical spray to the roof will be the best way forward. Although we don't normally recommend this it looks to be the best

course of action. We would also recommend the roof is vented. However this is very difficult where the roof has been spray foam insulated such as this one has. You will need to add this to the gable end of the roof.

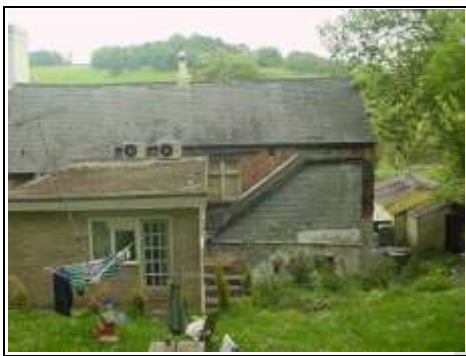
You appear to have a structural frame forming the rear extension that is used as the Chefs accommodation. The concrete looks to be deteriorating and requires repair.

Chefs Private Living
Accommodation

ACTION REQUIRED: The metal and the concrete needs to be inspected. We feel it is likely to need repair. Your Legal Advisor to obtain any information they can from the Local Authority with regard to this and forward it to us.

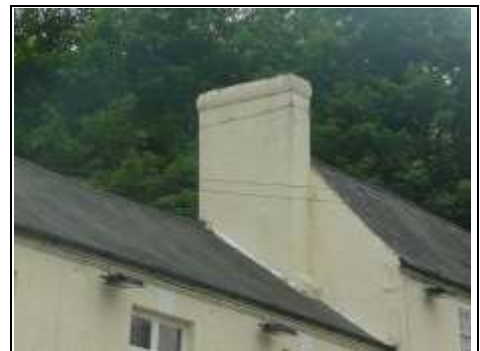
This chimney has a paint finish. From what we could see from ground level it looked in average condition considering its age, type and style with the exception of the base where there is a Flashband flashing. We would expect water to be getting in this area.

Middle Chimney

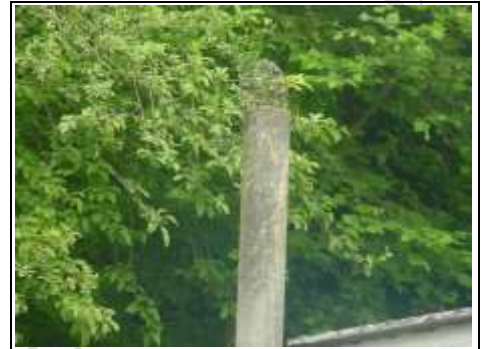
Asbestos Flue

ACTION REQUIRED: Please see our comments within the Executive Summary about removing asbestos.

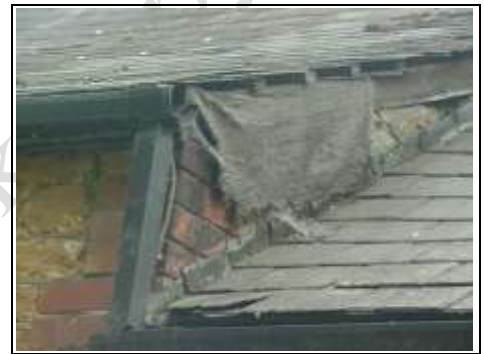
We do need to point out the detailing to the rear left hand side of the main roof where we can see that the battens are open and exposed and also that there is a slate flashing. This area is exposed to rain and wind and needs to be sealed as soon as possible.

Rear roof where battens are exposed.

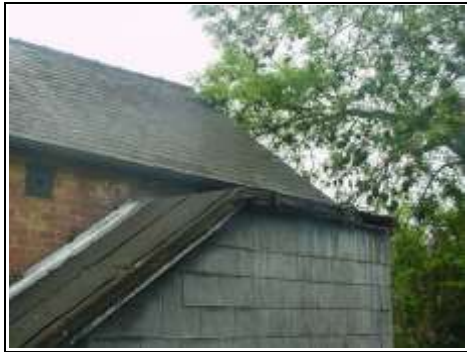
Flashband where the felt roof meets the main building.

ACTION REQUIRED: Please see our comments in the Executive Summary.

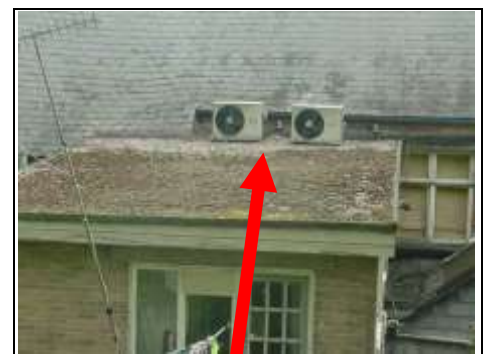
Chefs accommodation roof. Arrow indicates where the leak was.

ACTION REQUIRED: Please see our comments in the Executive Summary.

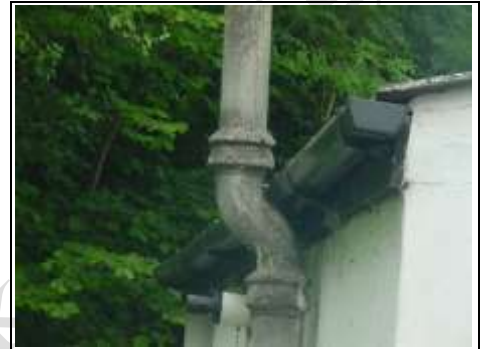
The property has cast iron, plastic and asbestos soil and vent pipes. The asbestos soil and vent pipe should be removed and the remaining soil and vent pipes should be checked.

Asbestos soil and vent pipe

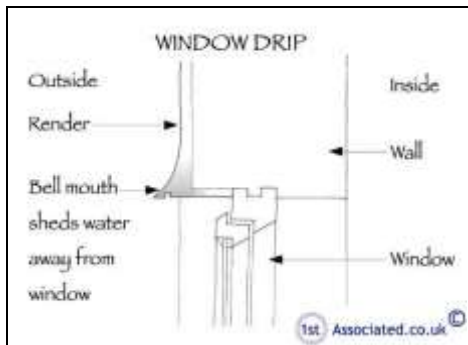
In this case we would comment that there are no drips to the render indicating that it is from the cheaper end of the market. There is also no bell mouth to the render. The render goes down to the ground meaning that capillary attraction will cause dampness at ground level and will bridge any damp proof course if there is one (which we doubt).

Drip detail

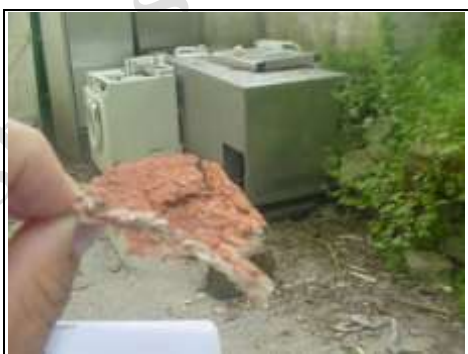
Piece of painted brick that came away

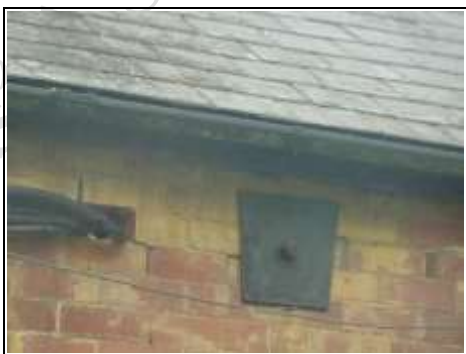
We can see the tie bar to the function room indicates that there has been movement in the walls which has been restrained by the tie bars. This has been hidden to the front of the property. There may be other areas of hidden structural repairs such as this which you will only be able to truly see once the property has been opened up. As mentioned earlier this tie bar may well have been put in place due to the roof defects that have perhaps caused roof spread.

Tie Bar on the back of the function room

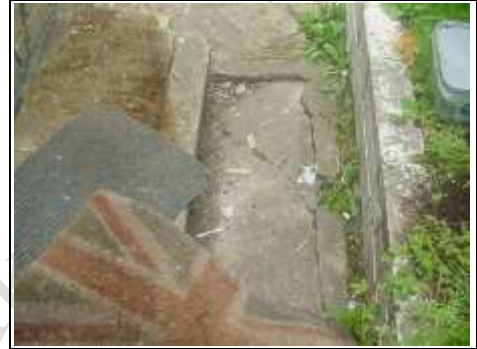
Movement next to Chefs private living accommodation

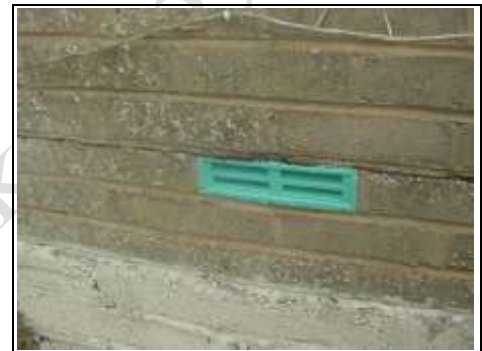
Airbricks are present to the Chefs private living accommodation and have been painted a turquoise/aqua colour. We have no idea why? This does indicate to us that there is a timber floor that needs ventilation and access to the floor. Unusually the floor had wood blocks similar to the ones that were found in the function room.

Air brick in chefs private living accommodation

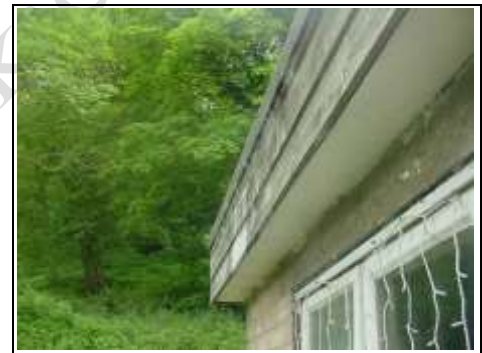
Fascia and soffit to the chefs private living accommodation

ACTION REQUIRED: You need to budget in your redecoration work to repair, replace and redecorate the fascia and soffit boards. Make sure gutters and downpipes are watertight before carrying out any work on fascias and soffits.

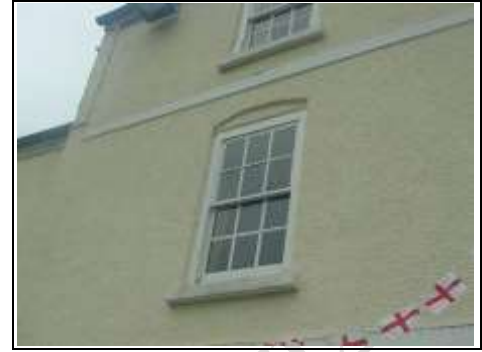
The property has predominantly single glazed timber sliding sash windows to the right hand side of the property, casement windows to the left hand side and a mixture of windows to the rear. We would specifically comment that all of them are in generally below average condition

Sliding sash window

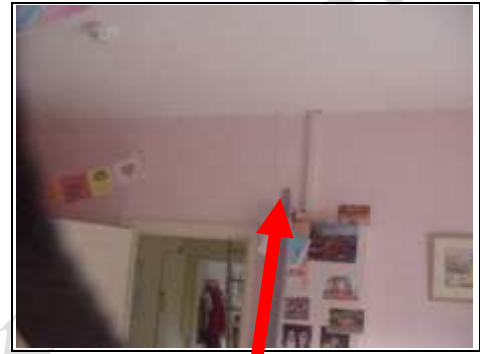
Hairline cracking in second floor left hand bedroom

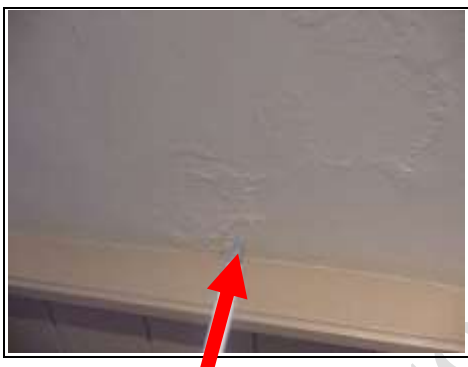
Dampness in front wall in left hand bar

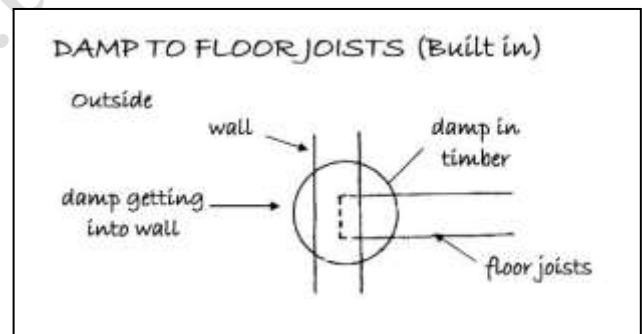
Damp to floor joists

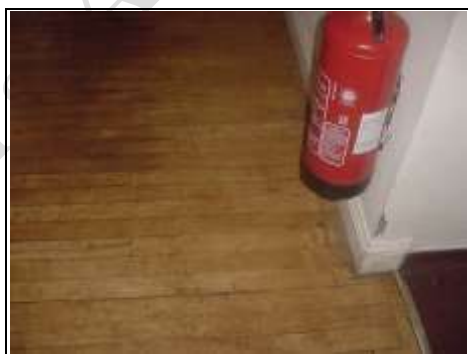
Condition of suspended floor in the function room

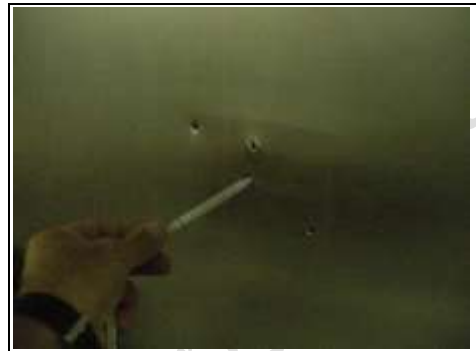
Holes in the stainless steel

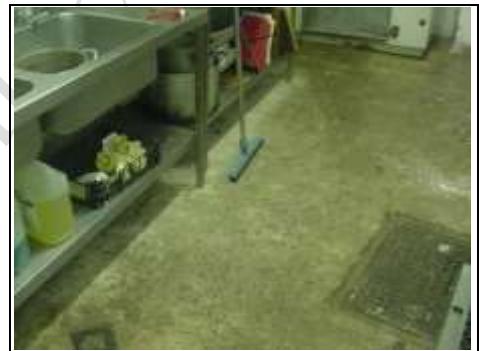
Floor that will not meet environmental health standards

ACTION REQUIRED: You advise us that you have spoken to the Environmental Health Officer. We would recommend that you actually meet with them.

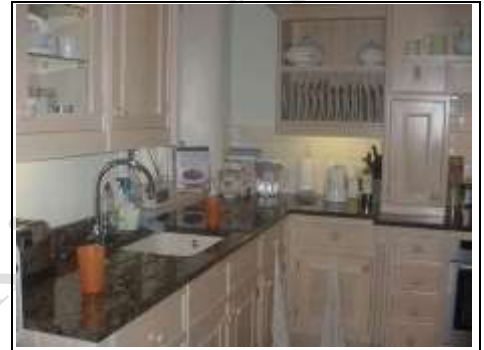
Wood exposed in kitchen

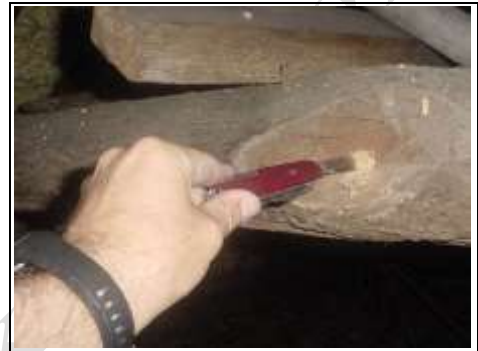
Active Woodworm in the roof

ACTION REQUIRED: Please see our comments within the Executive Summary. The only way to be 100 per cent certain with regard to woodworm is to have all areas emptied of fixtures and fittings and then have a re-check which we would be happy to carry out. Please contact us to discuss this.

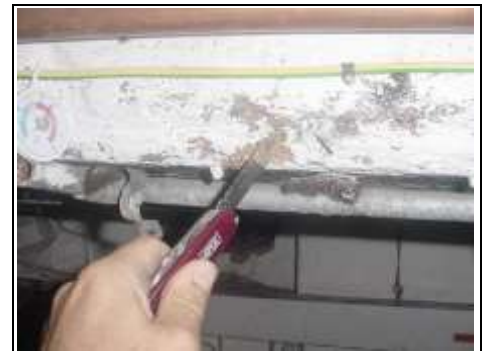
Active Woodworm in the cellar

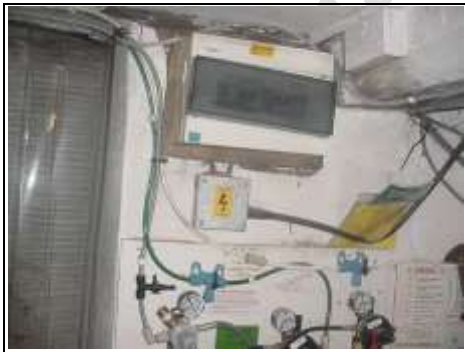
We do not usually see so many fuse boards even on a property of this size. It looks like the electrics have been added to over the years.

Electrics in the cellar

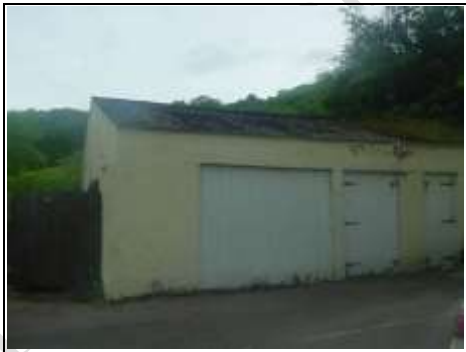
Outbuilding with cracked asbestos roof

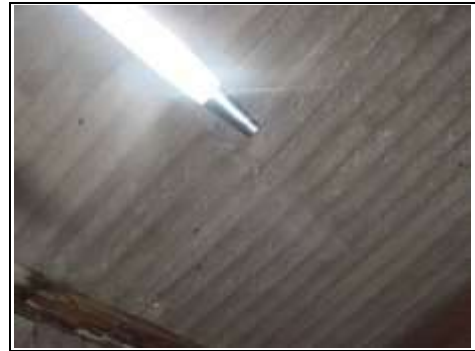
Asbestos roof – the pen identifies cracking in the roof

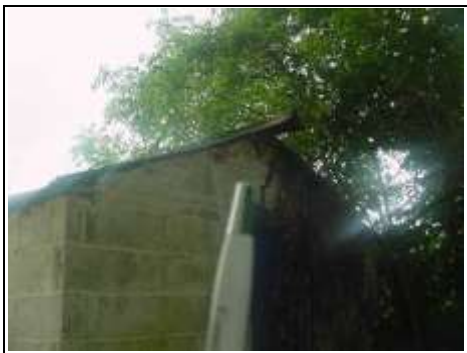
Huge crack to the rear of outbuilding because of the tree

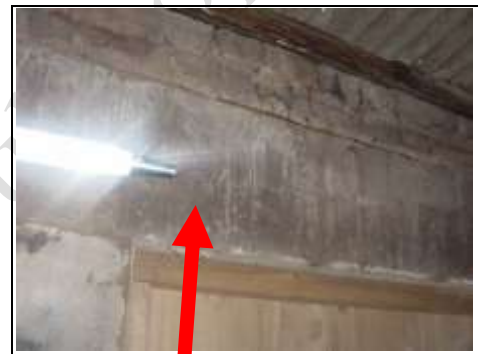
Crack to the lintel in the outbuilding
