SCHEDULE OF CONDITION

Swanley

We have been instructed to inspect and prepare a Schedule of Condition for XXXX, Swanley, Kent. BR8 XXX.

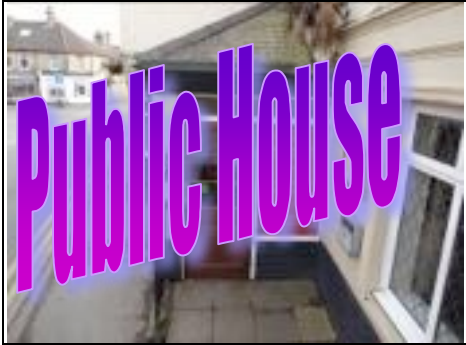
Front External Elevation

Front entrance

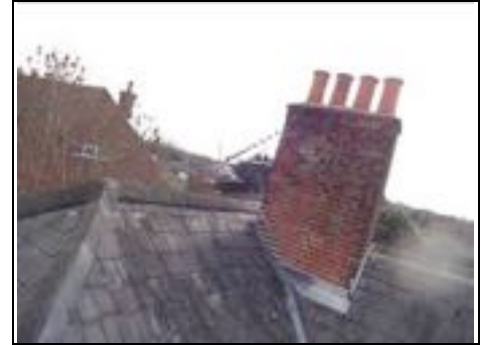
Front roof and chimney

Weathered	Repoint within the next five years
Roofs: Main roof Pitched, clad with slates Limited view of roof from ground level	<p>Numerous problems including wood deterioration to roof structure and large number of tingles to the rear part of the roof indicating there could be nail sickness.</p> <p>Roof being repaired at time of our inspection.</p> <p>Repairs to ridge</p>

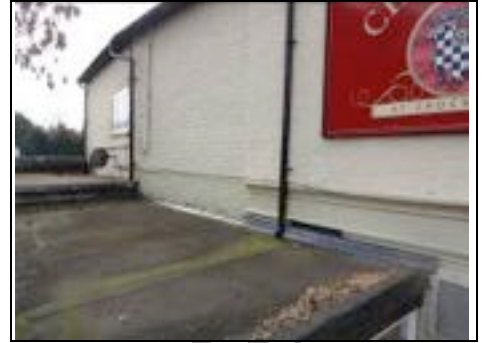
Left elevation

DESCRIPTION	CONDITION	ACTION REQUIRED
Chimneys:		See Front Elevation
Roofs: Hipped, clad with slates Limited view of roof from ground level	Deteriorating, numerous lead tingles used and also dips and undulations in the roof.  	See Front Elevation and Exclude from lease
Flat roofs: Flat felt roof  		See Front elevation

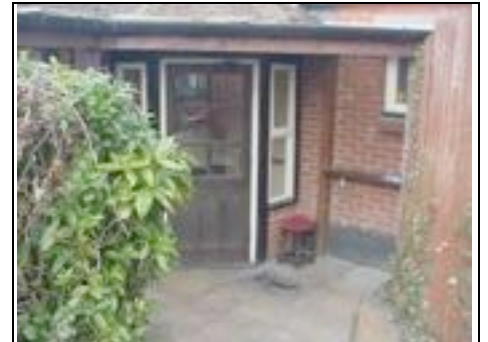
Rear elevation

Rear left entrance

<p>Deflection and undulations in the roof Deterioration to timber structure beneath roof</p>  	<p>Work required to roof structure.</p>
<p>Low level Roofs: Hipped, clad with concrete tiles to rear left</p>  		
<p>Hidden flat roof to middle</p>  	<p>Flat flat roof with moss sitting on it which will accelerate deterioration. Dampness coming into toilet area which may be via hidden flat roof/adjoining pitched roofs.</p>    	<p>Repair/renew</p>
<p>Shallow pitched roof, clad with concrete tiles to middle</p>	<p>Repairs to flashing</p>

Recommend re-roofing to rear of property. See Front Elevation and Exclude from lease

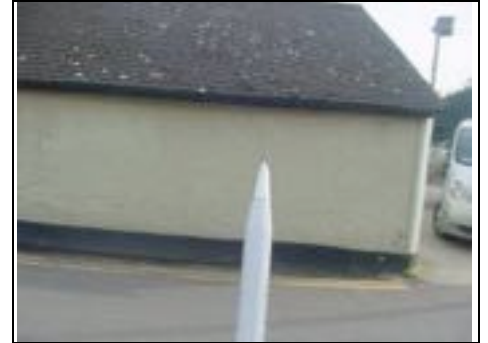
Right elevation

Cracking

<p>Cracking visible, this may be long term movement or new movement/progressive cracking.</p>

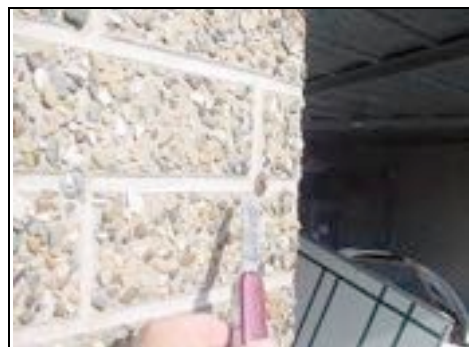
Rusting fittings

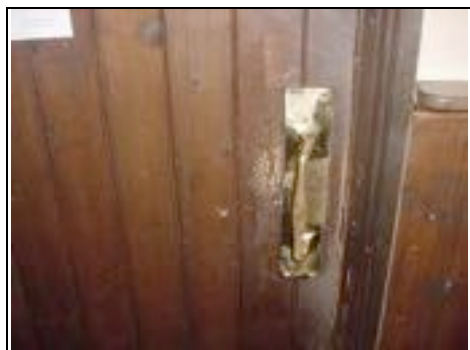
Worn door

Detailing: Doors: Stained timber door	 Worn  	 Repair, prepare/sand and re-stain
Services:		See Services Section

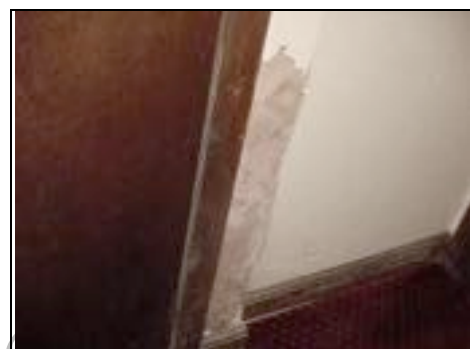
Paint coming off walls

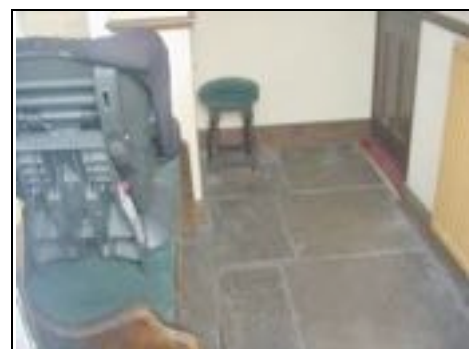
Flagstones

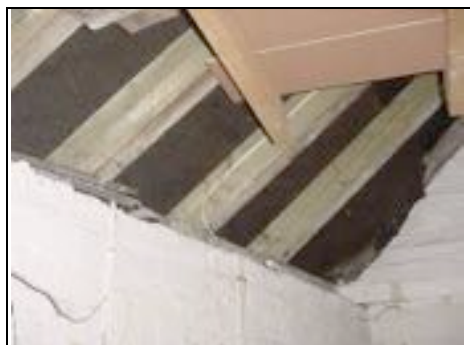
Open ceiling

DESCRIPTION	CONDITION	ACTION REQUIRED
Ceiling: Open ceiling, common rafters visible	Common rafters backed to backed (additional support) Dampness staining to common rafters

Signs of woodworm	Resolve dampness and woodworm.
Walls: Painted	Dampness deteriorating and Cracking visible to external of the walls	Resolve dampness Repair, prepare and redecorate. Property owner to place insurance claim
Floors: Concrete	Marked	Make good

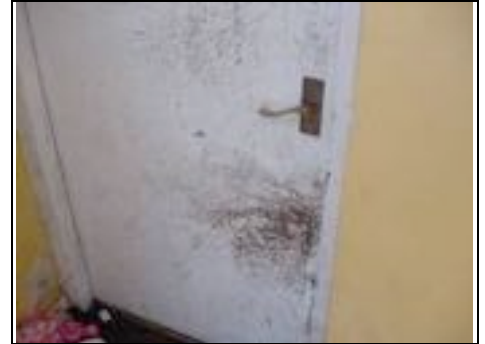
Inner entrance hall

Door damaged

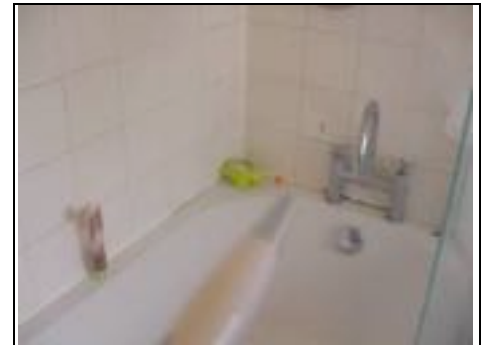
Mould to mastic

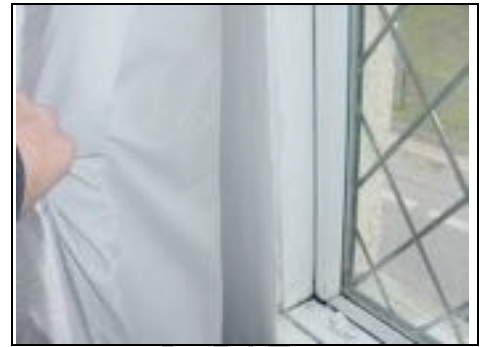
Mould to window

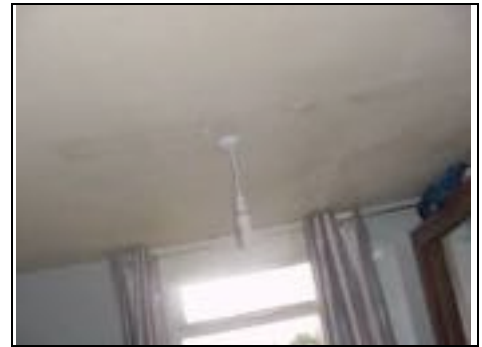
Dampness to ceiling

DESCRIPTION	CONDITION	ACTION REQUIRED
Ceiling: Painted	Undulating Signs of dampness around windows	Resolve dampness Repair, prepare and redecorate.
Walls: Modern plaster Timber boarded partition rather than studwork partition Dry lining	Marked	Repair, prepare and redecorate. Possible dampness problem.
Floors: Carpet	Worn Floors uneven	Replace
Detailing: Windows: Plastic double glazed	Dated	Clean

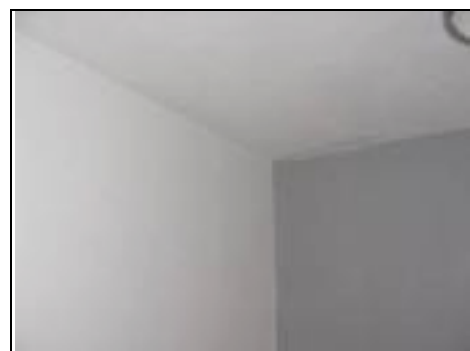
Dampness from roof

DESCRIPTION	CONDITION	ACTION REQUIRED
Ceiling: Modern painted plaster	Marked, some dampness visible	Resolve dampness Repair, prepare and redecorate.
Walls: Modern painted plaster Dry lining	Marked	Repair, prepare and redecorate. Possible dampness problem.
Floors: Carpet	Worn Uneven floor	Replace
Detailing: Windows: Plastic double glazed	Dirty	Deep clean
