PROPERTY REPORT AND NEGOTIATION DOCUMENT

INDEPENDENT CHARTERED SURVEYORS

The XXX Public House
XXX
XXXX
Swanley,
Kent, BR8 XXX

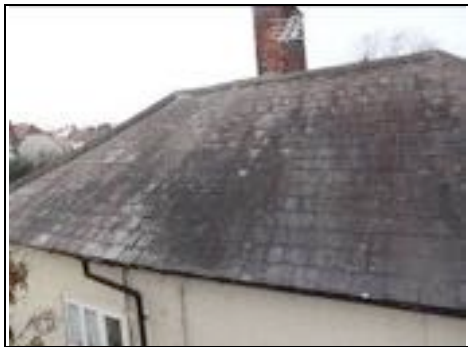
The main pitched hipped slate roof has had long term problems, we can see this from the propping of the timber within the roof structure particularly to the left side. There also appears to be general damage to the timber including wet rot and woodworm and also there looks to have been a fire or there is a defect in the chimney that is allowing smoke into the roof. The roof is in a relatively poor condition, ideally it should be excluded from the lease.

Problems to slate roof on left side

ACTION REQUIRED: We recommend that the roof area is excluded from the lease or completely refurbished by the property owners or the present leaseholders.

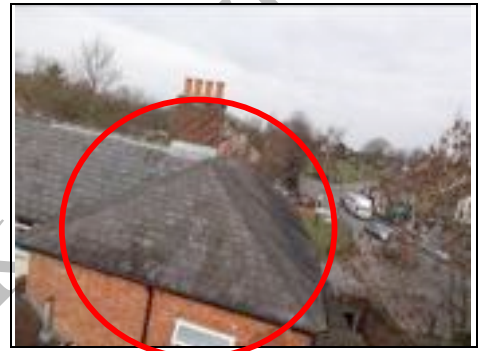
Problems with roof to the rear

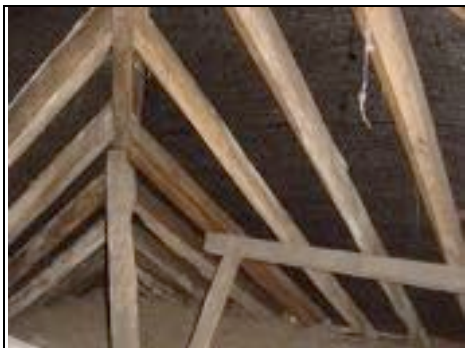
Props

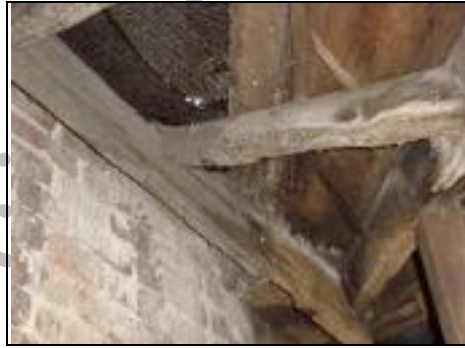
Fire damage/chimney smoke

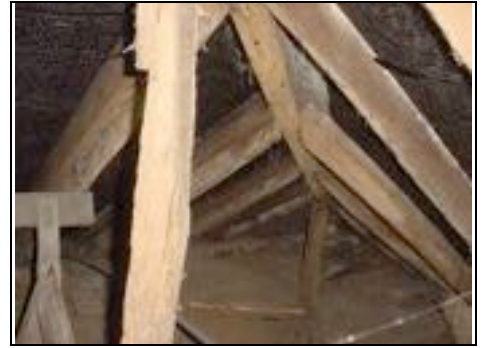
Woodworm

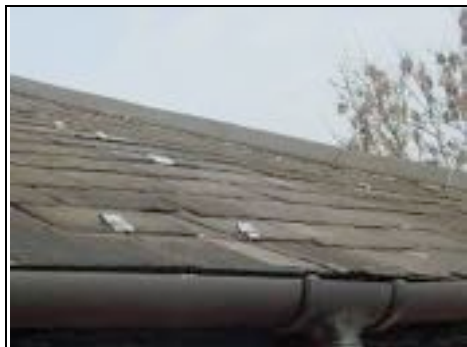
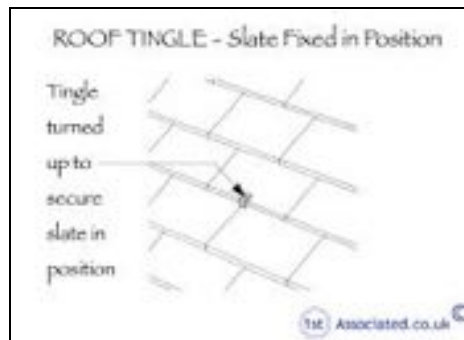
In addition to this there are a lot of tingles to the slates indicating that there may be problems with the nails rusting.

Roof tingles

Roof tingle

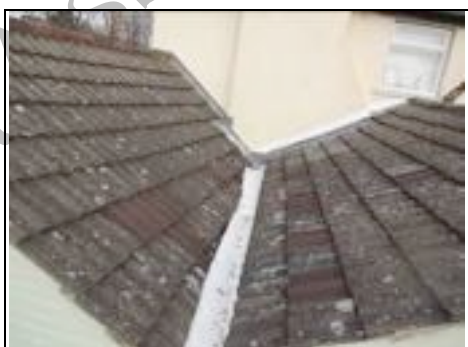
To the rear of the property is a valley gutter, we can see this has been repaired. It appears to be leaking into the pub, both where the valley is and also where the roof meets the flat roof to the rear.

Leaking, painted sealer on top of lead

ACTION REQUIRED: Repair and make watertight both the valley gutter and where it meets the flat roof.

ANTICIPATED COST: £2,000 - £5,000, possibly more. We would also comment that the valley gutter which looks to be in lead at the moment has already had a bitumen covering and by a repair to this we do not mean further bitumen or liquid paints, we mean replacement of the valley gutter and renewing in lead which is why we have costed this work as we have; please obtain quotations.

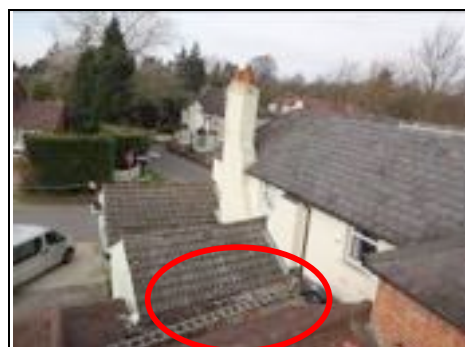
Leak to flat roof

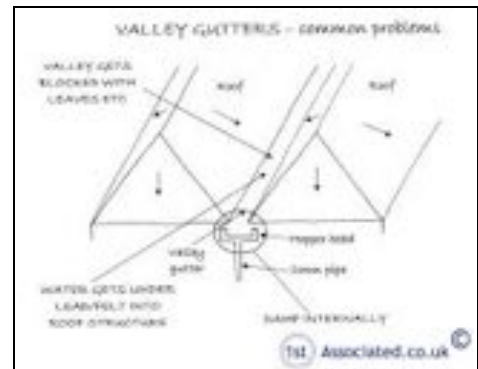
Valley gutter problems

Also the associated damage and deterioration needs to be repaired internally. At the time of our inspection one of the ladies toilets was closed down due to water damage

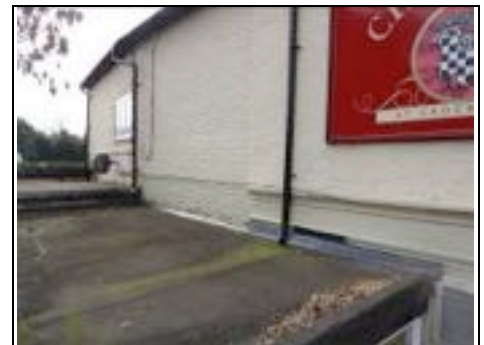
This is a flat flat roof which has above average deflection (movement) to the flat roof indicating to us either deterioration in the decking below and/or a sub-standard decking has been used.

This roof is over the access to the private living accommodation and the kitchen area. We believe that ultimately during the course of the lease this would have to be renewed and replaced to modern day standards including insulation which is often known as a warm roof construction and ventilation.

Left flat roof

ACTION REQUIRED: Reduction in the lease based on the future maintenance requirements/replacement.

ANTICIPATED COST: To replace the roof £3,000 - £6,000 depending upon the amount of the existing roof that can be kept; please obtain quotations.

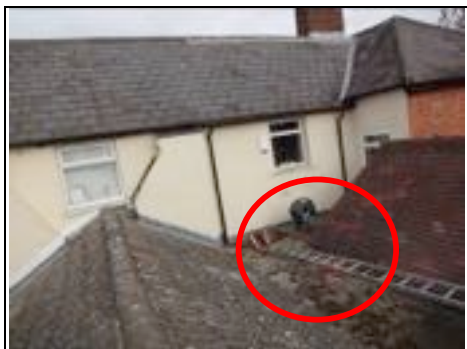
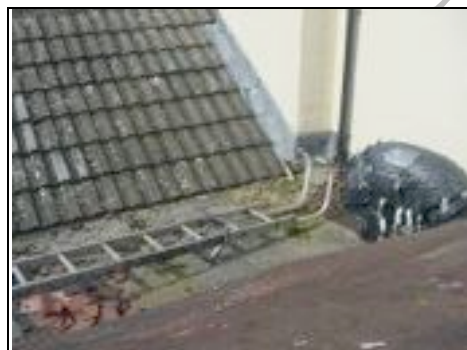
Hidden flat roof

Close up of hidden flat roof

ACTION REQUIRED: Please see our comments on the valley gutter where it meets the pitched roof. Also, the roof as a whole needs to be repaired/replaced. We are aware that there was some work being carried out at the time of our inspection however you do need to ensure that this is not just a sticking plaster or patchwork repair work.

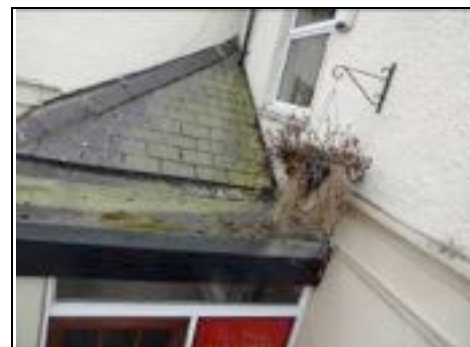
This is a flat flat roof which is allowing water to sit on it so you may get leaks in this area.

Flat roof to front entrance

ACTION REQUIRED: Allow for replacement.

ANTICIPATED COST: £500 - £1,500; please obtain quotations.

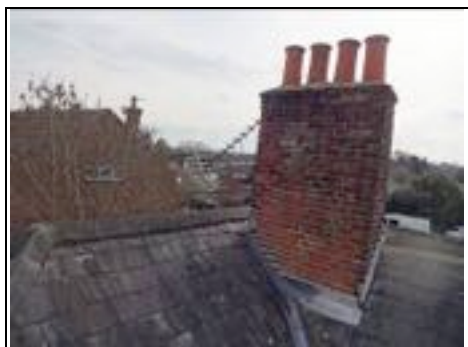
The lead detailing seems to generally be below standard for example to the right hand side roofs and also to the left hand chimney.

Flashing to left chimney

ACTION REQUIRED: General repair and renewal of flashings.

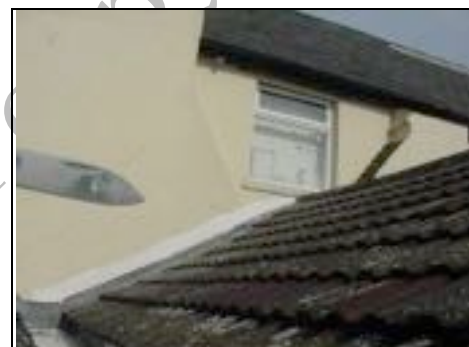
Where roofs meet walls or other roofs there should be a flashing to make a watertight seal. There looks to be problems with a number of flashings, which would benefit from work.

Repairs to flashing to rear middle pitched roof

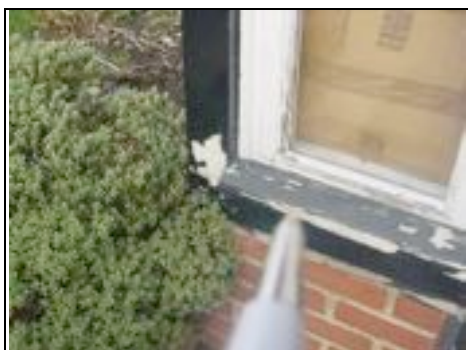
The external joinery is in poor condition with bare timber visible in several areas. We also, when we carried out a knife test (literally pushing a knife into the timber) found areas of wet rot.

Bare timber visible

ACTION REQUIRED: The property under most Full Repairing and Insuring leases is required to be redecorated every three to five years and also when the lease comes to an end. Repair and redecoration is now required.

ANTICIPATED COST: £3,000 to £6,000 depending upon the amount of repair work however this should be part of the existing leaseholder's work that should be carried out. The work should either be carried out by the leaseholder or the landlord or have a reduction in your lease cost; please obtain quotations.

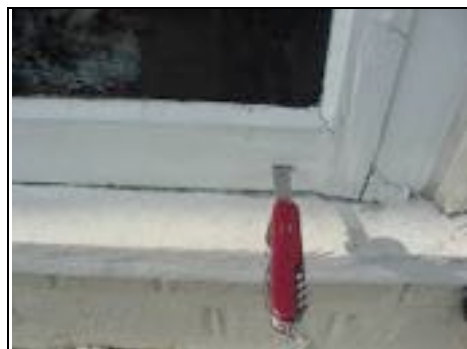
Timber in poor condition

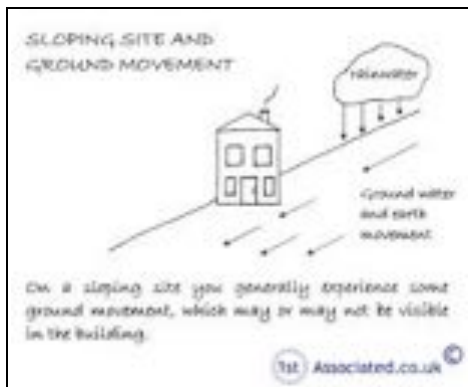
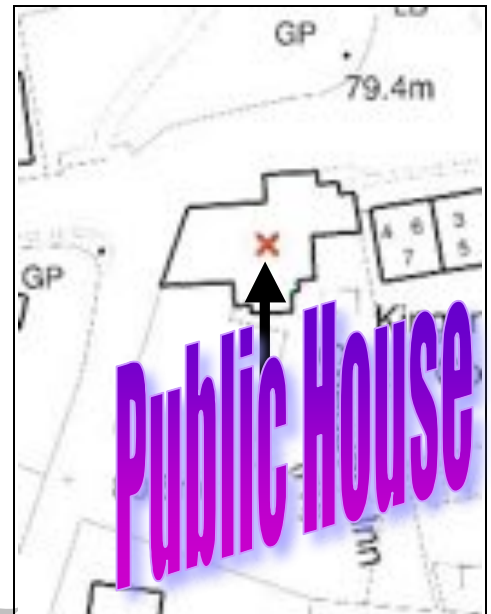
To the rear of the property there is a high ground level which is allowing dampness into the property. The whole of the property sits on a sloping site, sloping from the rear car park and play area/beer garden towards the road.

Sloping site

Direction of slope

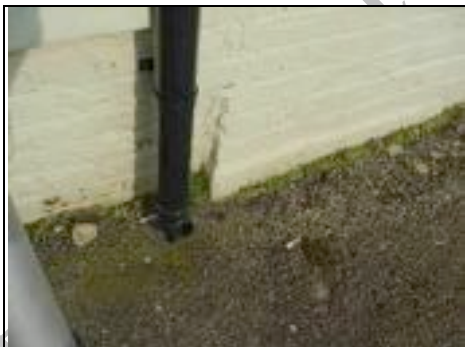
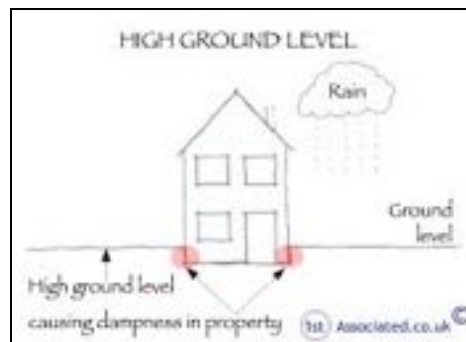
High ground level to rear of toilets and right hand storage area

High ground level

- 1) The high ground level which needs lowering

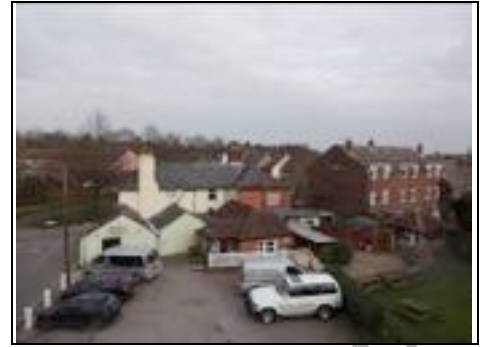
- 2) The slope of the car park and site in general which is discharging water against the rear of the property. There may be some underground streams as well from what you have said about the area in front of the pub which once had another pub on it.

Sloping site

ACTION REQUIRED: A very difficult problem to resolve and you may have to consider it a characteristic of this property. We believe you can reduce the amount of dampness in the following ways:

ANTICIPATED COST: £2,500 - £7,500; please obtain quotations.

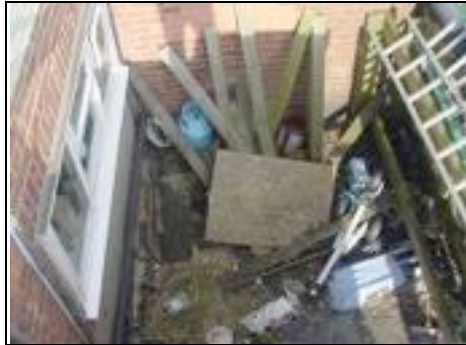
There are a lot of stored items particularly to the left hand side of the property. We were unsure whether there was a problem with drainage or there is an overflowing manhole; we could not gain proper access to the area due to the sheer amount of stored items to the left hand side of the pub.

Stored items to left.
Water sitting in this area.

ACTION REQUIRED: Clear the area to check if there is a drainage problem. If there is a closed circuit TV camera report of the drains is required.

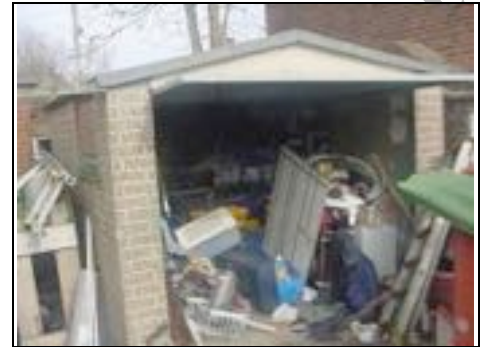
Stored items in garage

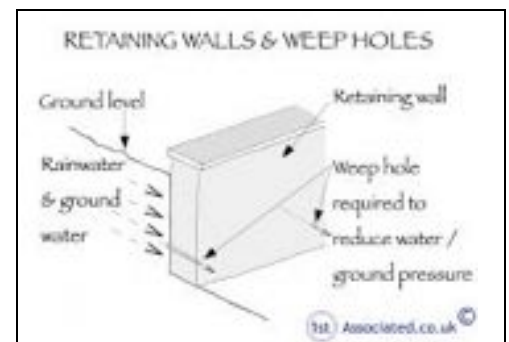
Due to the sloping site that we have mentioned and the high ground levels there have been some retaining walls added to allow levelling out of areas around the pub. These retaining walls are for example to the smoking area which we are aware you want to improve. We recommend weep holes are added to these.

Add weep holes to retaining wall

ACTION REQUIRED: Add weep holes.

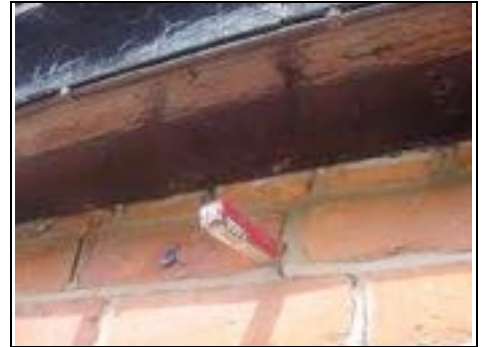
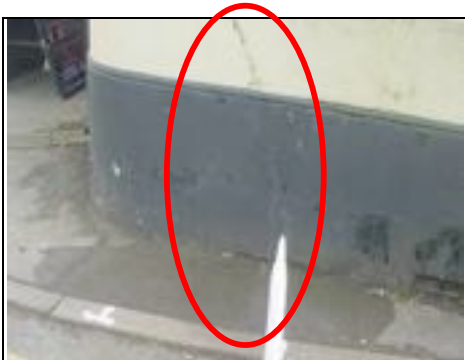
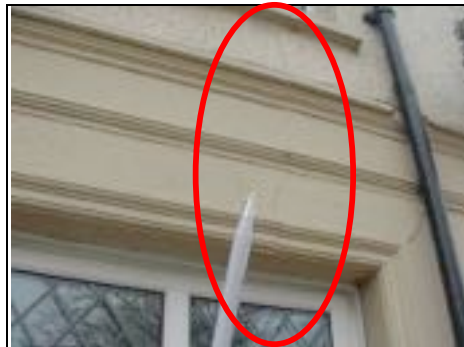
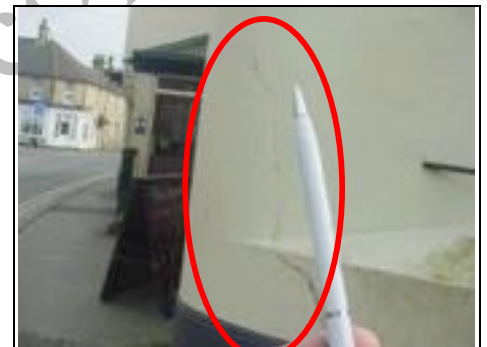
We can see there has been movement in the property to the front right hand corner and right hand side. This may be historic and relate to ground conditions, etc.

Cracking to rear

Cracking to right at low level

Cracking to right elevation

ACTION REQUIRED: Request the existing property owner/landlord places an insurance claim, advising that the cracking has been noted by a structural surveyor (this should cost them nothing other than time to write the letter). This usually means that the insurance company will carry out a monitoring exercise (the Building Research Establishment recommend monitoring any cracks for a minimum of one year) to establish if there is any progressive movement. Your future liability will be limited to the cost of the excess on the insurance providing the insurance company is happy for you to take over the insurance claim.

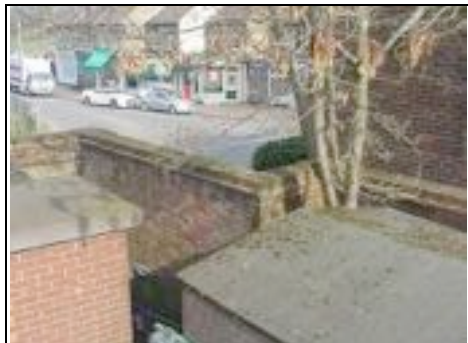
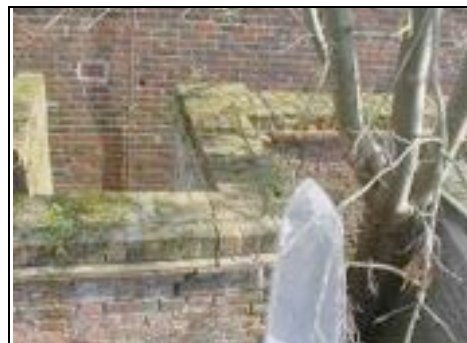
There are substantial cracks to the left hand wall which is adjacent to a footpath area.

Boundary wall

Tree to left causing damage to boundary wall

ACTION REQUIRED: As above, request the existing property owner/landlord places an insurance claim, advising that the cracking has been noted by a structural surveyor. Tree to be inspected and advised upon by an arboriculturalist and trimmed/maintained. Wall to be repaired and made safe and secure.

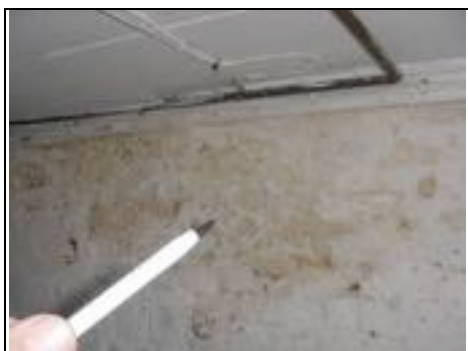
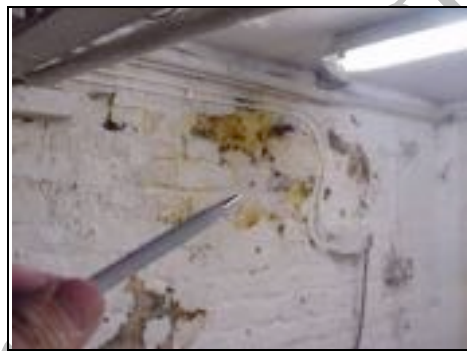
There is a lot of dampness within the cellar area. We also believe improvements could be made to the kitchen area and would often be recommended by Environmental Health for example such things as fly screens.

Dampness

ACTION REQUIRED: We would recommend you meet with the Environmental Health Officer before you legally commit to purchase the lease. It is very difficult to stop dampness coming into a below ground level cellar in the long term however there are treatments to the walls that can be made to limit the amount of dampness as long as they are regularly carried out.

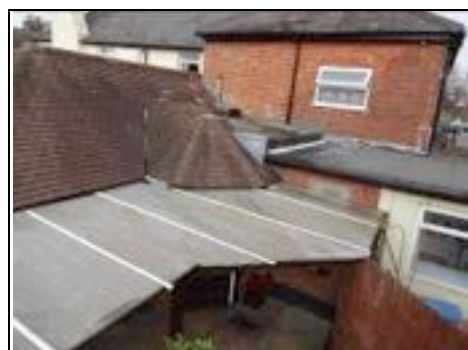
The roof to the smoker's area looks to be leaking and deteriorating and is DIY quality. We recommend this is replaced.

Roof to smoker's area

ACTION REQUIRED: Replace smoker's shelter.
