SCHEDULE OF CONDITION

Public House, West Berkshire

We have been instructed to inspect and prepare a Schedule of Condition for XXXX

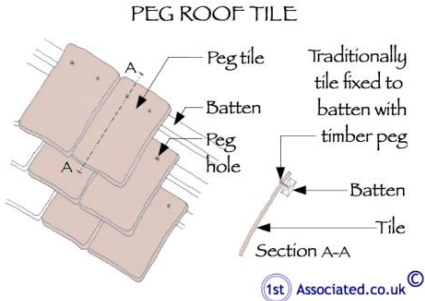
Deteriorating and spalling brickwork	Joint high level inspection with the landlord's surveyor to be carried out prior to signing of the lease or legal completion of the lease from high level cherry picker or equivalent.
Roofs: Pitched roof clad with clay peg tiles

Undulating and tiles missing

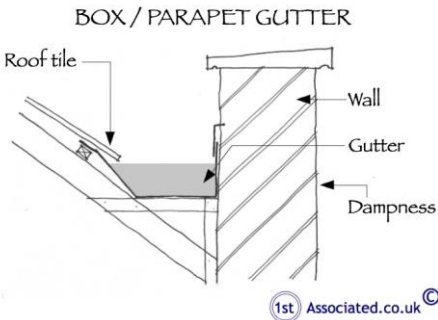
<p>Parapet wall and box gutter viewed from dormer windows as well as ground level.</p>	<p>Plant growing out of front box gutter/hopperhead and dampness noted to some of the rooms, believed to be from the box gutter</p>

<p>Box gutter flashing coming away slightly</p>	<p>Clear and ensure watertight. Likely to require re-bedding of lead and coping stones to be lifted and re-bedded and repointed or possibly changed as the drip detail may not be correct. It simply wasn't possible to view from the window properly and we believe it unsafe to go out onto the box gutter.</p> <p>Joint high level inspection with the landlord's surveyor to be carried out prior to signing of the lease or legal completion of the lease from high level cherry picker or equivalent.</p>
<p>Dormer windows:</p> <p>Three dormer windows with lead finish</p>	<p>Flat roofs viewed from ground level.</p>	<p>Joint high level inspection with the landlord's surveyor to be carried out prior to signing of the lease or legal completion of the lease from high level cherry picker or equivalent.</p>

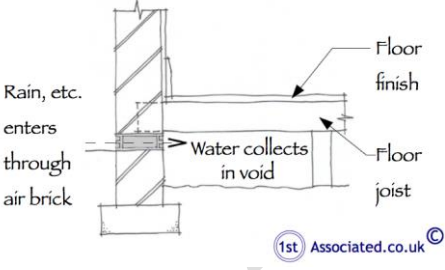
<p>Gutters and Downpipes:</p> <p>Cast Iron and Plastic</p> <p>We viewed the gutters from ground level.</p>	<p>Gutters discharge directly onto pavement, dampness likely in these areas.</p>	<p>Joint high level inspection of the guttering with the landlord's surveyor to be carried out prior to signing of the lease or legal completion of the lease from high level cherry picker or equivalent.</p> <p>Ensure all gutters are watertight and falling towards the downpipe and clear.</p> <p>Repair downpipes and secure as necessary, ensure downpipes are clean and clear.</p>
<p>Walls:</p> <p>Painted render</p> <p>Stucco style in some areas</p> <p>AIR BRICK ACTS AS GUTTER</p>

<p>1st Associated.co.uk ©</p>	<p>Hairline cracking</p>

<p>Repair hairline cracking, prepare and redecorate. We recommend redecoration in the summer of 2015 if existing landlord doesn't redecorate as part of their yield up clause.</p> <p>Protect airbrick</p> <p>AIR BRICK TO FLOOR</p>

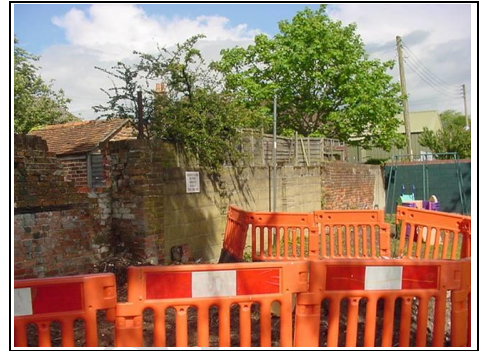
Wall partly fallen down

<p>Left wall:</p> <p>Flemish bond brickwork with timber bearers</p> <p>Blockwork</p>	<p>Deterioration, part fallen down protected by barrier</p>

Part rebuild, repair and repoint
Play area: Disused play area to rear left side		
Fenced off area: Dilapidated condition with shed in it		
Fire exit:		
Wall: Green blockwork wall		
Mature tree

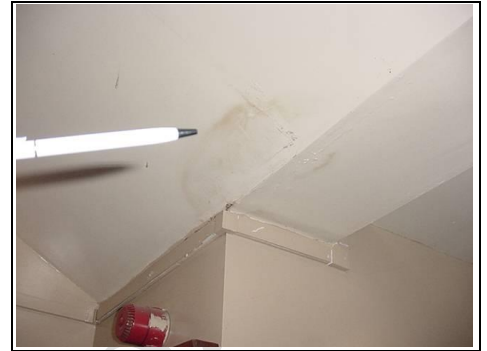
Damp staining

Dirty and some minor water staining Dirty	Resolve dampness Repair, prepare and redecorate. Clean and make watertight Clean

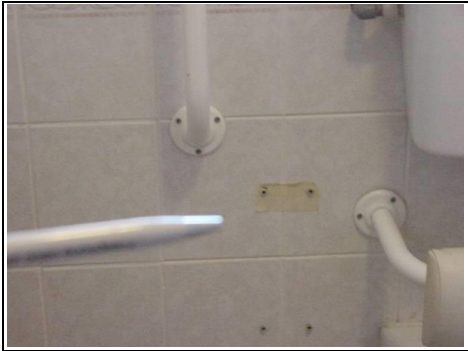
Old fixing points

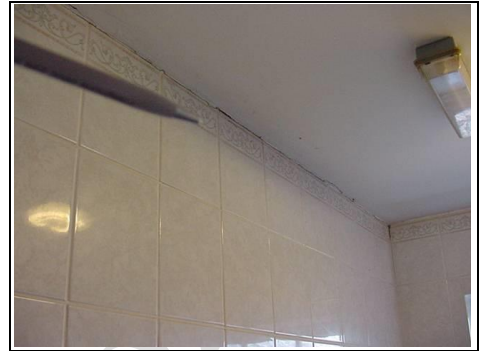
Cracking at high level

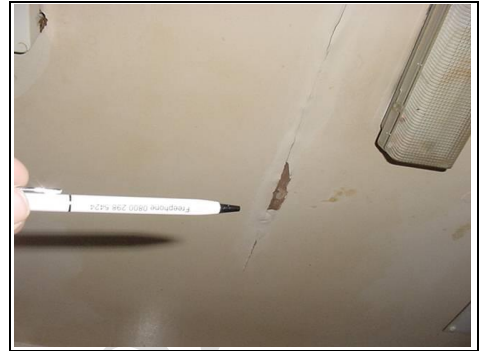
Dampness staining

DESCRIPTION	CONDITION	ACTION REQUIRED
Ceiling: Painted	Dampness

Resolve dampness. Repair, prepare and redecorate
Walls: Tiled floor to ceiling	Dated Rising damp	Clean Resolve dampness
Floors: Tiled	Heavily worn with tiles missing

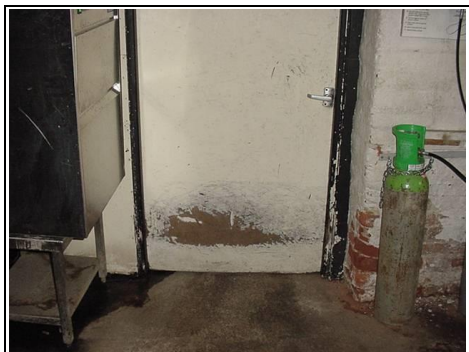
Door worn

Resolve dampness Repair, prepare and redecorate.
Floors: Concrete	Marked	Make good and clean.
Detailing: Doors: Timber	Heavily marked	Replace or repair, prepare and redecorate.

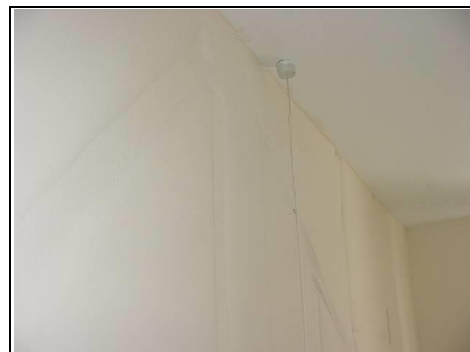
Cracking

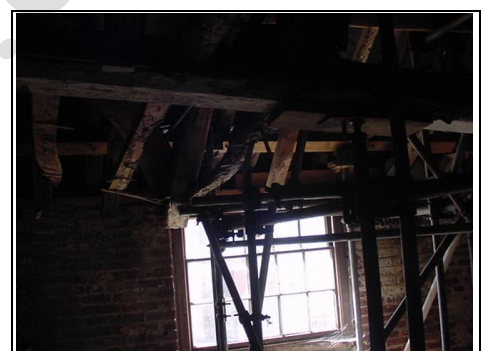
Rear left Room, lath and plaster coming down due to old age and dampness
