PUB SCHEDULE OF CONDITION

XXXXXXXXXXXXXXXXXX

We have been instructed to inspect and prepare a Schedule of Condition for xxxxxxxxxxxxxxxxxxxx. We inspected the property on xxxxxxxx.

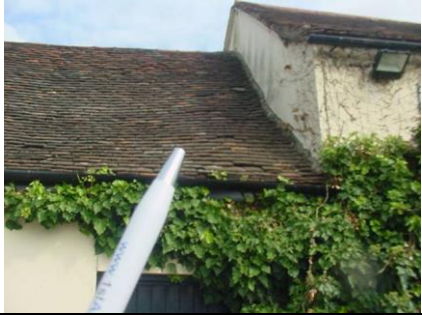
<p>Roofs:</p> <p>Handmade and machine cut plain clay tiles</p>	<p>Undulating, broken and missing tiles allowing dampness in.</p> <p>Missing/slipped tiles.</p>

<p>Joint high level inspection with the landlord's surveyor to be carried out prior to signing of the lease or legal completion of the lease from high level cherry picker or equivalent.</p> <p>ACTION REQUIRED: Recommend exclude from the lease.</p>
<p>Hopperheads, Gutters and Downpipes:</p> <p>Plastic and cast iron gutters and downpipes</p> <p>Cast iron soil and vent pipe</p>	<p>Rusting cast iron and debris filled gutters/poorly functioning gutters.</p> <p>Signs of long term dampness to the front rooms we believe relates to displaced guttering/poorly functioning guttering or defects within the roof.</p> <p>Poorly functioning guttering/roof allowing dampness in</p>

<p>Make watertight by existing tenants/landlord.</p> <p>ACTION REQUIRED: Recommend exclude from the lease.</p>

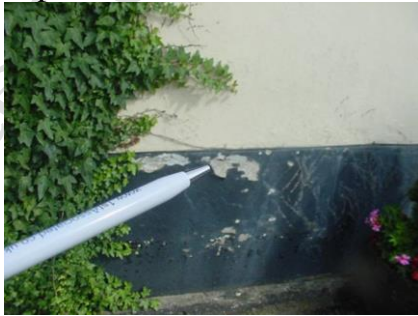
<p>Paint peeling at low level relating to high ground level and dampness coming into the property as well as the previous mentioned issues with regards to paint</p>

<p>Repair/removal of existing paint. Apply correct paint.</p>
---	---	---

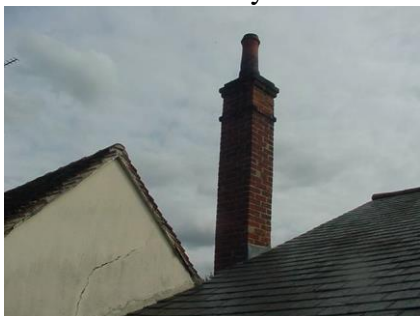
DESCRIPTION	CONDITION	ACTION REQUIRED
Chimneys: Substantial brick built chimneys Chimney Three: Middle left chimney

Areas of cement repairs to brickwork. Dampness coming in at base.

Make appropriate repairs and make watertight.
Chimney Four: Rear left chimney

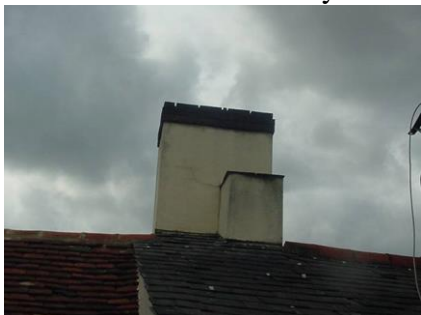
DESCRIPTION	CONDITION	ACTION REQUIRED
<p>Chimneys:</p> <p>Chimney Five: One small rendered chimney</p> <p>Rear of rendered chimney</p>

<p>Damp staining noted within roof space.</p>	<p>Make watertight. Repair, prepare and redecorate.</p>
<p>Roofs:</p> <p>Manmade and machine cut clay plain tiles</p>	<p>Undulating, broken and missing tiles allowing dampness in.</p>	<p>Joint high level inspection with the landlord's surveyor to be carried out prior to signing of the lease or legal completion of the lease from high level cherry picker or equivalent.</p>

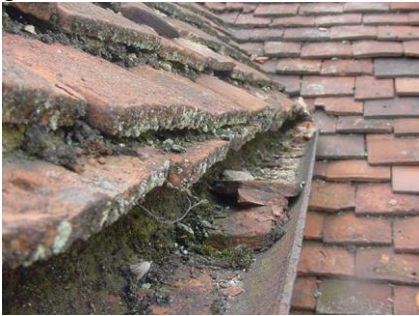
<p>Hopperheads, Gutters and Downpipes:</p> <p>Cast Iron and Plastic</p>	<p>General clean required to gutters</p>

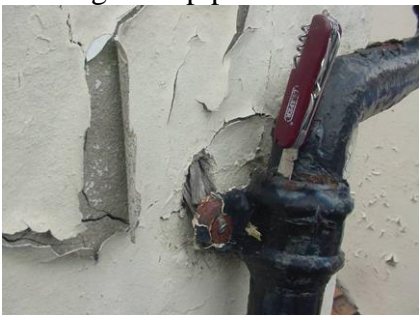
<p>Leaking downpipe</p>

<p>Ensure all gutters are watertight and falling towards the downpipe and clear.</p> <p>Repair downpipes and secure as necessary, ensure downpipes are clean and clear.</p> <p>ACTION REQUIRED: We recommend excluded from the lease.</p>
<p>Walls:</p> <p>Painted Render</p>

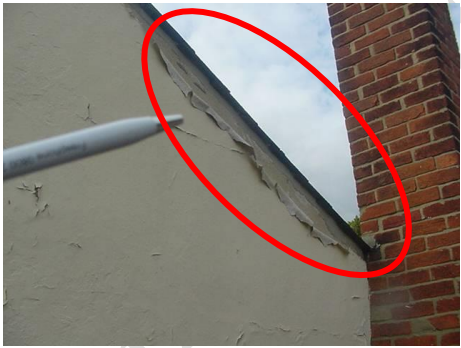
<p>Flaking paint to rear of property</p>

<p>Remove existing paint and carry out associated repairs, prepare and redecorate.</p>

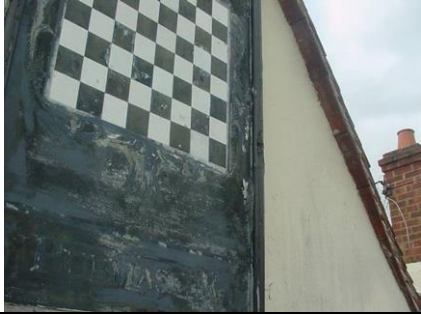
<p>Signage:</p>	<p>Deterioration. Note that screws have been removed from this sign.</p>

<p>Repair, prepare and redecorate.</p>
<p>Other:</p> <p>Extract system</p>	<p>Extract system discharging grease, etc onto walls</p>

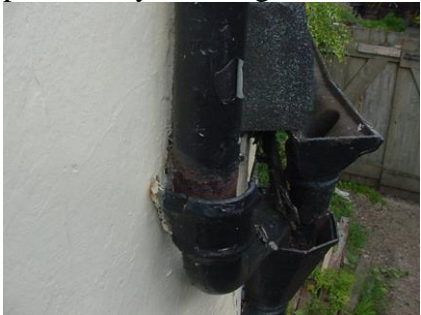
<p>Hopperheads, Gutters and Downpipes:</p> <p>Cast Iron and Plastic</p>	<p>Leaking gutter and downpipes particularly to far right side</p>

<p>Ensure all gutters are watertight and falling towards the downpipe and clear.</p> <p>Repair downpipes and secure as necessary, ensure downpipes are clean and clear.</p> <p>ACTION REQUIRED: We recommend are excluded from the lease.</p>
<p>Walls:</p> <p>Painted render</p> <p>Cracking:</p>	<p>Dated and general deterioration of paintwork</p> <p>Cracking due to nearby drains</p>

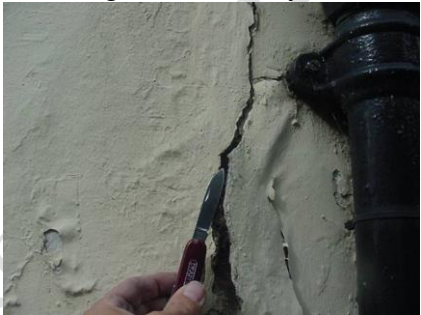
<p>Crack near drains</p>

<p>Areas of moss and deteriorating paintwork</p>	<p>Repair, prepare and redecorate.</p> <p>Insurance claim to be made by landlord and monitoring work take place.</p>

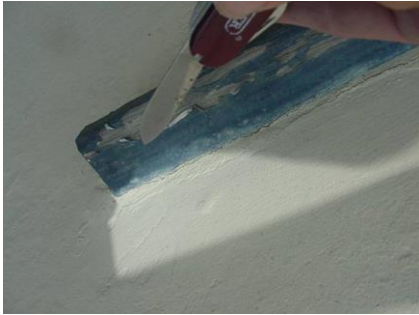
<p>External Detailing:</p> <p>Windows:</p> <p>Timber casement windows</p> <p>Deterioration to windows</p>

<p>Dated and flaking paintwork, areas of bare timber.</p> <p>Deterioration</p>

<p>Repair, prepare and redecorate.</p> <p>Replace glass.</p>
---	---	--

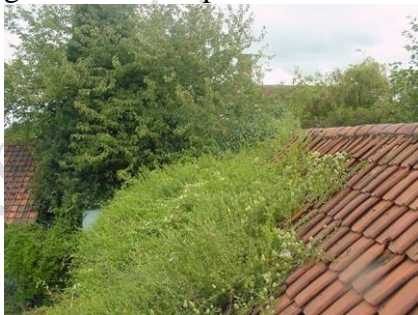
DESCRIPTION	CONDITION	ACTION REQUIRED
Roofs: Clay tile roof to rear adjoining residential property.	Undulating tiles. Extensive plant growth which goes into roof space.

Remove and ensure roof is left watertight.
Gutters and Downpipes: Plastic	Leaking to rear of prep area making wall damp Downpipe not joined

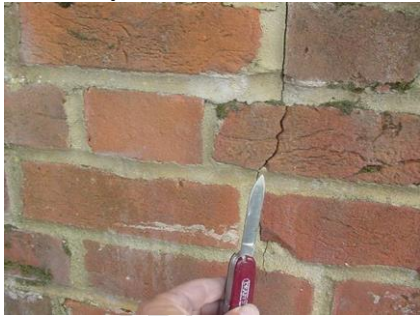
<p>Trees and hedges:</p>  		<p>General maintenance required.</p>
<p>Beer garden</p>  	<p>Cracking to right hand boundary wall</p>

<p>General repointing required and cutting back of trees, ivy, etc.</p>
<p>Drainage</p>	<p>Blocked drain on right side</p>

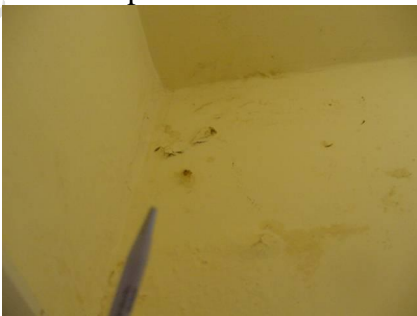
DESCRIPTION	CONDITION	ACTION REQUIRED
Ceiling: Painted	Dated Hairline cracking	Repair, prepare and redecorate.
Walls: Painted Tiles to approx 1.5m	Dampness, hairline cracking from damp from roof above.

Parts of tiles painted over	Resolve dampness. Repair, prepare and redecorate.
Floors: Quarry tile	Worn	Deep clean.

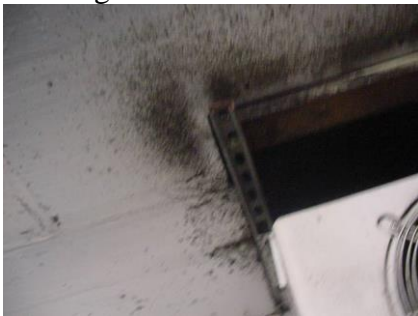
DESCRIPTION	CONDITION	ACTION REQUIRED
<p>Ceilings:</p> <p>Not to environmental health standards</p> <p>Painted</p> <p>Staining around extract fan</p>

<p>Black mould to ceiling</p>

<p>Clean. Repair, prepare and redecorate.</p>

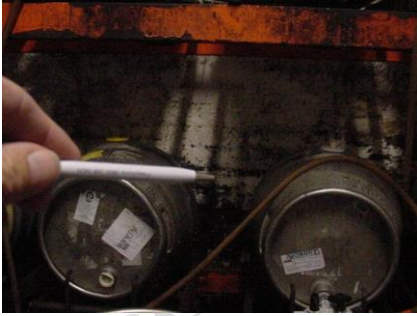
<p>Black mould</p>

<p>Paint coming off walls</p>	<p>Clean. Repair, prepare and redecorate.</p>
<p>Floors:</p> <p>Exposed aggregate concrete floor</p>	<p>Deteriorating</p>	<p>Make good and seal with a floor paint.</p>
<p>Detailing:</p> <p>Doors:</p> <p>Door to bar</p>	<p>Dated and marked</p>	<p>Repair, prepare and redecorate or replace.</p>
<p>Services:</p> <p>Piping</p>		<p>See Services section at rear of report.</p>

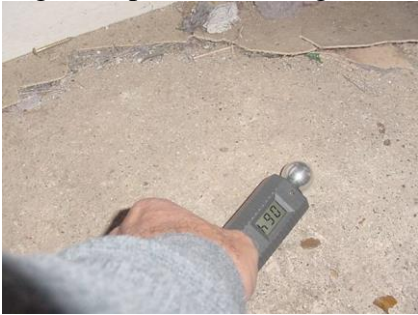
DESCRIPTION	CONDITION	ACTION REQUIRED
Ceilings: Painted	Dated	Repair, prepare and redecorate.
Walls: Painted	Dated Dampness in walls from cast iron guttering	Repair, prepare and redecorate.
Floors: Concrete Altro style flooring	High damp meter readings

Entrance dirty and dated	Repair altro style flooring

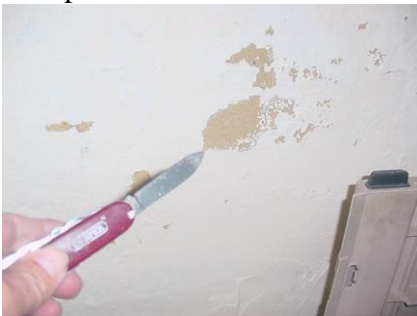
Remove plant life
Walls: Painted	Dampness

Paint coming off walls due to dampness	Resolve dampness. Repair, prepare and redecorate

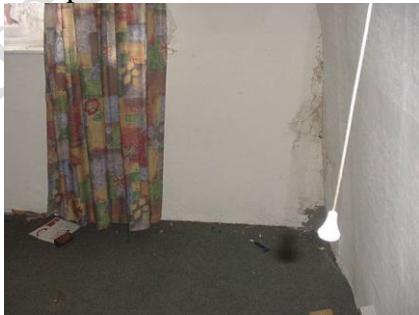
DESCRIPTION	CONDITION	ACTION REQUIRED
Ceilings: Painted embossed wallpaper	Dated	Repair, prepare and redecorate
Walls: Painted embossed wallpaper Real embedded timbers	Dampness visible to left corner

Resolve dampness. Repair, prepare and redecorate
Floors: Carpet	Undulating floors Settlement within structure

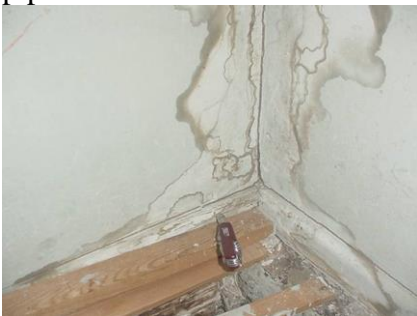
DESCRIPTION	CONDITION	ACTION REQUIRED
Ceilings: Roof window Painted	Leak from roof window and valley gutter

Resolve leak Repair, prepare and redecorate
Walls: Painted fibreboard	Damage from ceiling and pipework

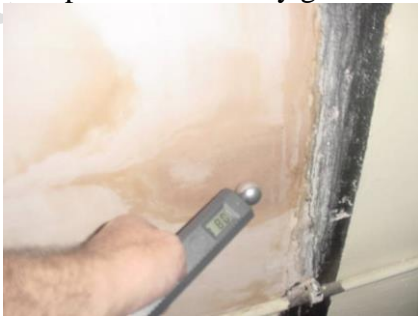
DESCRIPTION	CONDITION	ACTION REQUIRED
Ceilings: Vaulted ceiling Fireboard type ceiling	Dated	Repair, prepare and redecorate
Walls: Feature timbers Wrought iron tie bars in corners of corridor	Dampness from valley gutter

Repair, prepare and redecorate
Floors: Carpet	Undulating floor

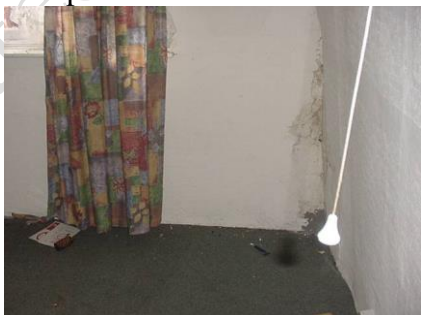
DESCRIPTION	CONDITION	ACTION REQUIRED
Ceilings: Painted plasterboard	Dated	Repair, prepare and redecorate
Walls: Painted plasterboard dry lined with frieze	Dampness

Repair, prepare and redecorate
Floors: Carpet	Slight slope	
Detailing: Windows: Casement windows to right side	Dated	Repair, prepare and redecorate

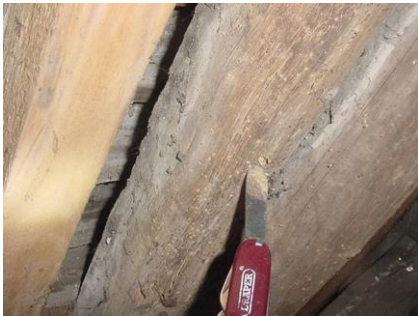
Missing purlin:	Missing purlin  	
Woodworm:	Frass from woodworm

Woodworm  	Exclude from lease
Protective Underlayer: No protective underlayer	Blinding holding tiles in place  	Exclude from lease
Fire wall/Fire break: Wattle and daub and timber firewall between right hand side of building and left hand side over store area/cold cellar	Damaged	Repair

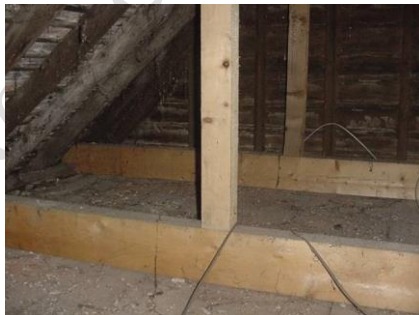
DESCRIPTION	CONDITION	ACTION REQUIRED
Roof Access: Accessed from crisp store on left side	No ladder, lights or floorboards, viewed by torchlight.	
Roof Structure: Cut timber roof with newer extensive amendments Note: area has tie bar (within ground floor)		
Roof Timbers: Dampness  	New timbers added

Dampness coming through tiles into batons  	Make watertight

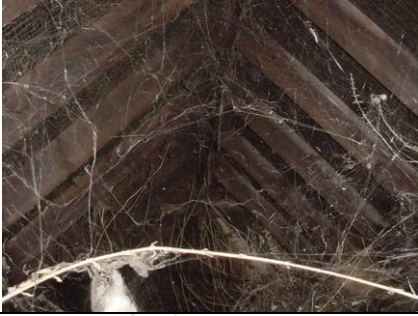
Plant growing within roof space Remove plants	
Protective Underlayer: Protective underlayer
