SCHEDULE OF CONDITION

Public House Surrey

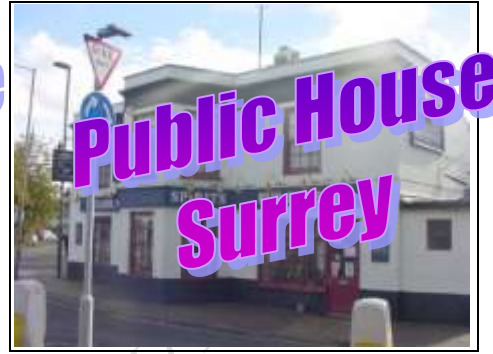
FRONT EXTERNAL ELEVATION

DESCRIPTION	CONDITION	ACTION REQUIRED
<p>Chimneys:</p> <p>Two chimneys visible: Front left – render with one flue and one chimney pot</p> <p>Front middle – brick with two chimney pots and one flue</p>

<p>Front left chimney</p>

<p>Dampness coming in through middle chimney</p>	<p>Resolve dampness and make watertight</p>
<p>Parapet wall:</p> <p>Parapet wall with asphalt box gutter</p>

<p>General view of parapet wall</p>

<p>Dampness coming in through parapet wall</p>	<p>Resolve dampness and make watertight</p>

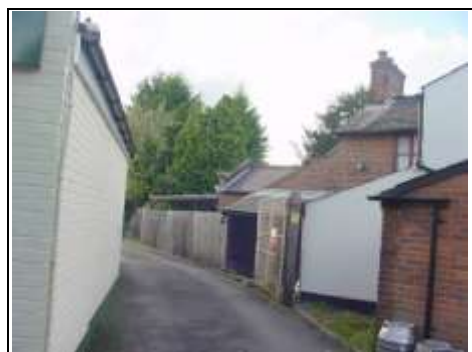
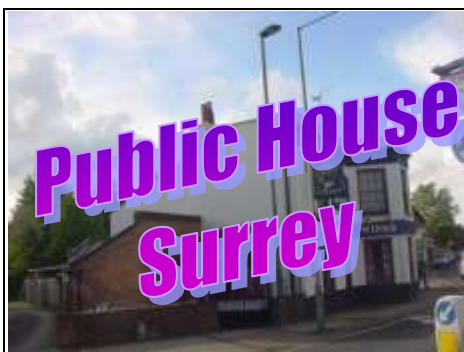
LEFT HAND EXTERNAL ELEVATION

DESCRIPTION	CONDITION	ACTION REQUIRED
<p>Chimneys:</p> <p>Two chimneys visible: Front left – render with one flue and one chimney pot (also on front elevation)</p> <p>Rear brick chimney</p>	<div style="text-align: center;">

Front left chimney </div> <div style="text-align: center;">

Rear brick chimney </div>

<p>Roof window</p> <p>Low level roofs: Two low level slate roofs</p>	<p>Poor.</p> <p>Poor.</p>	<p>Slate roof is in poor condition with deterioration and displaced slates. In need of a general overhaul and making watertight. Associated detailing such as the flashings need to be checked.</p>
<p>Gutters and Downpipes:</p> <p>Cast iron hopperhead and downpipe Cast iron and plastic gutters and downpipes</p>	<p>Leaking and need realigning</p>

<p>Paint flaking around hopperhead indicating dampness is coming through</p>	<p>Ensure all gutters are watertight and falling towards the downpipe.</p> <p>Repair and secure as necessary, ensure downpipes are clear.</p>

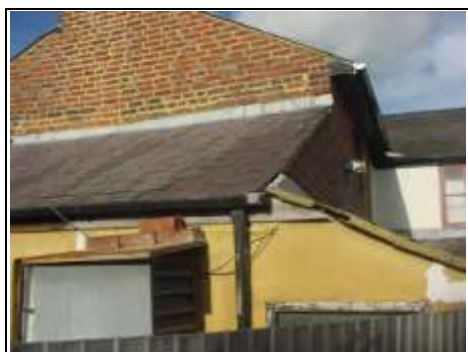
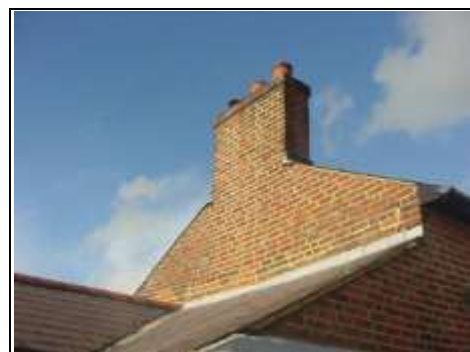
REAR ELEVATION

DESCRIPTION	CONDITION	ACTION REQUIRED
Chimneys: Rear view of left hand chimney with one flue and one chimney pot

Rear view of middle chimney with two chimney pots and one flue	
Roofs: Main Roof: Pitched, clad with slates with holes from displaced slates

Displaced slates

Slates completely displaced

Roof in poor condition Slate roof is in poor condition with deterioration and displaced slates. In need of a general overhaul and making watertight. Associated detailing such as the flashings need to be checked.

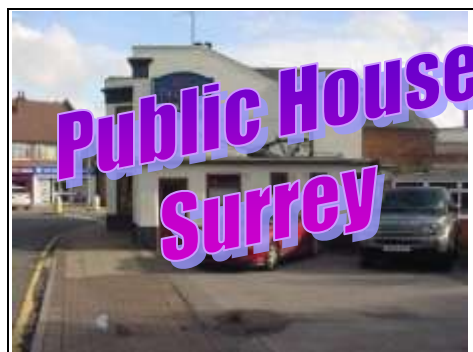
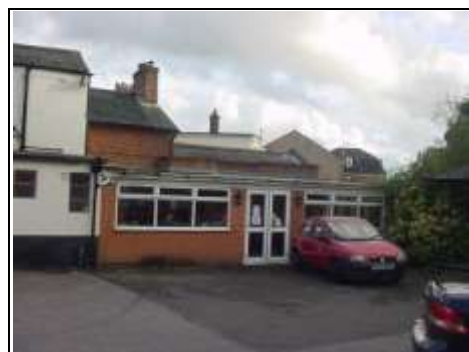
RIGHT HAND EXTERNAL ELEVATION

DESCRIPTION	CONDITION	ACTION REQUIRED
<p>Roofs:</p> <p>Main roof:</p> <p>Pitched, clad with slate</p> <p>Parapet walls:</p> <p>Rendered</p> <p>Slate roof over kitchen:</p>

<p>Turnerised roof</p>

<p>Slate roof over kitchen</p>	<p>Slate roof is in poor condition with deterioration and displaced slates. In need of a general overhaul and making watertight. Associated detailing such as the flashings need to be checked.</p>

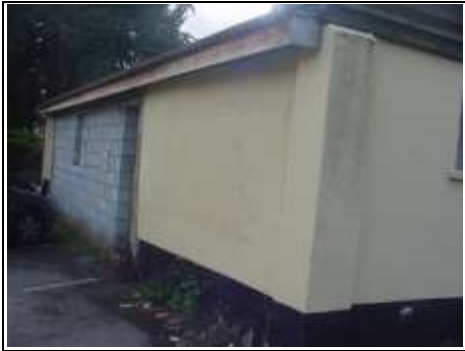
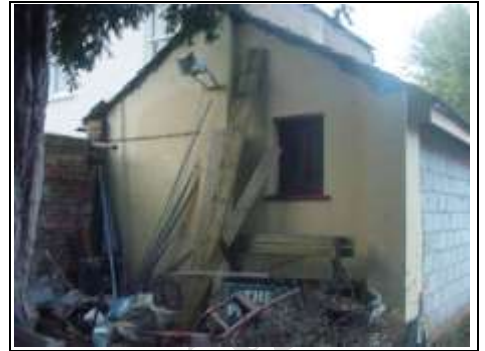
OUTBUILDING - EXTERNAL

DESCRIPTION	CONDITION	ACTION REQUIRED
Roofs: Pitched roof clad in concrete tiles Hidden valley gutter to right hand side causing dampness into adjoining property

Valley gutter allowing dampness into property	Make box gutter watertight.
Gutters and Downpipes: None

No gutters	Add gutters and downpipes and soakaway.

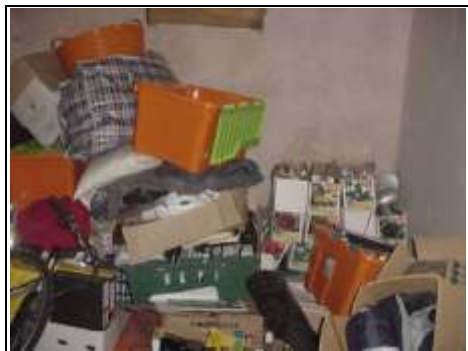
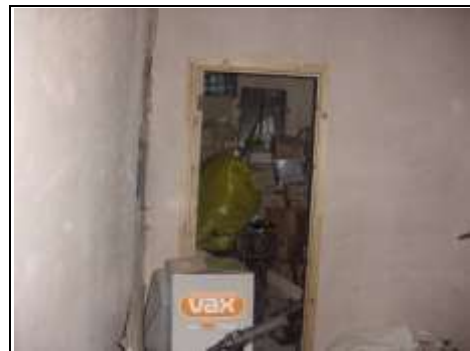
OUTBUILDING – INTERNAL
Generally stored items – limited view and rear not accessed

DESCRIPTION	CONDITION	ACTION REQUIRED
Ceilings: Modern gypsum plaster		Repair, prepare and redecorate.
Walls: Modern gypsum plaster Dry lined wall to left hand side

Dampness	Resolve dampness issues. Repair, prepare and redecorate.
Floors: Concrete		Carpet
Detailing: Windows:		Add windows
Services:	We are advised that no services have been installed.	
Stored Items: Full of stored items, owner advised were owned by third party.		Clear.

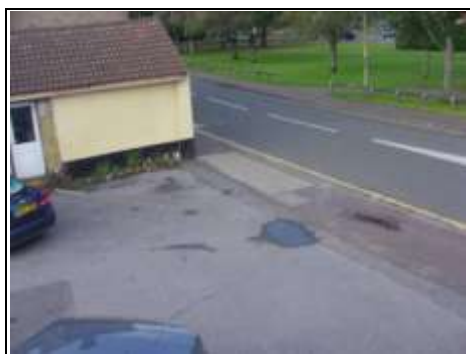
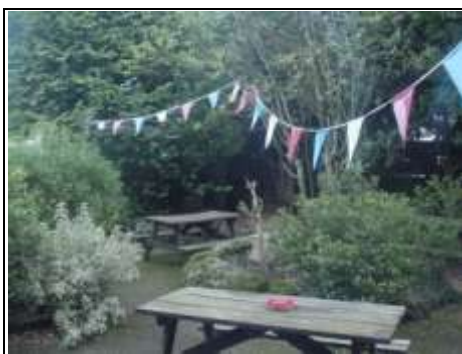
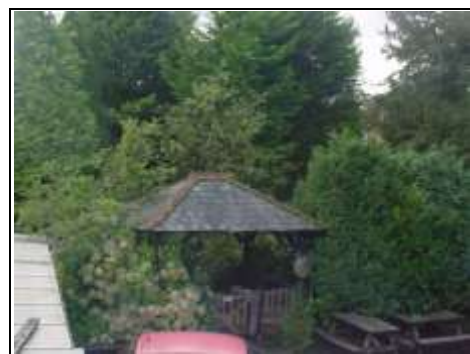
OUTSIDE AREAS

DESCRIPTION	CONDITION	ACTION REQUIRED
<p>Car Park</p> <p>Tarmac, no white lines</p>

<p>Car park</p>	<p>Car park generally drains towards the pub. Some ponding</p>

<p>Crossover</p>	<p>Drainage is required, ad hoc repairs and white lines.</p>
<p>Surface water drainage</p> <p>Water from car park discharges against the building causing dampness.</p>

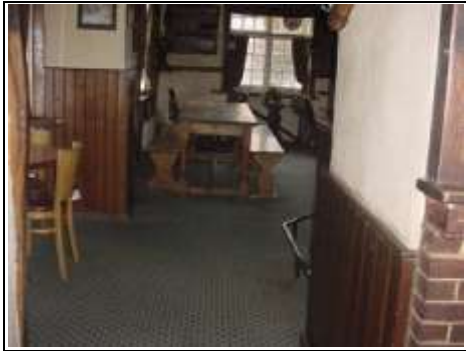
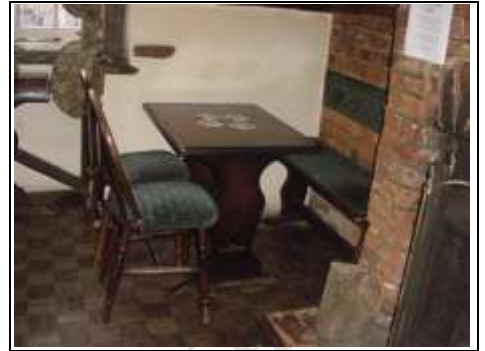
Left hand side of L shaped bar

DESCRIPTION	CONDITION	ACTION REQUIRED
Ceilings: Timber feature beams, painted panels between

Dated.	Repair, prepare and redecorate.
Walls: Exposed brickwork Painted render	Dated. Dampness found.	Resolve dampness. Repair, prepare and redecorate.
Floors: Carpet Wood block section to far left hand corner	Worn	Clean and/or replace. Sand and re-stain

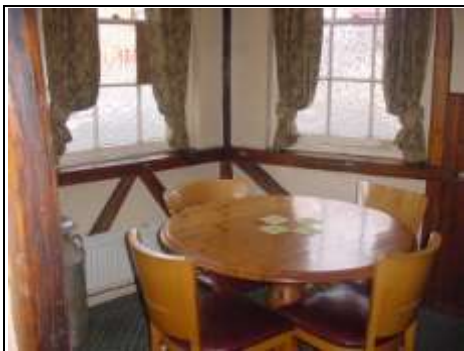
Bay section of bar (central)

CONDITION	ACTION REQUIRED
Ceilings: Timber feature beams, painted panels between

Dated.	Repair, prepare and redecorate
Walls: Painted render	Dated. Dampness found.

Rising damp	Repair, prepare and redecorate
Floors: Carpet	Worn	Clean or replace.
Detailing: Windows: Bay window with three sliding wash windows 6 x 6 panes, opaque glass to base Doors:	Dated	Repair, prepare and redecorate

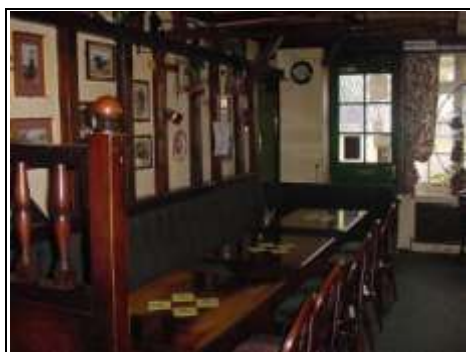
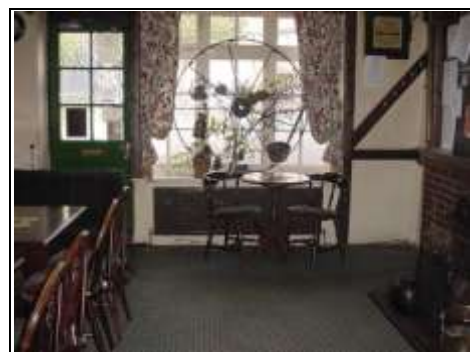
Bar right hand side near toilets

DESCRIPTION	CONDITION	ACTION REQUIRED
Ceilings: Timber feature beams, painted panels between

Dated.	Repair, prepare and redecorate
Walls: Painted render	Dated. Dampness found.	Resolve dampness. Repair, prepare and redecorate
Floors: Carpet	Worn	Clean or replace.

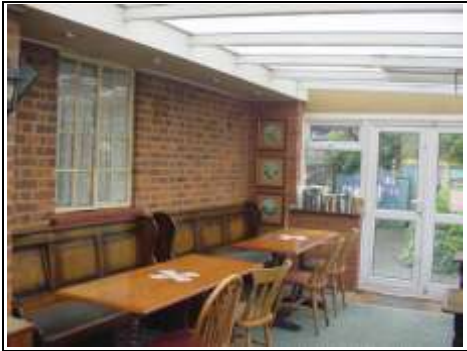
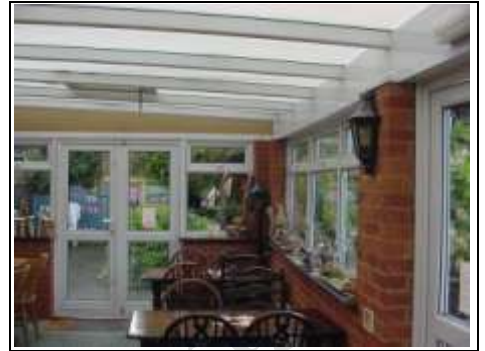
Conservatory

DESCRIPTION	CONDITION	ACTION REQUIRED
Ceilings: Polycarbonate (right hand side)

Polycarbonate roof	Clean
Walls: Exposed brickwork Our inspection was limited by bench seating		Resolve dampness.
Floors: Carpet	Worn	Clean or replace.
Joinery: Windows Plastic double glazed Doors: Plastic double glazed		Clean Clean
Services: See Services section

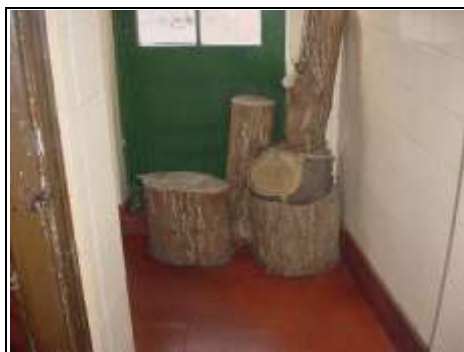
Lobby to Gents Toilets

DESCRIPTION	CONDITION	ACTION REQUIRED
Ceiling: Painted	Dated. Hairline cracking following plasterboard lines.	Repair, prepare and redecorate.
Walls: Floor to ceiling tiles	Fixing holes. Dampness to walls	Re-grout. Fix holes.
Floors: Red quarry tiles		Deep clean.
Detailing: Entrance door: Glazed panels, locked. Door to pub:	Dated. Dated.	Repair, prepare and redecorate. Glazed panels should be amended for security Repair, prepare and redecorate.

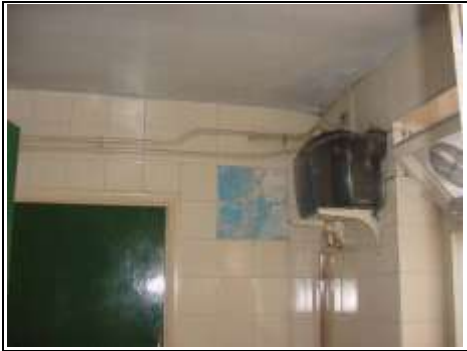
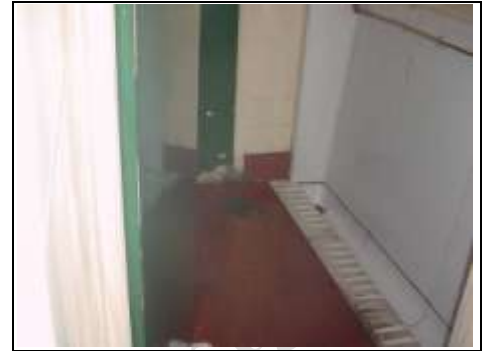
Gentlemen's Toilets

DESCRIPTION	CONDITION	ACTION REQUIRED
Ceiling: Painted	Pattern staining from flat roof above	Repair, prepare and redecorate.
Walls: Floor to ceiling tiles

Dampness found within walls. Tiles missing and blown tiles due to dampness to walls	Resolve dampness. Replace missing tiles, clean and re-grout. General deep clean.
Floors: Red quarry tiles

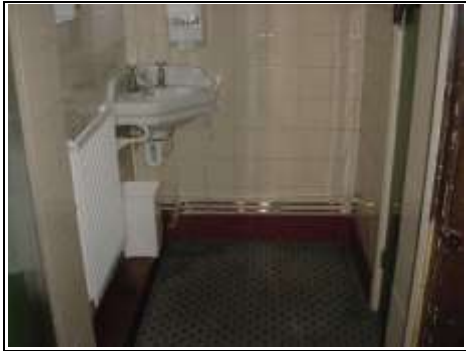
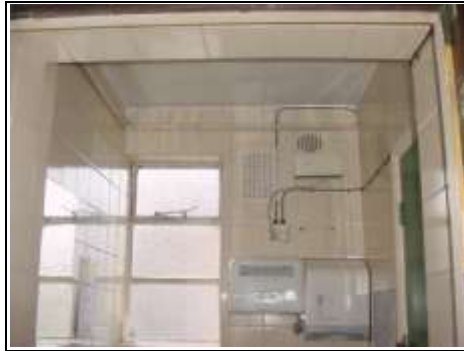
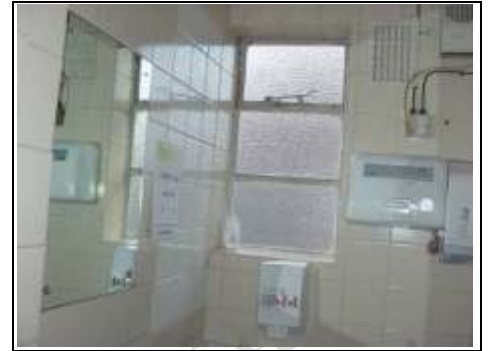
Lobby to ladies' Toilets

DESCRIPTION	CONDITION	ACTION REQUIRED
Ceiling: Painted	Dated.	Repair, prepare and redecorate
Walls: Tiled

Tiles missing due to dampness to walls	Replace tiles. Clean grout.
Floors: Carpet	Worn	Clean or replace
Sanitary Ware: Wash hand basin Hand dryer		Deep clean.
Detailing: Small windows Vent	Dated	Repair, prepare and redecorate.
Services: Dimplex water heater

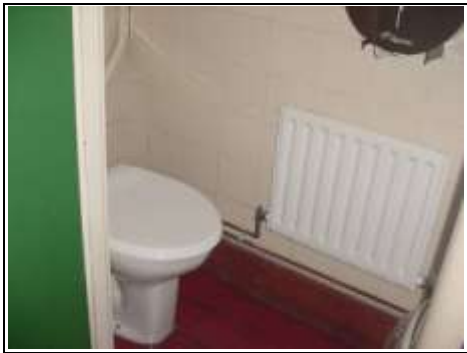
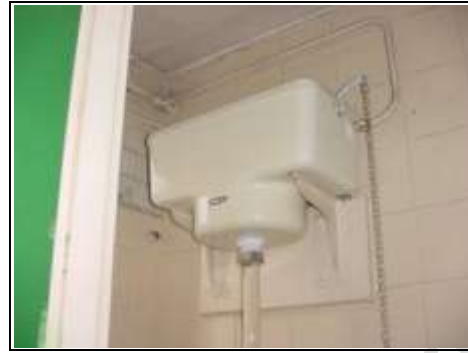
Ladies Toilets

DESCRIPTION	CONDITION	ACTION REQUIRED
Ceiling: Painted	Dated.	Repair, prepare and redecorate
Walls: Floor to ceiling tiles	Dampness to walls. Old fixing holes	Resolve damp problems and then re-tile.
Floors: Vinyl

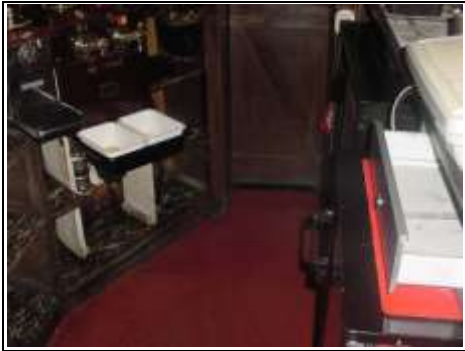
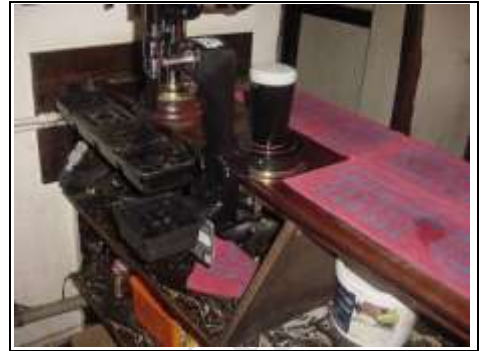
Bar Servery Area

DESCRIPTION	CONDITION	ACTION REQUIRED
Ceiling: Old sign with embossed paper behind		Clean sign and redecorate ceiling.
Walls: Painted	Dated	Repair, prepare and redecorate.
Floors: Altro style flooring

Worn	Replace or repair.
Detailing: Formica bar worn to right hand side

Shelving to bar worn	Replace shelving
Services: See Services Section.

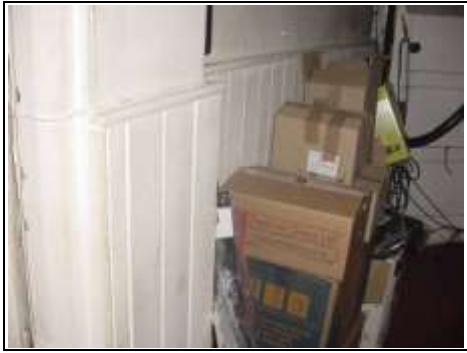
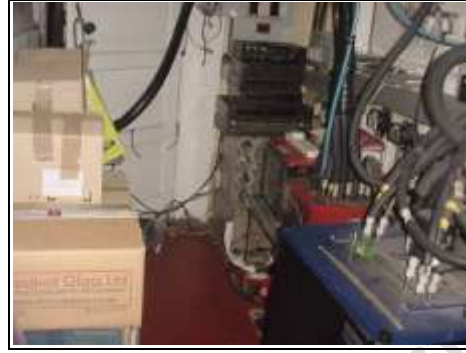
Python room

DESCRIPTION	CONDITION	ACTION REQUIRED
Ceilings: Low level ceiling painted over old distemper/lime wash

Flaking paint to ceiling	Resolve any dampness from roof above. Repair, prepare and redecorate
Walls: Painted Close boarding to approx 1.2m	Dated	Repair, prepare and redecorate
Floors: Altro style flooring	Average	Clean and/or replace
Joinery: Doors Painted panel door	Dated.	Repair, prepare and redecorate
Services: See Services section Dated fuse boards.

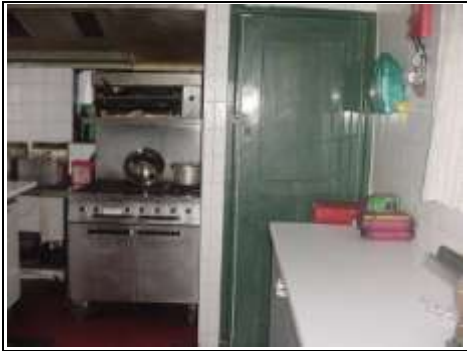
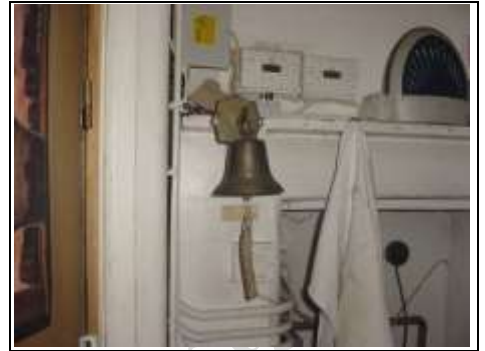
Catering kitchen cooking area

DESCRIPTION	CONDITION	ACTION REQUIRED
Ceilings: Textured paint

Part of ceiling paintwork coming down	Repair, prepare and redecorate
Walls: Floor to ceiling tiling Painted to left hand wall

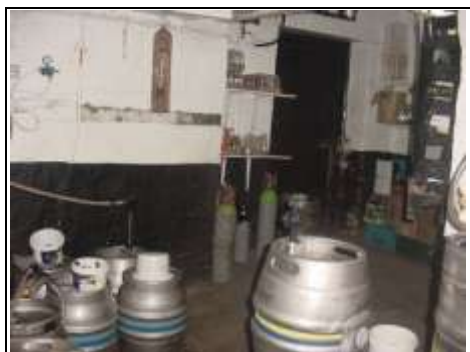
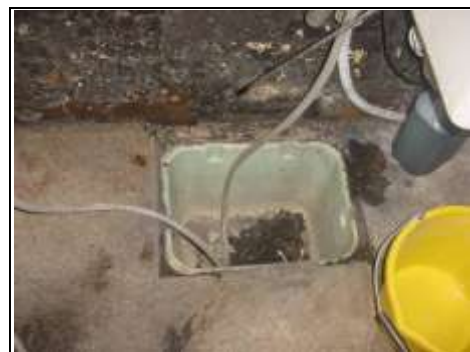
Cellar

DESCRIPTION	CONDITION	ACTION REQUIRED
Ceilings: Painted fibreboard

Dated, stained, dirty	Repair, prepare and redecorate.
Walls: Painted

Damp	Resolve dampness. Repair, prepare and redecorate.

<p>Floors:</p> <p>Concrete</p>   <p>Damaged floor</p>	  <p>Cracked and undulated Advised there is high water table level which does flood cellar</p>	<p>Level and screed, paint floor</p>
<p>Joinery:</p> <p>Doors</p>	  <p>Painted door to cellar</p>	<p>Repair, prepare and redecorate.</p>
<p>Services: See Services section</p>   <p>Electric fuse board – IEE test and report required.</p>   <p>Sump pump This has not been tested. We are aware from discussions that the property does flood.</p>   <p>Belfast sink</p>

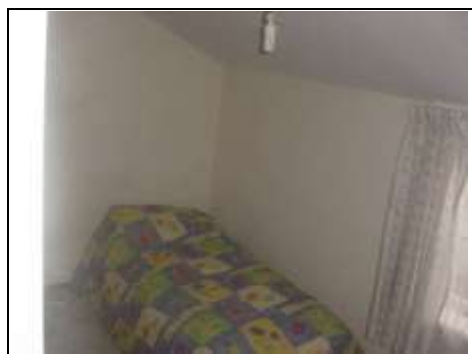
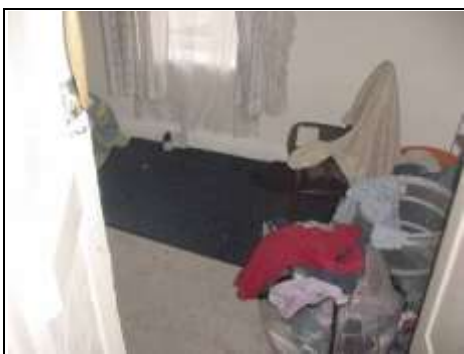
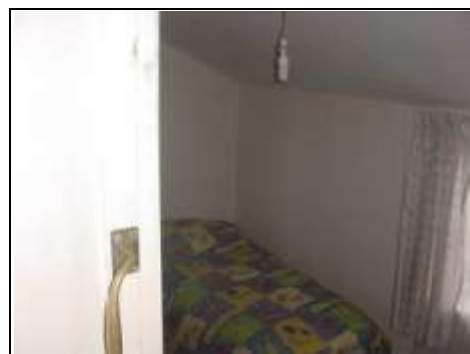
Bedroom rear left

DESCRIPTION	CONDITION	ACTION REQUIRED
Ceilings: Wood chip paper	Paper coming off	Make roof watertight. Repair, prepare and redecorate.
Walls: Painted paper

Damp to chimney	Repair, prepare and redecorate.
Floors: Carpet over carpet	Dated and paint stained	Replace
Detailing: Windows: Sliding sash single glazed 6 x 6 windows Doors: Painted panel entrance door Two painted panel doors to cupboards	Dated. Dated.	Repair, prepare and redecorate. Repair, prepare and redecorate.

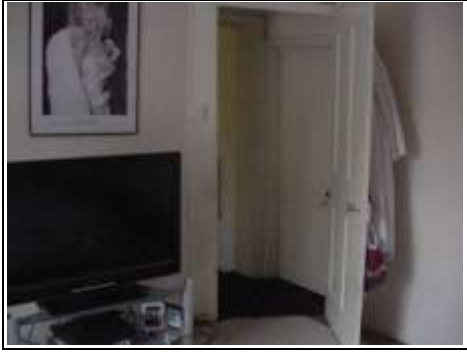
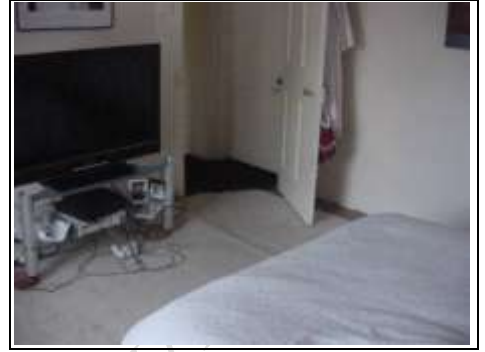
Bedroom rear right hand side (pink)

DESCRIPTION	CONDITION	ACTION REQUIRED
Ceilings: Painted

Dampness visible front right hand corner	Make roof watertight. Resolve dampness, repair, prepare and redecorate.
Walls: Painted	Dampness

Front corners obtaining readings over 100, should typically be 30-60	Resolve dampness. Repair, prepare and redecorate.
Floors: Carpet	Worn	Replace

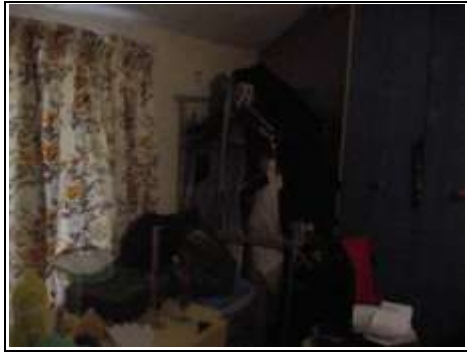
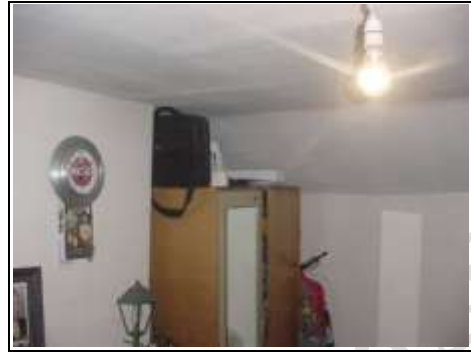
Bedroom rear middle

DESCRIPTION	CONDITION	ACTION REQUIRED
Ceilings: Painted

Ceiling where there will be cold bridging Hairline cracks	Possible cold bridging issues
Walls: Woodchip paper	Dated	Repair, prepare and redecorate.
Floors: Carpet	Worn	Clean or replace.
Detailing: Windows: Doors:	Dated	Repair, prepare and redecorate

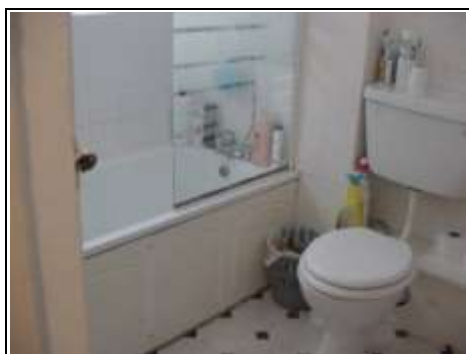
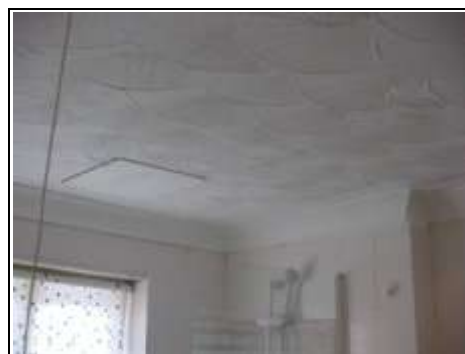
Bathroom rear right hand corner

DESCRIPTION	CONDITION	ACTION REQUIRED
Ceilings: Textured paint 1970's style

Repaired hole	Make roof watertight. Repair, prepare and redecorate
Walls: Floor to ceiling tiles painted	Dated	Clean and re-grout.
Floors: Vinyl	Worn	Clean or replace.
Detailing: Windows: Doors: Painted timber	Dated. Dated.	Repair, prepare and redecorate. Repair, prepare and redecorate.
Sanitary Ware: Bath W.C. Wash hand basin	Old style	Deep clean and/or replace.
Services: Vent, no extract fan

No extract	Add humidity controlled extract fan
