COMMERCIAL BUILDING SURVEY

London

**Victorian
Two Storey
Public House**

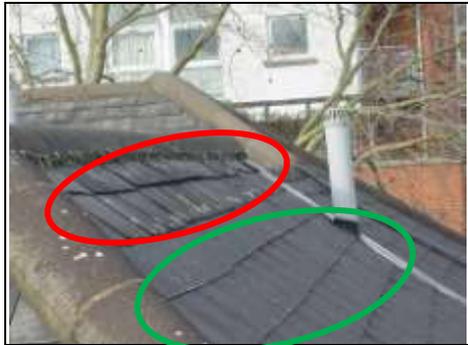
The main pitched roof has a mixture of quarried slate and manmade slates, possibly with asbestos mix. We can see some of the slates are starting to turn from a black colour to a white colour showing through, which can often mean an asbestos mix.

Original slate to top (red oval)
Manmade slates below (green oval)

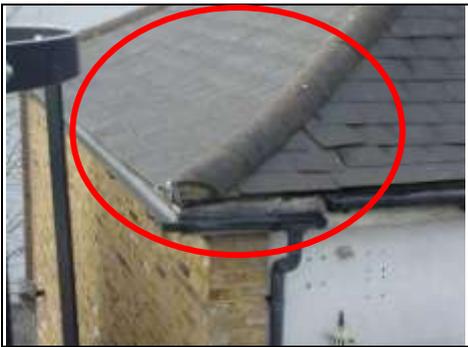
Rear right corner where there is some movement and whitening of slates

ACTION REQUIRED: The whole roof needs to be overhauled and made watertight, replacing damaged slates and re-positioning slipped slates.

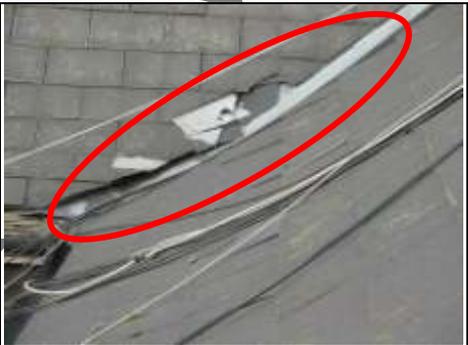
Problems with valley gutter

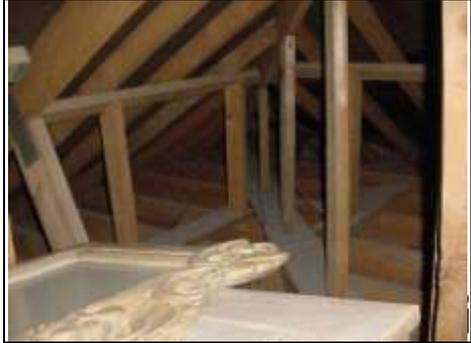
We can see to the rear right corner on Middle Row that the roof has been propped, therefore there are known about problems with this roof. We can also see roof structure problems externally, for example rear left side and other areas. Unfortunately there was no access into the left side of the roof.

Props in roof space

ACTION REQUIRED: Form an access into the left side of the roof. We recommend you prop the roof timbers to both the left and right sides of the roof. Also investigate the dip in the roof.

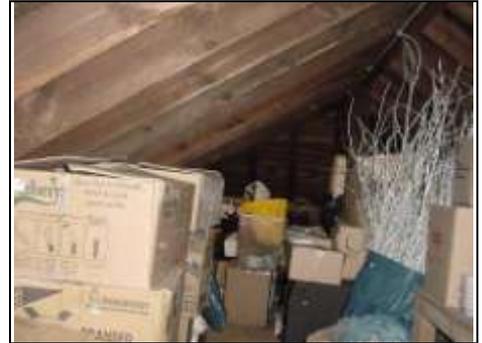
Our inspection was limited by the large amount of stored items within the roof.

Mass of stored items limited our view of the roof

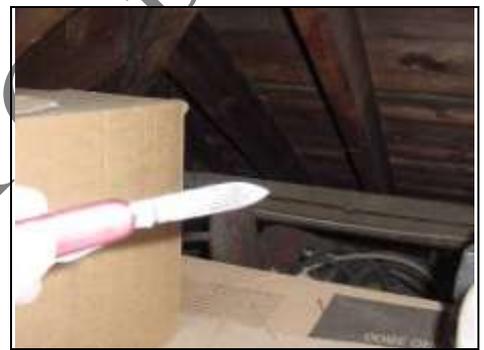
We were able to see some splits along the lines of the purlins.

Split in purlin

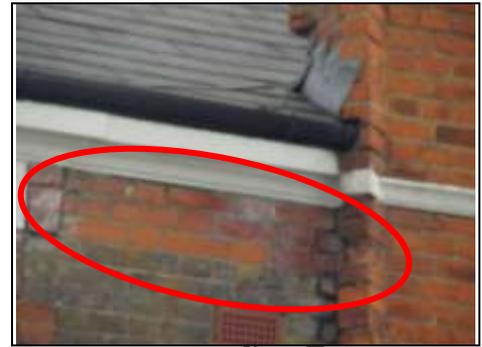
Some of the gutters are sit on gutters. They are leaking and causing efflorescence to the brickwork below.

Dampness in the form of efflorescence on brickwork from overflowing gutter

ACTION REQUIRED: General overhaul of gutters, ensuring the joints are not leaking and are clear and that the gutters go towards the downpipes. Thereafter, regular maintenance and checking of the gutters and downpipes.

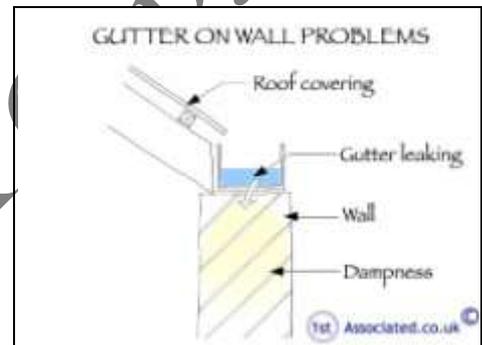
Sit on gutter

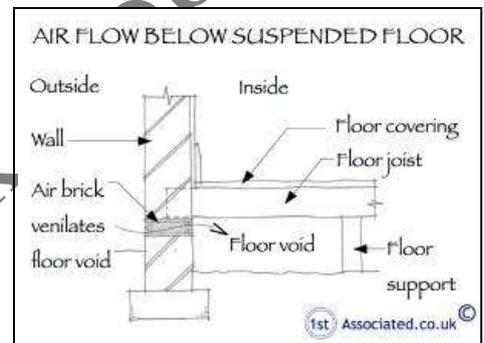
There is a suspended timber floor that we suspect has damp underneath it. It should have vents but we did not see any and we think this is why the floor is undulating.

Suspended timber frame

ACTION REQUIRED: Ideally open up the floor before you commit to purchase the property to establish its condition underneath.

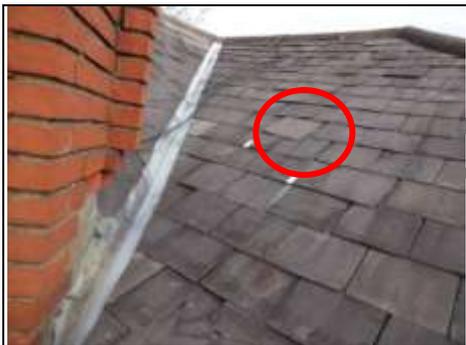
Slipped tiles on roof
Aerial view -360 photo

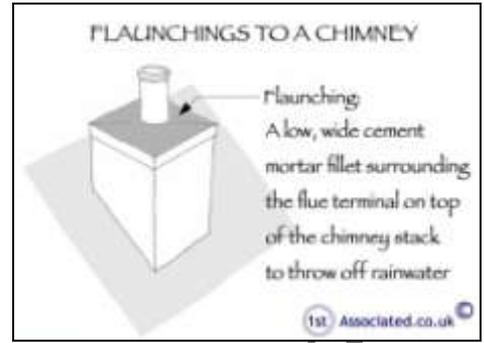
Unfortunately we were unable to see the flaunching, we therefore cannot comment upon them.

Flaunching

ACTION REQUIRED: Please see our comments in the Executive Summary.

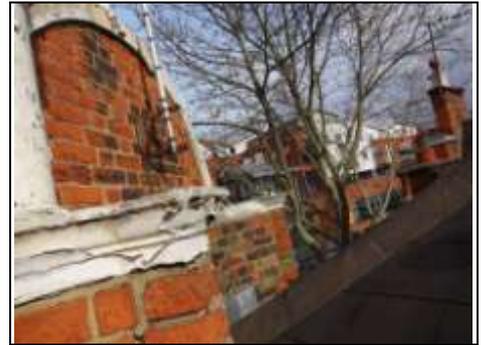
Close up of back of corner chimney
Aerial view – 360 photo

ACTION REQUIRED: Please see our comments in the Executive Summary.

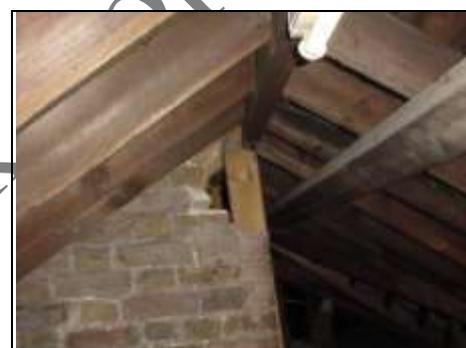
We would comment that a chimney may have been partially removed, as seen within the roof space.

Chimney partially taken down
visible within roof

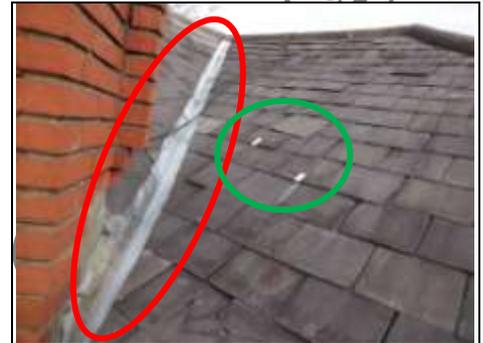
Rear valley gutter (red oval) and lead tingles (green oval)
Aerial view – 360 photo

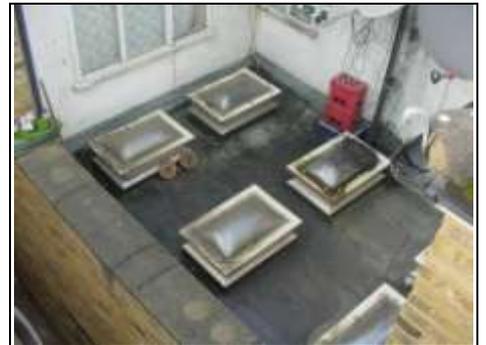
This roof is felt covered with six roof windows / sky lights. This is also a flat, flat roof without a fall.

Flat roof with domed roof windows / sky lights, surrounded by parapet walls

ACTION REQUIRED: During our discussions you advised that you will be looking to extend to the rear which will make this roof redundant, although again, from what we can see, it will be possible to patch repair it for some time (a year or so) until development is carried out.

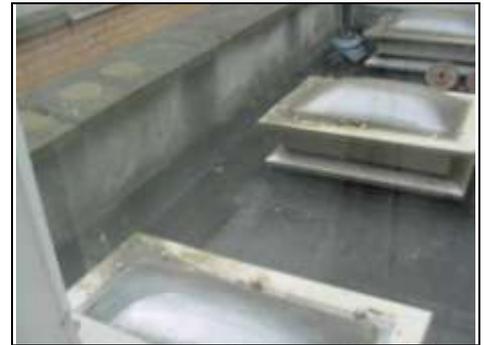
There is a small parapet wall surrounding the flat roof. The staining on the parapet wall indicates dampness is getting through the joints of the coping stone.

Parapet wall surrounding flat roof

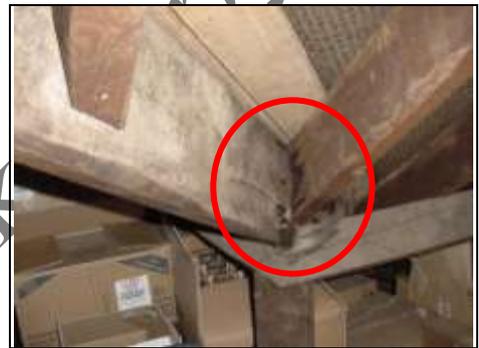
Dampness coming in through rear valley

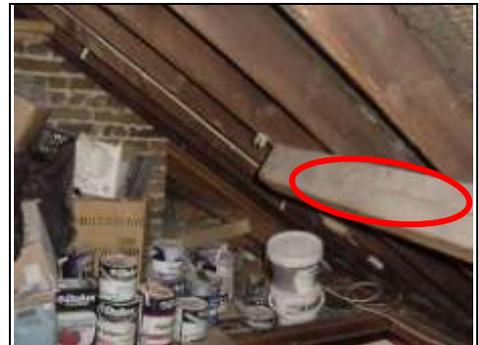
Split in purlin over entrance to roof

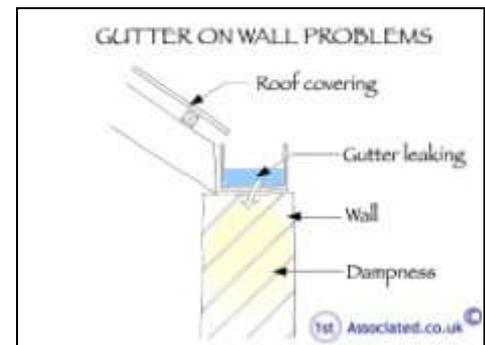
Some of the gutters are sit on gutters. They are leaking and causing efflorescence to the brickwork below.

Sit on gutter

We would always recommend that the gutters and downpipes are cleaned out, the joints are checked and the alignment checked to ensure that the gutters fall towards the downpipes.

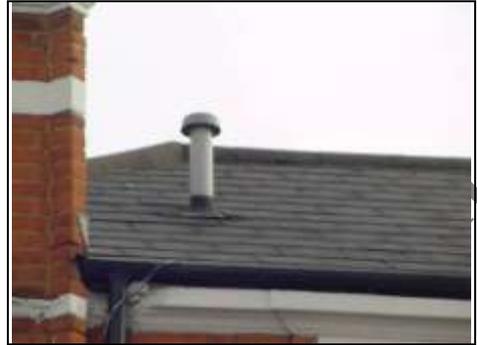
Although we can see vents at roof level we can also see within the roof space they are not connected.

Soil and vent pipe

ACTION REQUIRED: If you wish to carry on using it as guest accommodation then we recommend all soil and vent pipes and extract systems are connected.

ANTICIPATED COST: A few hundred pounds; obtain quotes.

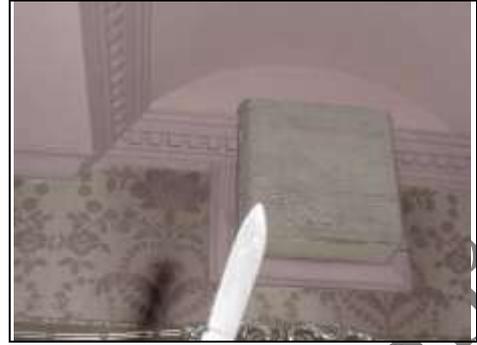
ACTION REQUIRED: We noticed the vent is blocked up internally.

High level vent needs unblocking

Please ensure all vents are clear.

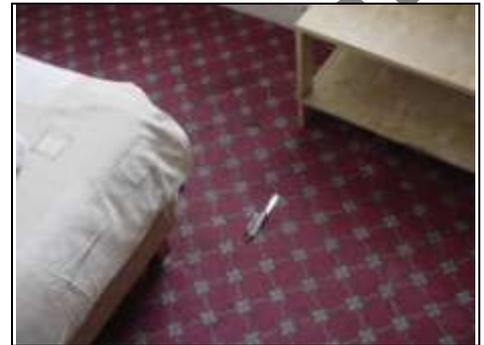
We noted a dip in the floor in the rear right bedroom. There may be rot to the embedded timbers.

Dip in floor in Bedroom 5 to the rear right

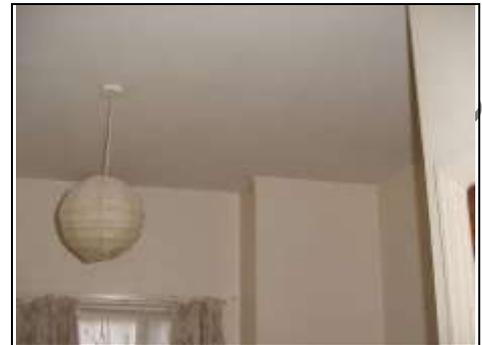
Room 8 to rear middle
Is this a chimney breast?

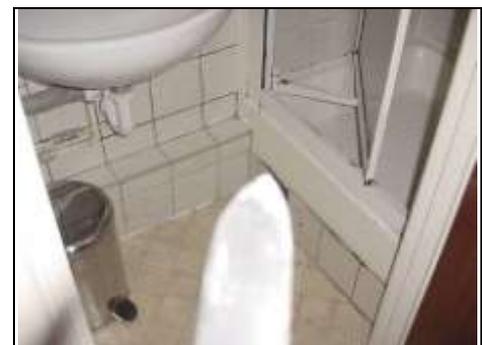
At the time of the inspection there were obvious signs of condensation in the form of black mould.

Condensation and black mould in Room 3 to front middle

Condensation and black mould depend upon how you utilise the building. Common sense is needed and a balance between heating, ventilation of properties and opening windows to air the property regularly.

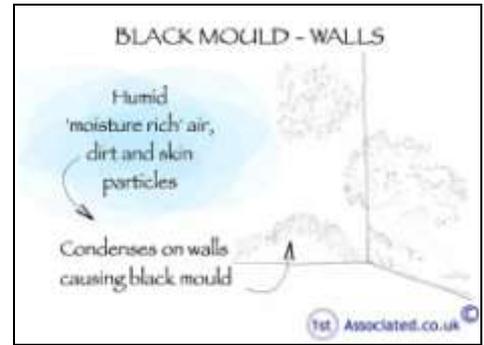
Black mould

ACTION REQUIRED: We would recommend large good quality humidity controlled extract fans be added to kitchens and toilets.

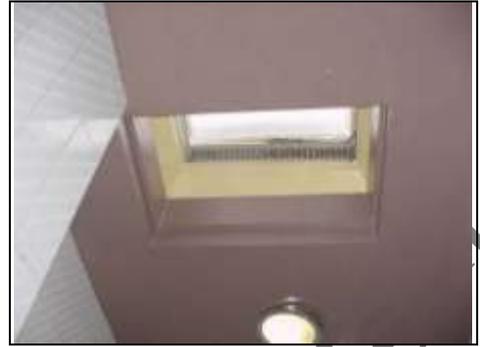
Roof window/sky light in Gents WC on single store flat roof

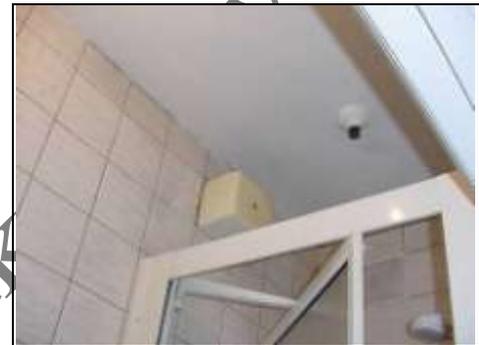
Room 9 – small extract
