PROPERTY REPORT AND NEGOTIATION DOCUMENT

We have been instructed to inspect and prepare a Property Report and Schedule of Condition for:

The XXXX
XXXX Hertfordshire, HP23 XXX

Property Report

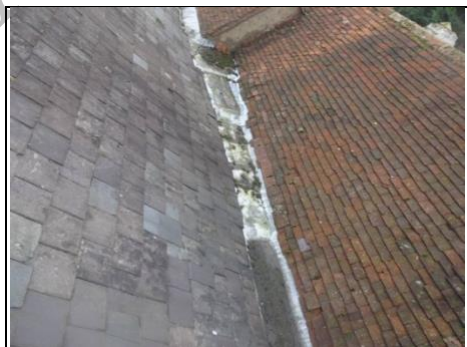
Valley gutter

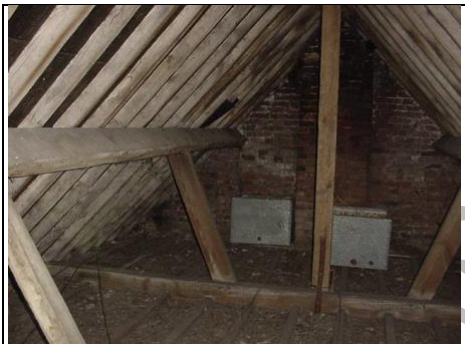
General bend in common rafters

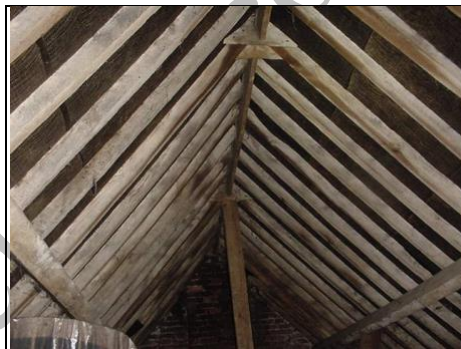
Thinner common rafters than we would expect

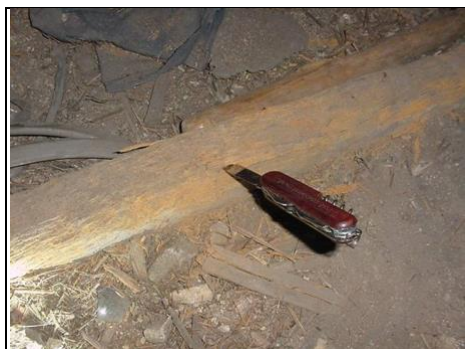
Woodworm

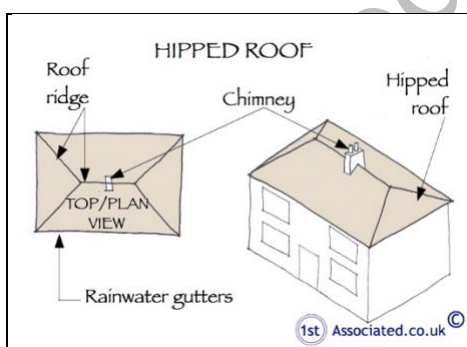
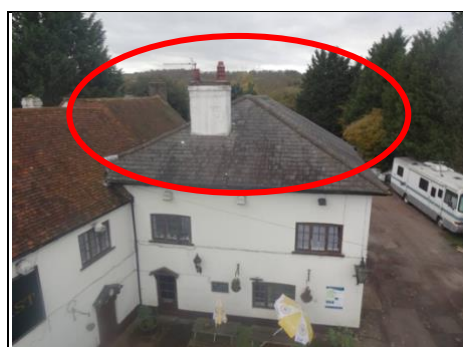
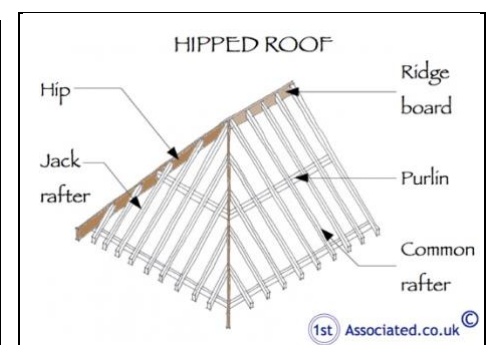
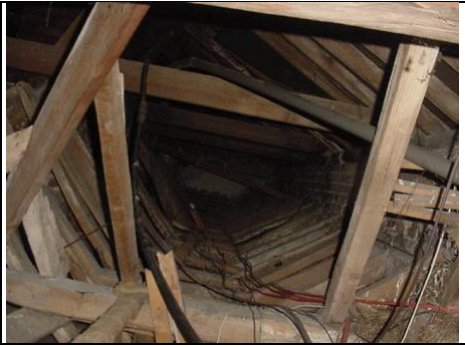
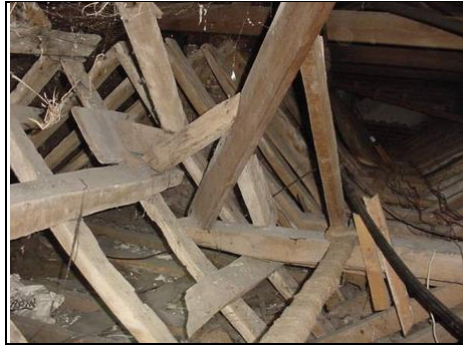
We had a limited view of the hipped roof however this also looked to have woodworm.

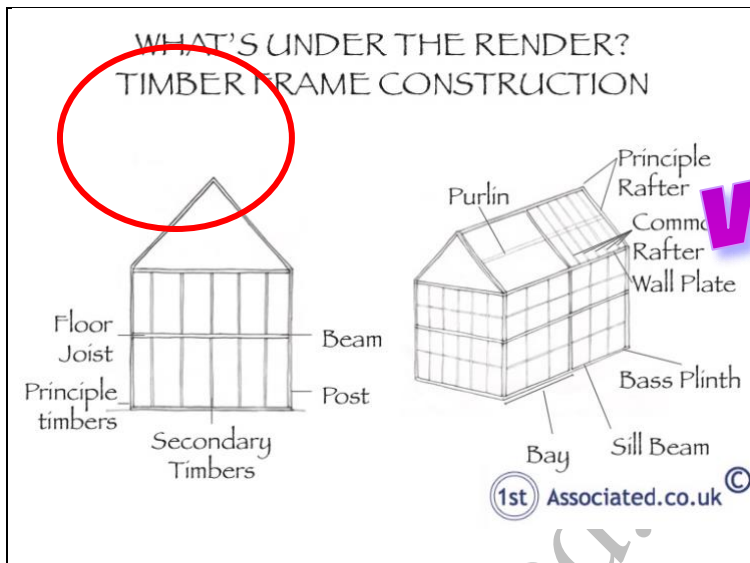
There is a hidden timber frame structure which unfortunately has been incorrectly covered by a cement render, particularly bearing in mind this is a listed building it is completely inappropriate and is causing damage to the timber frame structure behind it. There may well be timber structures underneath other parts of the property as well; further investigation needs to be carried out by discreetly opening up the structure.

Box timber frame

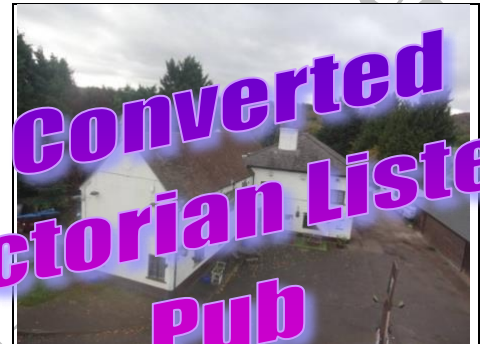
Timber frame

Cement mortar stops the building from breathing, this should be a lime based render. It also causes accelerated deterioration to the timber frame.

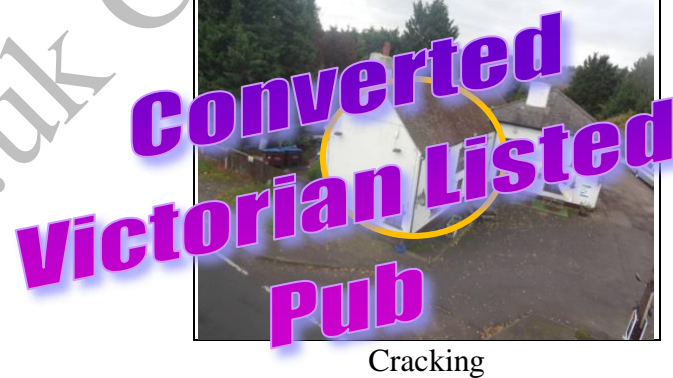
Throughout the render to the central part of the building we can see cracks. There is movement occurring in the structure which is probably due to the timber frame having differential movement to the cement render.

Cracking below window

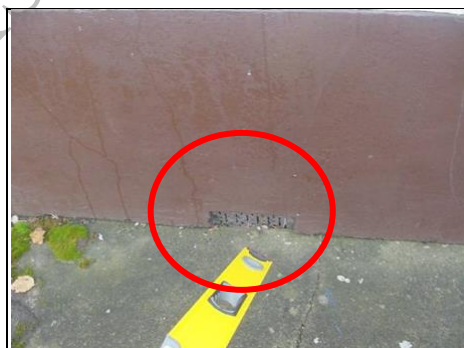
Airbrick acting as gutter

ACTION REQUIRED: Add a French drain linked into the drainage system.

ANTICIPATED COST: In the region of £1,000 - £2,000; quotations required.

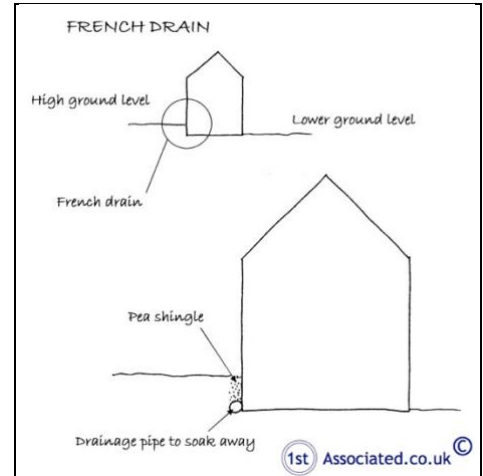
French drain

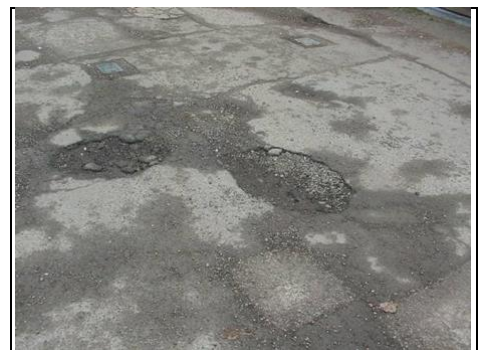
The car park has pot holes and is in need of repair and general tidying up of the vegetation and plant life around it.

Pot hole repaired

ACTION REQUIRED: Fill all pot holes and re-tarmac where currently tarmacked and shingle unmade car park areas.

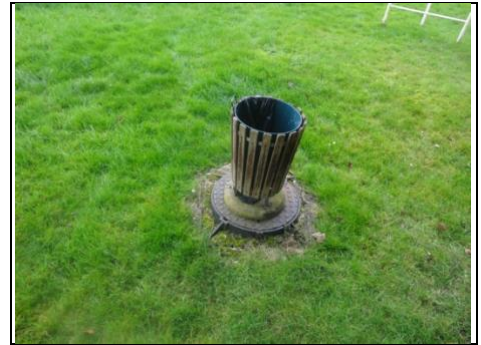
What is underneath ground?

It also mentions there are fourteen well shafts, the number suggests the industrial use of water in the area, probably for iron production.
