COMMERCIAL BUILDING SURVEY

**XXXXXXXXXX,
XXXXXXXXX, Lower Lydbrook,
Gloucestershire,
GL17 xxx**

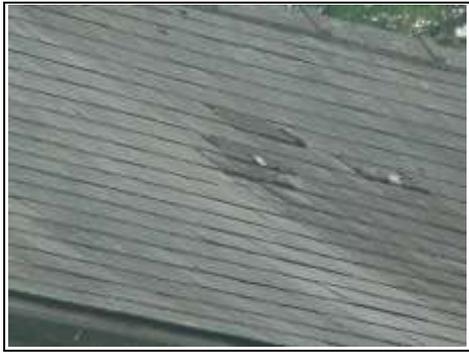
Main roof with some lead tingles

There is a possibility that the property has what is known as nail sickness. This is where the nail fixings have rusted and when you try to repair one section the entirety of that section will come away. We would base this on the fact that we can see lead tingles (please see our earlier photo and sketch).

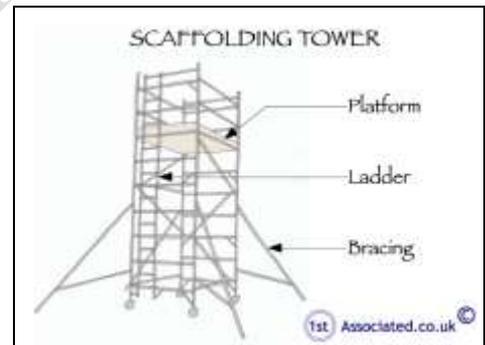
Scaffolding tower

ACTION REQUIRED: The purchase of a tower scaffold as soon as possible together with replacement slates for your roof. We would recommend that you repair the roof as and when necessary. At the start of the summer of 2013 you need to open up sections of the roof for a closer inspection. By then after having repaired the roof for a year you will have got to know and understand it a lot better.

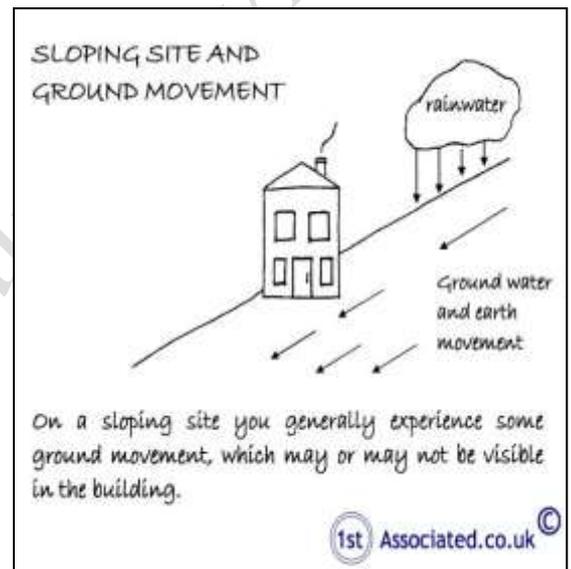
We feel you are likely to have a dampness problem as the property sits on a sloping site. Any rainwater that wishes to travel from the top of the sloping site to the bottom of the sloping site passes through the property. Please see our comments within the main body of the report.

Sloping site

With regard to this we feel a definite path should be built around the property to minimise deterioration. We draw your attention to section eight of the report in particular.

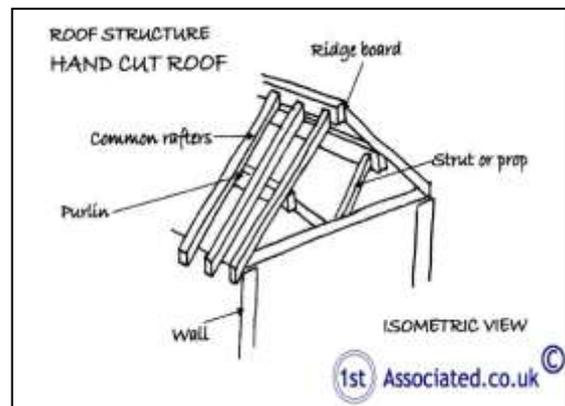
The shape of the roof indicates that the rafter feet (ends of the common rafters, the ones that form the pitch of the roof) have rotted/deteriorated. We were not able to physically see these as they are covered in spray foam and we had limited access into the roof.

Hand cut roof

ACTION REQUIRED: Two to three year plan - If you are looking in the short term you could probably get away with (if this is the right term) a purchase of a tower scaffold which gives you good access to the roof and carry out adhoc repairs. If you wish to be on the safe side with

a two/three year plan we would suggest you open up sections of the roof, particularly the front left hand side, to check the condition of the timbers and the nail fixings.

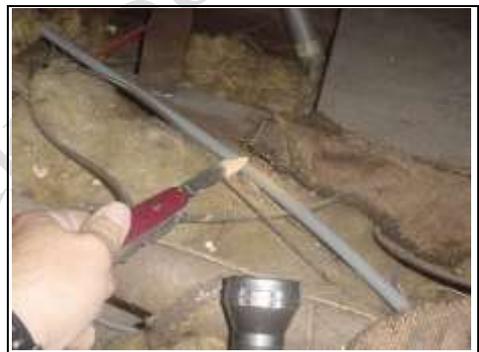
We can see active woodworm to the right hand side roof. We very rarely see active woodworm and we would comment that we feel that many of the woodworm companies blow woodworm out of all proportion regarding the problems it can cause. It takes a lot of woodworm holes to cause damage to a timber that we would term as significant structural damage.

Frass on the end of the knife

We would reiterate that we cannot see any of what we would term as structural woodworm problems to the modern timbers that have been put in the roof. We assume the modern timbers have been treated. Having said that the woodworm is still present in the older part of the roof structure in the areas we have viewed. Whilst we have viewed the timbers the best that we can and given the circumstances, i.e. we are in a roof, we have not viewed every single timber.

ACTION REQUIRED: In this roof we can see there is woodworm present. A chemical spray to the roof will be the best way forward. Although we don't normally recommend this it looks to be the best

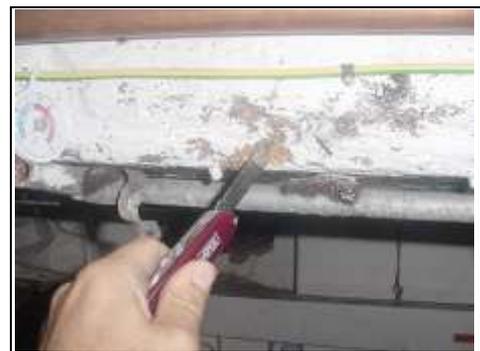
Much of the timber is covered up but we could see in certain sections active woodworm.

Active Woodworm in the cellar

ACTION REQUIRED: This needs to be inspected by a woodworm treatment company prior to purchasing the property. They need to open up areas of the cellar to check the timber.

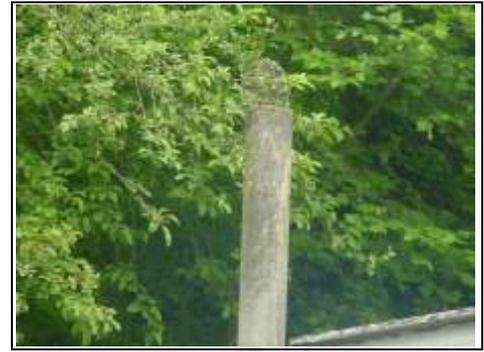
We have already spoken about the asbestos roof. There is also an asbestos flue visible to the rear. We suspect there is more asbestos within the property.

Asbestos flue

ACTION REQUIRED: The existing owner or yourself needs to have a full asbestos report on the property carried out. Our experience with asbestos reports is that you have to be hands on and literally have a meeting with the asbestos contractor at the end of the survey (make sure you tell them you are going to do this) and have a one to one discussion with them as to where the real problems are.

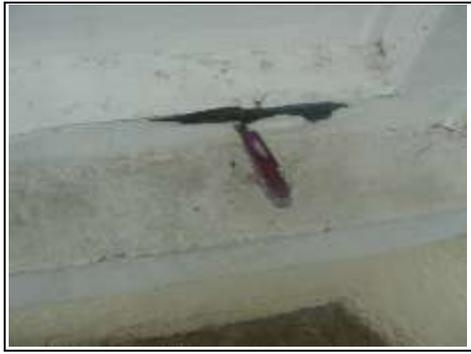
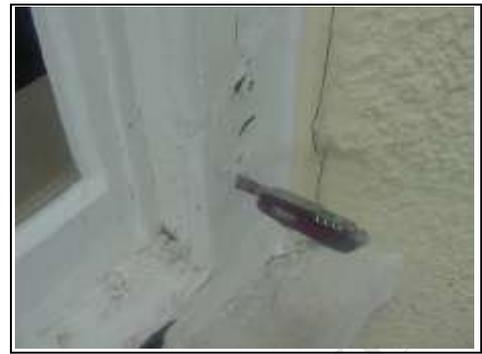
You have a lot of rot in the windows. Even the windows that looked in quite good condition simply gave way when we knife tested them.

Pushing a knife into the window

Rotten even when they do not look rotten

ACTION REQUIRED: Ultimately you will need to replace the windows. We suggest this is done in stages or by elevations of the property such as the front elevation first as this is the one that customers will see first.

ANTICIPATED COSTS: In the region of £5,000 - £15,000 (five to fifteen thousand pounds) dependent upon how good a repair you wish to have and the quality of timber being used etc.

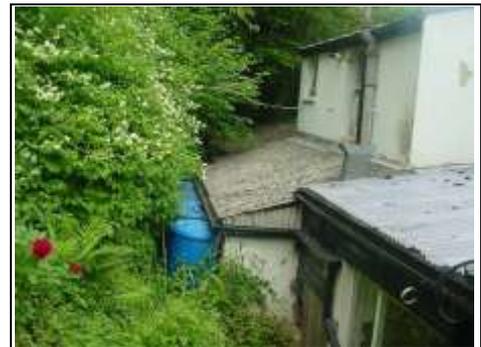
We would expect dampness to the rear of the property which is the kitchen area. We cannot see how this area will not be damp.

Area around the kitchen needs a path around the property rather than through it

ACTION REQUIRED: You need to have a one to one discussion with the existing owner to ask about the dampness. We feel the best option would be a French Drain type system around the property to give the water a direct path around the property.

ANTICIPATED COST: In the region of £10,000 - £15,000 (ten thousand pounds to fifteen thousand pounds); please obtain quotations.

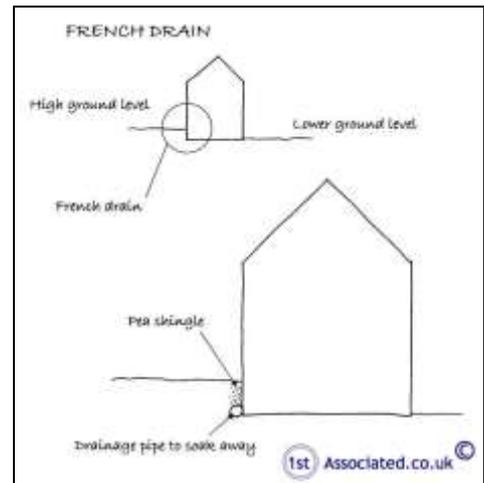
French drain

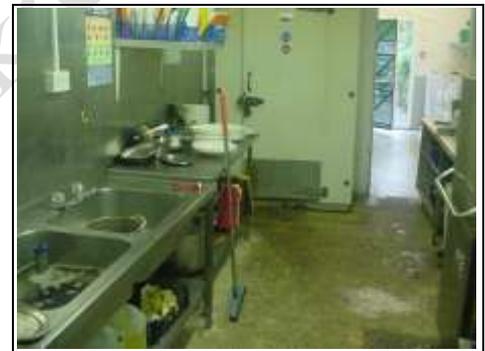
Floor will not meet Environmental health standards

As we understand it you have spoken to the Environmental Health Officer. We would also invite them down to view the property.

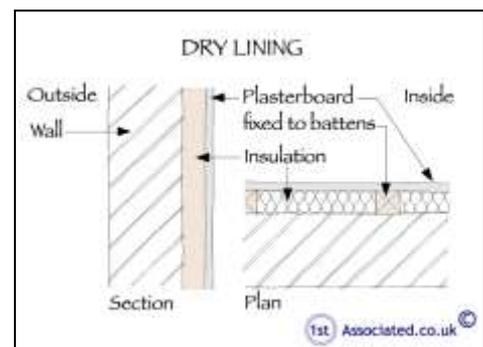
As with any property of this age there is a mixture of old and new construction. This may not be apparent to you as you walk round but, for example, the function room has been completely dry lined. This is where a wall is put in front of a wall and is known sometimes as a false wall. This means that we cannot see the real wall at all.

Dry lining

Often in older properties this system is used to avoid dampness and can also be used to add insulation or both! Without opening up the walls we cannot be certain.

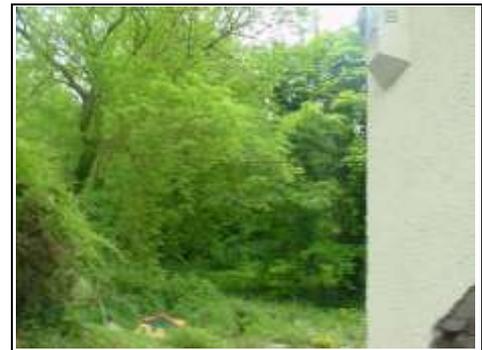
There are magnificent and mature trees surrounding the rear of the property. The root system is certainly within what insurance companies would term as influencing distance.

Mature trees to the rear of the property.

ACTION REQUIRED: Employ an Arboriculturalist (this is not a tree surgeon) to give advice on the trees.

ANTICIPATED COST: In the region of £250 - £500 (two hundred and fifty pounds to five hundred pounds); please obtain quotations.

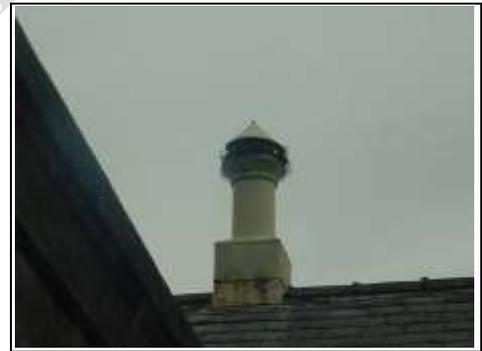
Left hand chimney

This is a metal built chimney/flue. We can see it is rusting to the base but we cannot see the reason for this.

ACTION REQUIRED: You need to trace back where this flue goes back to, bearing in mind you cannot go in the function room roof safely as it presently is.

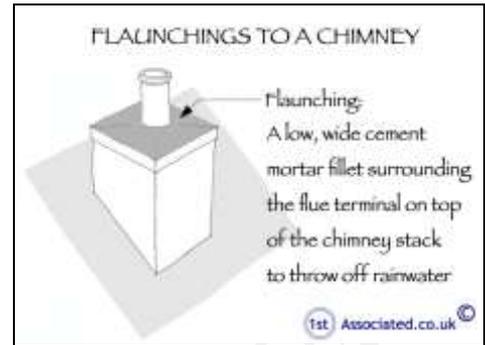
Unfortunately we were unable to see the flaunching, we therefore cannot comment upon them.

Flaunchings

ACTION REQUIRED: When the main roof is re-roofed this whole chimney needs to be checked and by the summer of 2013.

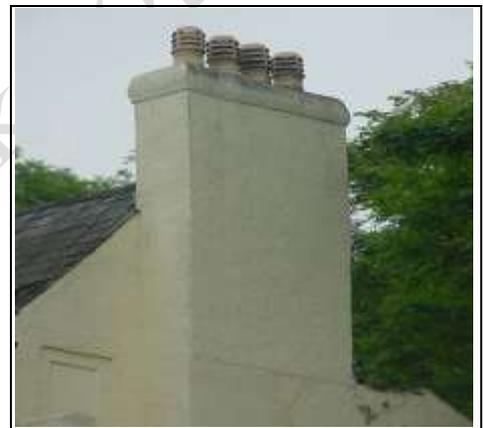
Right Chimney

This chimney is has a painted finish with four chimney pots.

Unfortunately we were unable to see the flaunching, we therefore cannot comment upon them.

ACTION REQUIRED: Please refer to our comments within the Executive Summary with regard to the chimney leaning and work required.

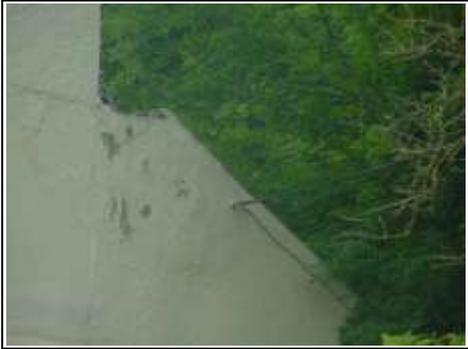
One area that we were unable to view was the rear right hand side where there looks to be a ledge. Unfortunately it is concealed by the nearby trees. When you buy your tower scaffold we would recommend this area is viewed. It may be hidden valley gutter from the size of the roof.

Ledge to the rear right hand side and over grown trees.

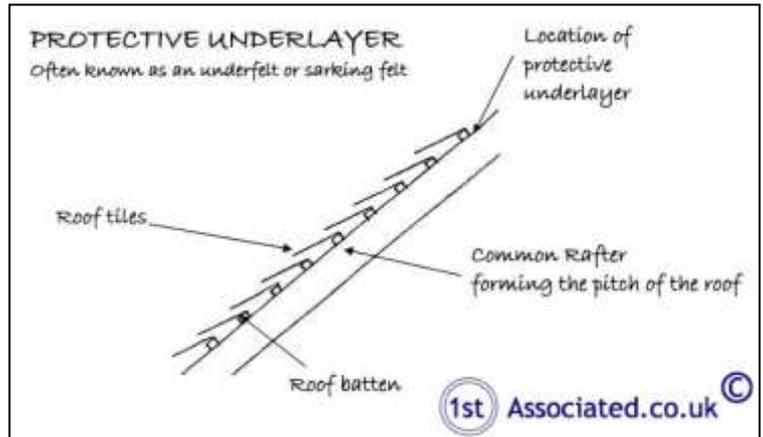
Spray Foam

We cannot see a protective underlayer as the underside of the roof is covered in spray foam. We think it's highly unlikely there is a protective underlayer as there is not usually spray foam where there is one.

ACTION REQUIRED: Please see our comments within the Executive Summary with regard to the spray foam and the future problems.

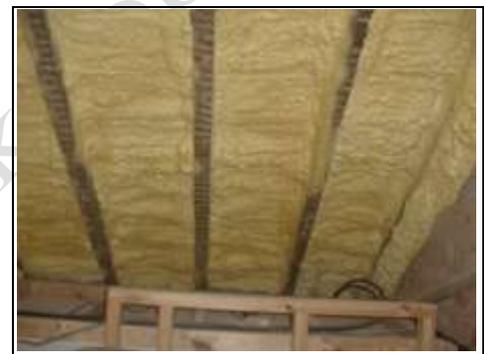
Spray foam in the roof

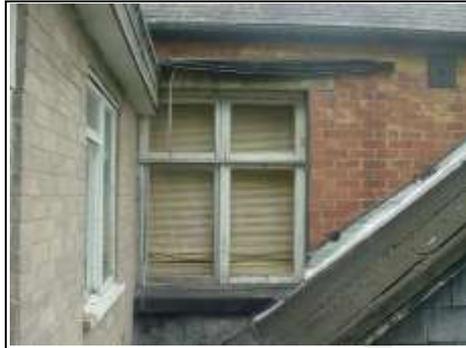
Bottom of felt roof

From our visual inspection we would recommend re-roofing, re-decking and new flashing. This looks to be the worst of the low level roofs.

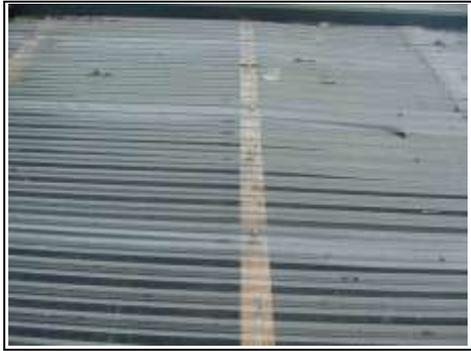
This is a plastic corrugated roof over a felt roof. Please see our comments within the Executive Summary. We believe the entirety of this roof will need to be re-roofed. You may be able add roof windows to it to help with the light in the work areas beneath.

Plastic has been put over the felt

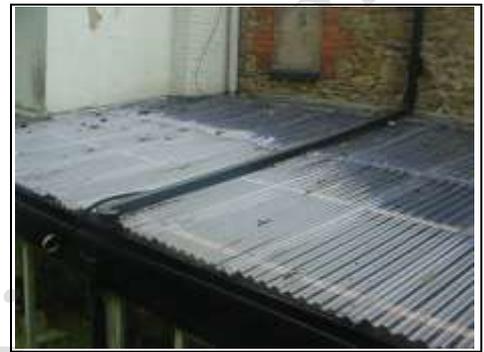
Plastic corrugated kitchen roof

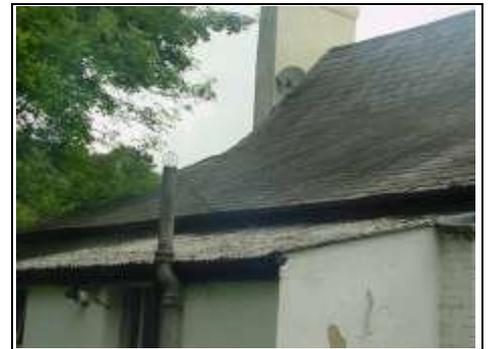
This is an asbestos roof. Please see our comments on asbestos and this particular within the Executive Summary.

Asbestos roof and flue

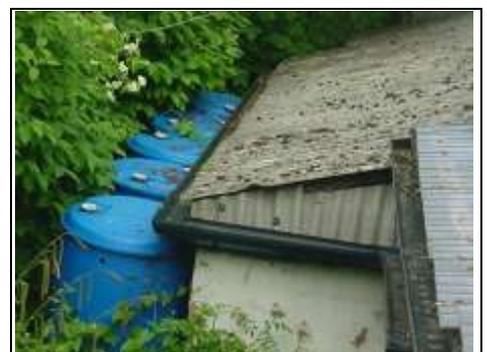
Asbestos has been used over the kitchen. This is the rear right side of the kitchen cooking area. We simply could not get close to this area. We would also ask what the blue barrels are?

Asbestos roof over the kitchen

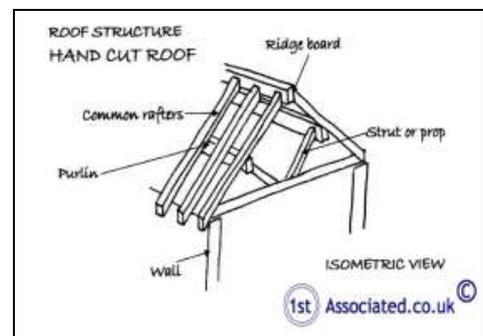
Hand cut roof

Both main roofs have what is known as a cut timber roof structure. This is a roof that is purpose made and hand built on site. We consider the roof to be of light weight construction compared to what we typically see i.e. the timbers were thinner than we typically see and spaced, in some cases, slightly further apart. Without the original

ACTION REQUIRED: It is likely that when you re-roof both roofs will need to have new timbers. This is a very difficult and messy job where spray foam has been added as in this case.

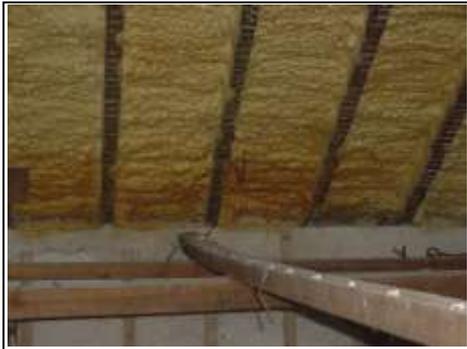
Left hand roof over the function room.

The darker areas are likely to be dampness

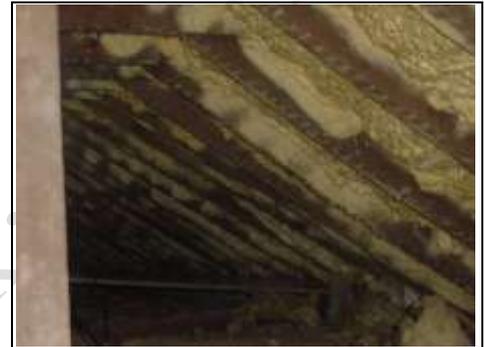
Spray foam in left hand roof

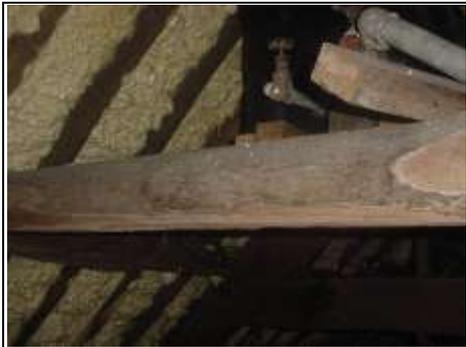
design details we cannot categorically confirm that there are no defects; this is with the exception of the right hand side roof where we can see an older roof structure within it. We mentioned this has timber bark and woodworm.

Bark timber and foam in the background

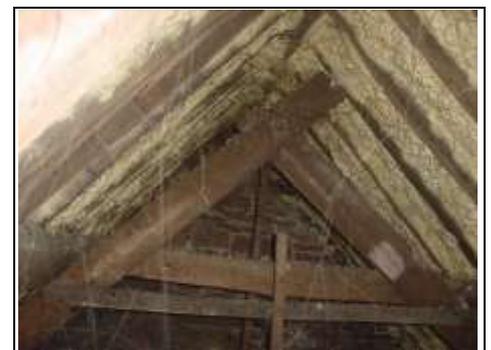
Roof over a roof – right hand roof

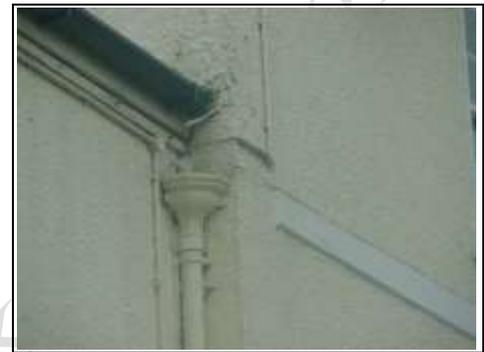
Cast iron hopper head with plastic gutters above.

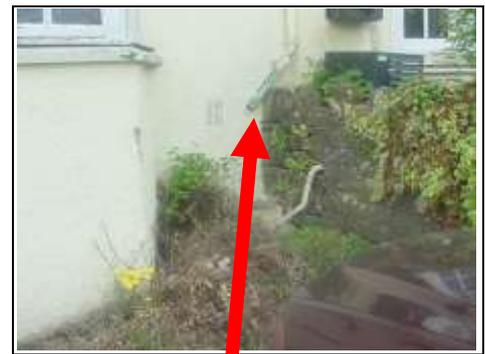
We would draw your attention to the rainwater disposal which we do not think has been thought through. We have noticed everything from rainwater discharging directly onto a wall, causing dampness to the area beneath, to several downpipes going to one place. No thought has been given to the drainage.

Rainwater discharging onto the wall, leaving the wall damp

ACTION REQUIRED: We would recommend that the joints are checked and the alignment checked to ensure that the gutters fall towards the downpipes and that they are initially cleaned out until the summer of 2012. We then recommend you set aside the sum of £3,000 (three thousand pounds) to realign and replace the gutters and downpipes.

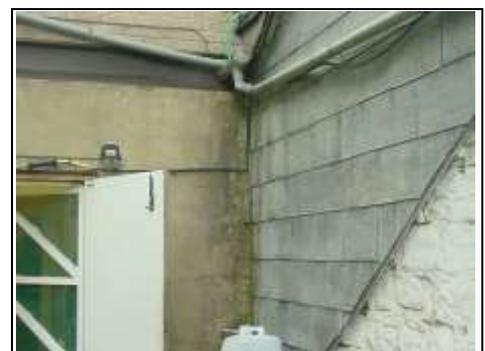
Water overflowing from staircase to function room area

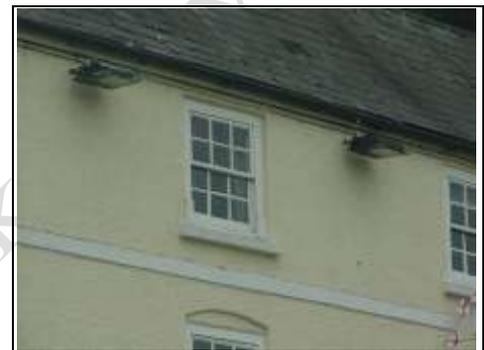
In this case we would comment that there are no drips to the render indicating that it is from the cheaper end of the market. There is also no bell mouth to the render. The render goes down to the ground meaning that capillary attraction will cause dampness at ground level and will bridge any damp proof course if there is one (which we doubt).

No drip detail to windows

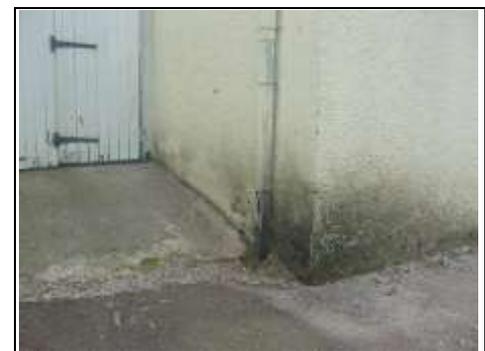
No bell mouth detail to base or render

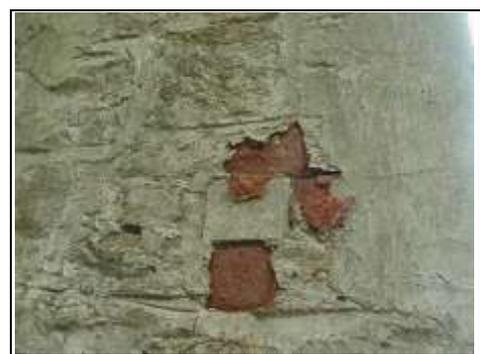
Other areas are painted brick and painted stone. This is stopping the brick and stone from breathing. As it is stopping it from breathing it is deteriorating.

Painted brick and stone wall

ACTION REQUIRED: Ideally we would remove the paint and see the condition of the property beneath. It may then need rendering.

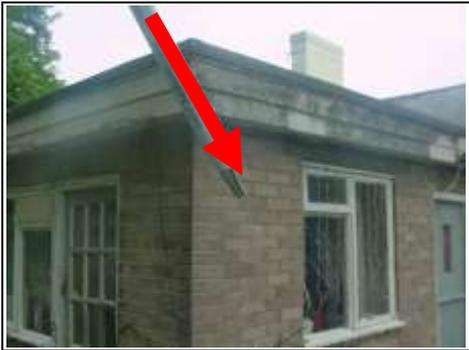
One of the newest areas is the brickwork building that is acting as the Chefs private living accommodation. It is stretcher bond brickwork with cement mortar bedding. We can see that there has been some movement in the brickwork which has been rebuilt. We believe this structure may have been built on a structural frame and if so the brick work may simply be a cladding around the structural frame.

Movement in the stretcher bond brickwork that has been rebuilt

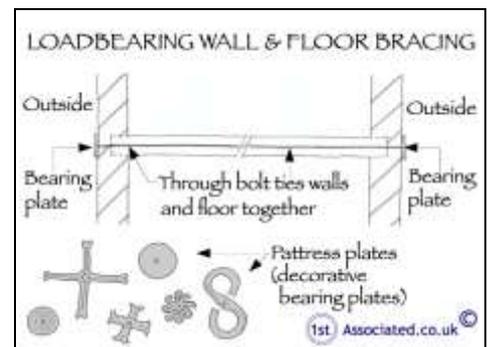
Tie Bars

We can see the tie bar to the function room indicates that there has been movement in the walls which has been restrained by the tie bars. This has been hidden to the front of the property. There may be other areas of hidden structural repairs such as this which you will only be able to truly see once the property has been opened up. As mentioned earlier this tie bar may well have been put in place due to the roof defects that have perhaps caused roof spread.

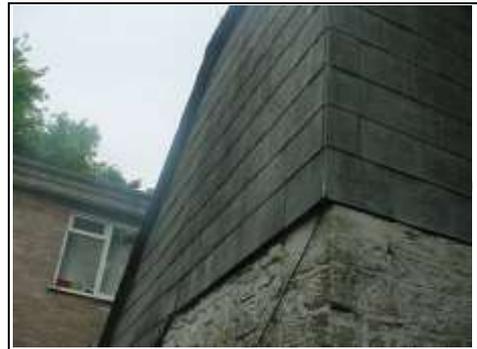
There is vertical tiling to the rear left hand side. We believe this is has been added as a lightweight / economical form of construction and is likely to have a timber frame beneath. When the work is carried out to the felt roof over the stair you should also look into the construction of these walls.

Vertical tiling –rear left hand side

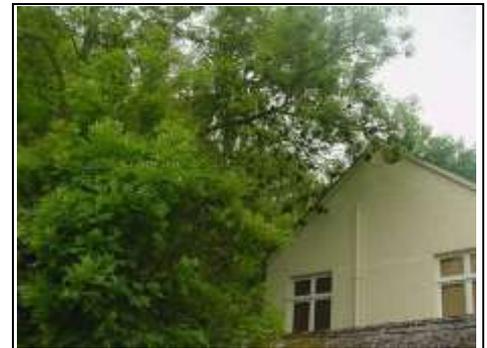
There are trees within what insurance companies would term as influencing distance of the property.

The trees located to the rear

ACTION REQUIRED: They need work. Please see our comments within the Executive Summary.

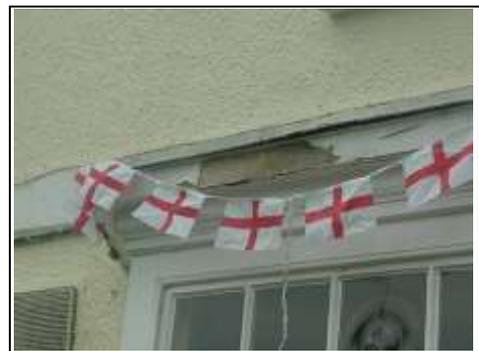
Fascia to bay windows
timbers exposed

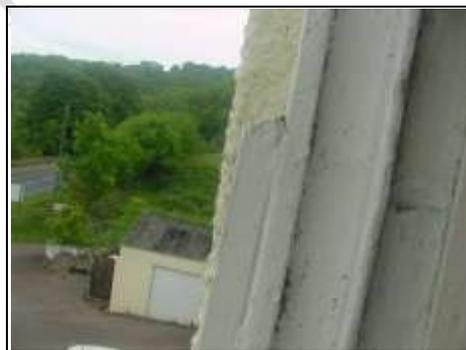
Cover plate over the timber window

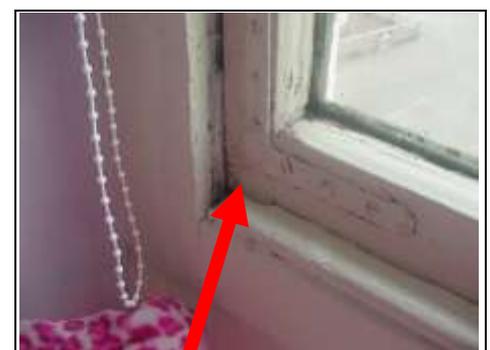
Angle bracket holding the window together on the second floor bedroom

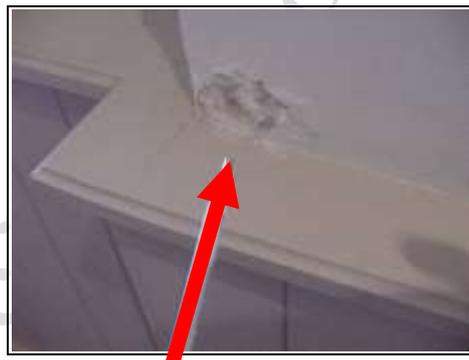
Close up of dampness

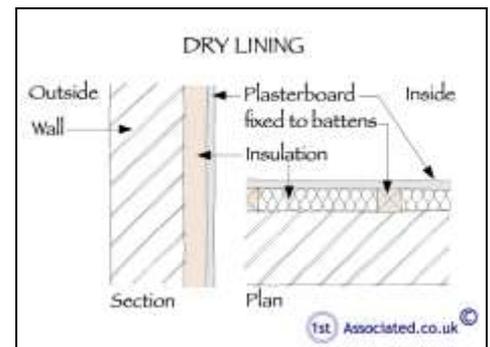
Dry lining

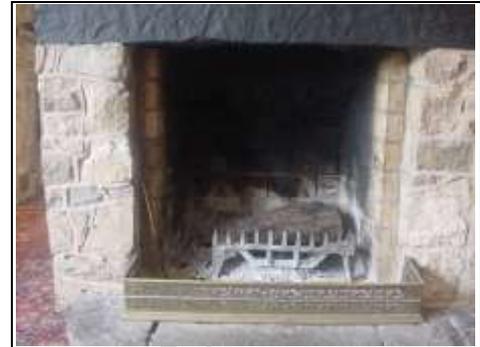
Restaurant fire on the ground floor

It is strongly recommended that flues be cleaned and checked for obstructions prior to use to minimise the risk of hazardous fumes entering the building.

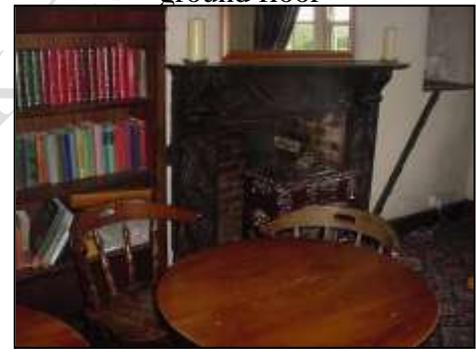
Fire in right hand bar ground floor

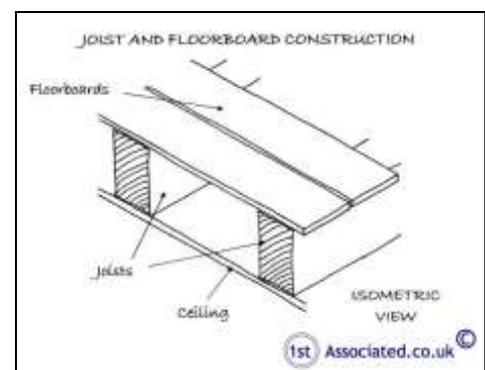
Joist and floorboard

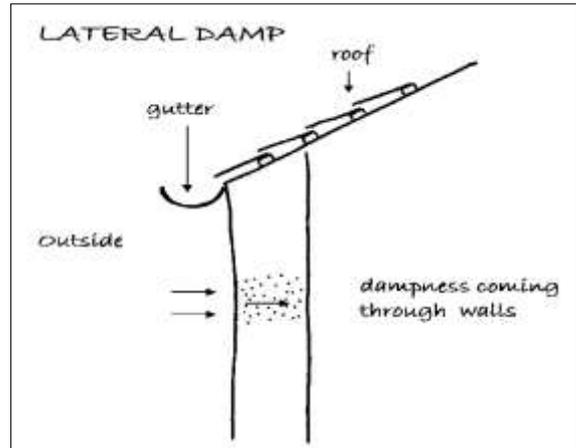
We used a damp meter on the external walls. The dampness readings are in line with what we would expect in an older property i.e. minor dampness.

Lateral dampness

ACTION REQUIRED: Please see our comments in the Executive Summary.

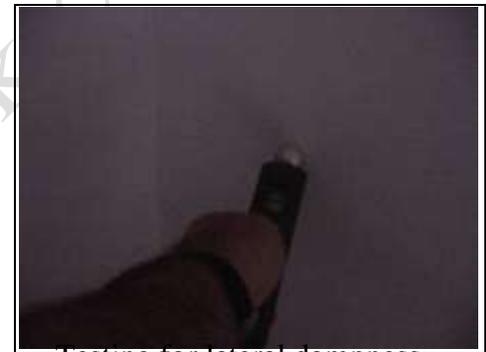
Testing for lateral dampness.

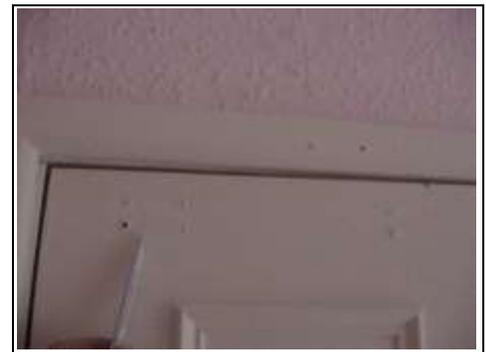
To reiterate our concern with this property regarding the fire doors. We can see doors where the door closers have been removed. We assume this was a requirement to have them on.

Door closers have been removed

ACTION REQUIRED: Please see our comments with regard to the property not meeting current Fire Regulations.

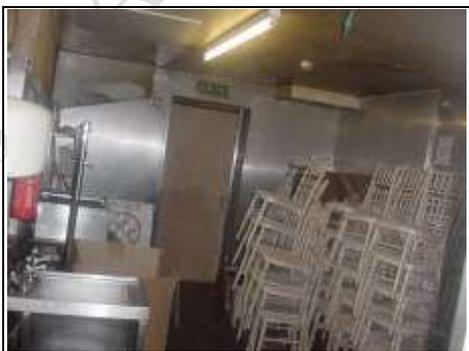
We assume that this kitchen is no longer in use.

Kitchen for the function room on the first floor

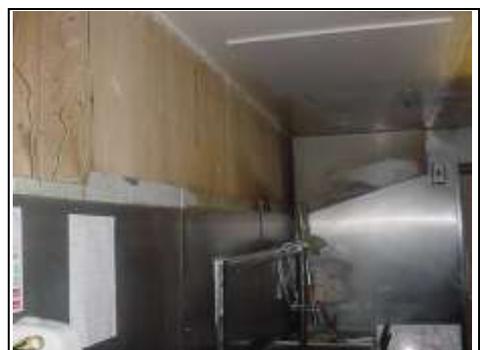
Wood exposed in kitchen

ACTION REQUIRED: You need to have a “cup of tea” meeting with the Environmental Health Officer before you commit to the purchase the property. You need as many of these meetings as it takes to ensure the Environmental Health officer is working with you on this property. We would also recommend having a meeting prior to committing to purchasing the property and ask them to record any issues they have and to bear these in mind when looking at costs as it is essential to keep your kitchen and your cellar open.

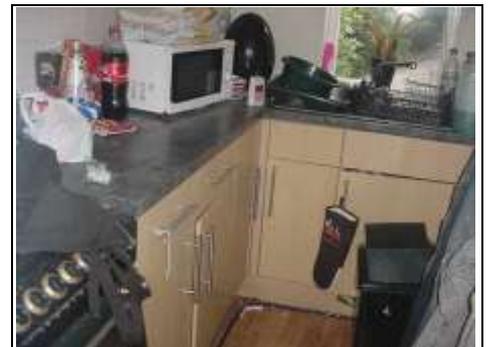
We found the Chefs kitchen in slightly below average condition and messy. Again we have not tested any of the kitchen appliances

Chefs Accommodation kitchen

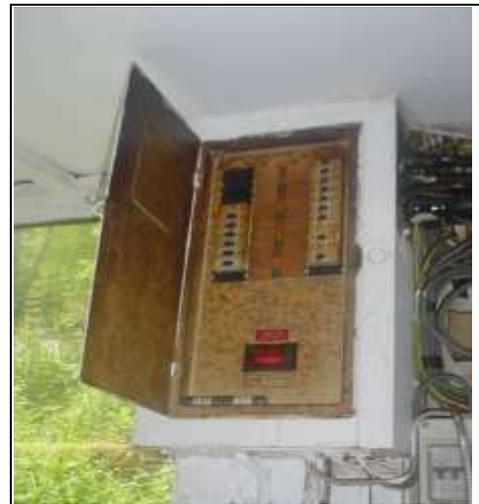
Electrics in the pub kitchen

The electrics are likely to require complete renewal however we would recommend in the first instance an Institute of Electrical Engineers standards (IEE) test and report is carried out by an NICEIC registered and approved electrical contractor or equivalent.

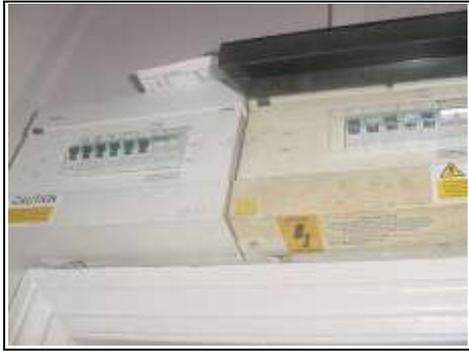
Fuse board on first floor adjacent to the kitchen

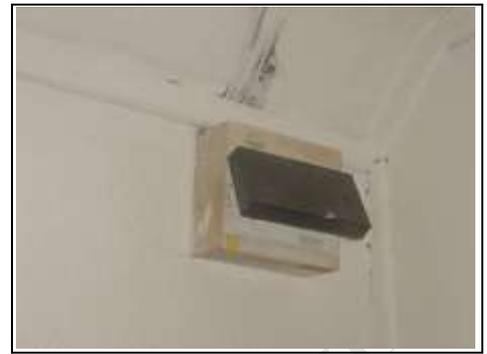
Electrics landing second floor

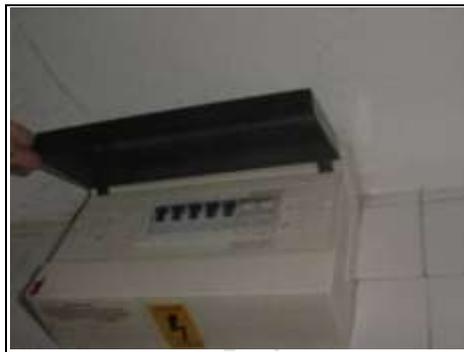
Electrics - Chefs Accommodation

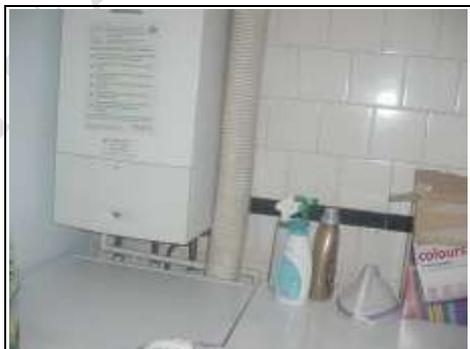
Worcester boiler in utility room

ACTION REQUIRED: Ask the owner where the remaining boilers are. We cannot believe the property is run on one boiler.

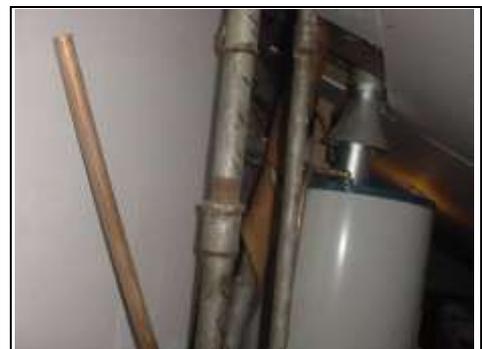
We did not see as many boilers as we expected. We noted in the private living accommodation that there is a Megaflo boiler for the heating which we generally find to be very good and this looked relatively modern.

Megaflo boiler in private living accommodation for heating

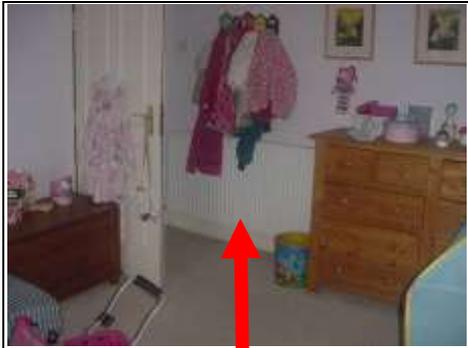
We also noted in the private living accommodation that some of the rooms have internal radiators. These can lead to condensation.

Radiator

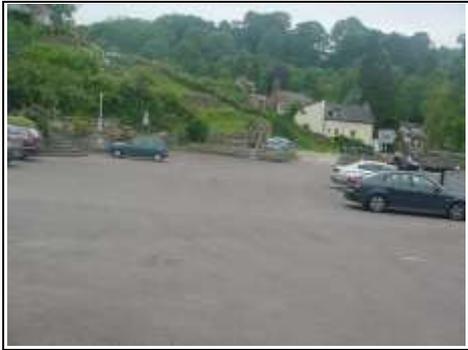
The boundary wall would benefit from work and the car park in general would benefit from being white lined with a drain also being added.

Car park

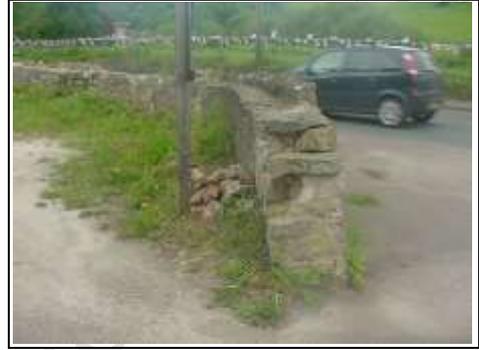
Car park wall could do with some work

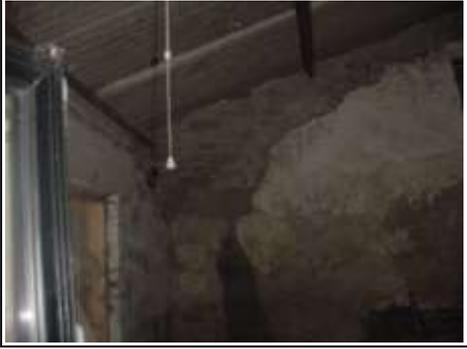
The outbuildings to the left hand side are generally in a dilapidated condition and they also have asbestos roofs. To the rear of the building which is close to the trees there is a large amount of cracking. We have classified this roof as being in a deteriorated condition.

Left hand side of outbuilding

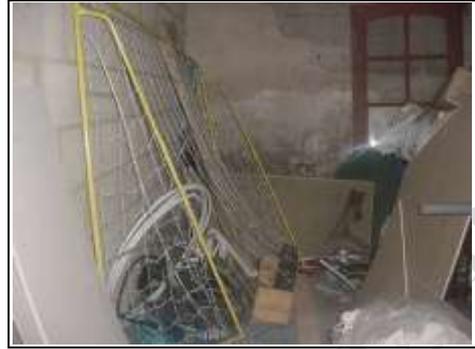
Right hand side of outbuilding

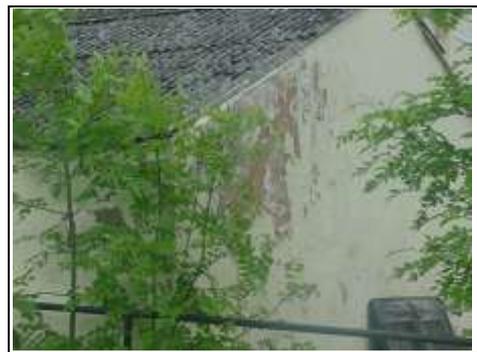
Dampness is getting in to the gable and we assume that the asbestos roofing is not covering that section.

Dampness getting into gable

ACTION REQUIRED: This is a useable space providing you do not want to store anything that has a value in it. At some point you will have to carry out work to tie the building back together.

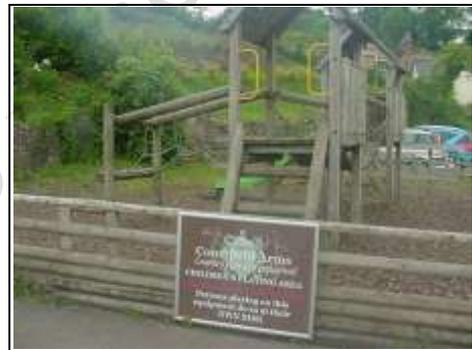
This needs to be checked to RoSPA safety standards. Please see our comments within the Executive Summary.

Childrens play area

ACTION REQUIRED: Check the RoSPA standards if not you are liable.

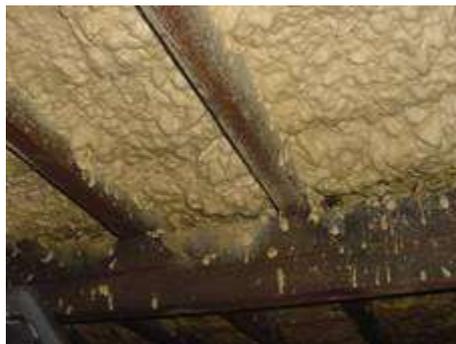
As we entered the roof we could see that the whole of the underside of the roof had been sprayed with spray foam insulation. If you haven't seen this before spray foam insulation is frequently advertised in newspapers and magazines and all over the internet. It looks a bit like a Crunchie bar without the chocolate or if you are a keen DIYer its very much like the expanding foam that you use to fill in gaps that's available from B&Q, Wickes or other similar good DIY places, that you spray in to fill any gaps or holes that you have when you have carried out work.

Spray foam, a close up

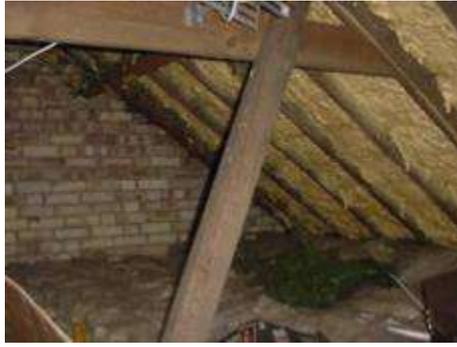
General view of roof with spray foam everywhere
