# COMMERCIAL BUILDING SURVEY

XXX

Worcestershire  
WR8 XXX

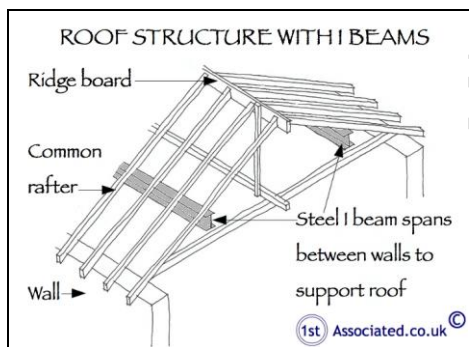
Point loading (from the structural frame type alteration) has been cracking both externally and internally.

Externally this is around the weaker areas which are to the windows and internally not directly this is below the metal "I" beam which is visible in the form of hairline cracks with the exception of the walls where it is hidden by dry lining covering (sometimes known as false walls) or plaster or similar.

"I" beam

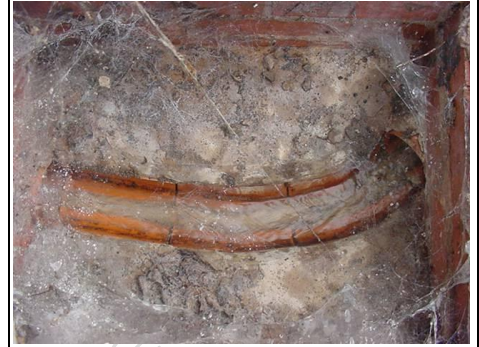
Foul water drains

We believe that the drains may be leaking and contributing to the movement of the structure.

We have run the taps on the foul water drains and would err on the side of caution as we do not believe the amount of water coming from the taps was that seen within the foul drain itself.

**ACTION REQUIRED:** We would recommend a closed circuit TV camera report is carried out to establish if there are any problems with the drains, this could relate to cracking from the drains to open joints.

We would recommend that this is carried out to all drains.

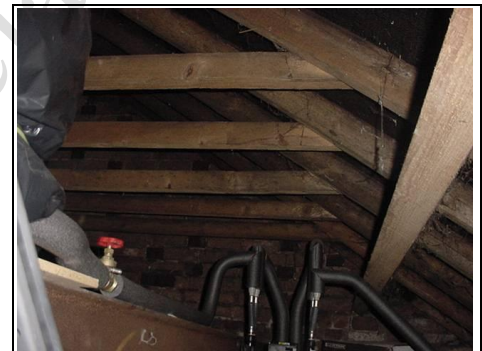
Middle roof “A” frame

In the centre of the property you have an “A” frame roof (we can also see a steel to the middle roof as well) these mixtures of construction indicate to us that there has been problems with the roof.

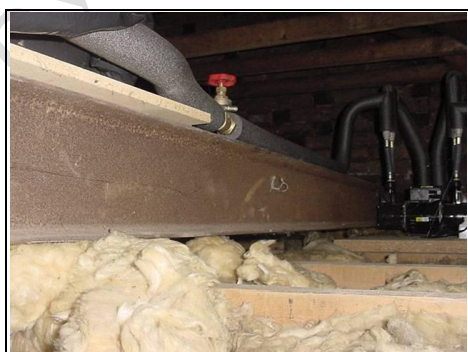
The roof has been constructed and amended in a variety of ways over the years. Either side we now have an “I” beam support in the form of purlins to the roof adding point loads to the building as described earlier.

“I” beam in middle roof section

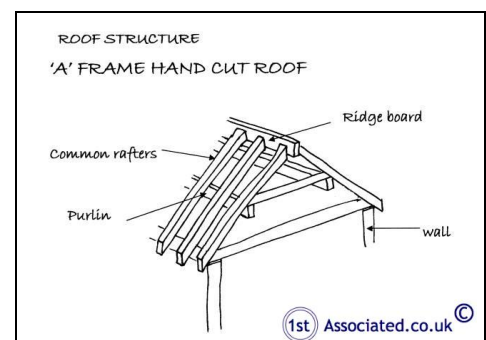
“A” frame

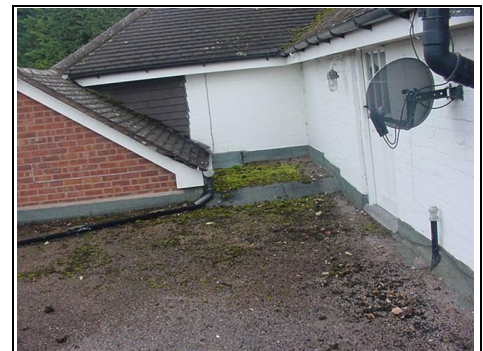
To the rear of the property is a large flat roof. The main problem with this flat roof is that it is flat without a typical fall of fifteen degrees. This means that water sits on the roof and causes the moss that you can see as well as reducing the life of the roof which will of course cause problems with leaks coming in as can be seen in the corridor downstairs (although the temporary management company advised that as far as they were aware it was not a problem when it rains anymore).

Moss to flat roof

**ACTION REQUIRED:** Ideally we would recommend a pitched roof is added however we also find flat roofs that have insulation cut to falls added and then a high performance felt have an increased thermal efficiency level and of course an extended life. We would also look at the detailing which currently has felt flashings and replace these with lead flashings. We would add that patch repair will no doubt continue the life of the roof for some years to come however it is an ever increasing problem.

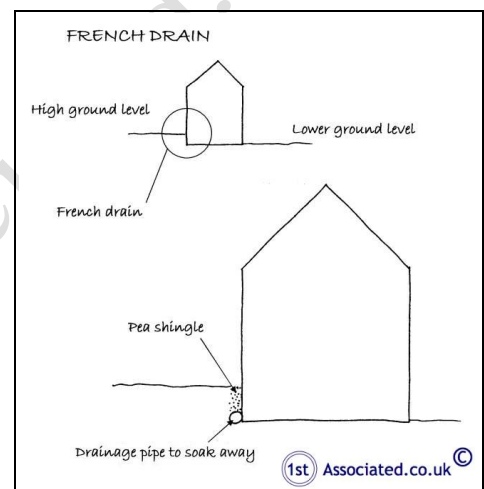
- 5.2) The rainwater pipes as you correctly noted discharge to the rear of the property and into the property itself.

**ACTION REQUIRED:** We would recommend a view of all the rainwater drains and this combined with your new drainage system should alleviate the problem of the rainwater being discharged into your cellar!

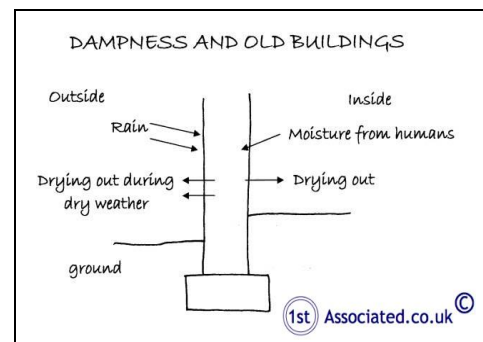
In an old property such as this the walls need to be allowed to breathe which we do not think is occurring due to the modern paint which we believe is plastic based (you cannot be certain without a test and analysis) and the internal modern gypsum plaster.

We would refer you to the adjacent sketch.

**ACTION REQUIRED:** We would recommend that the existing paint is removed and a micro-porous breathable paint is added.

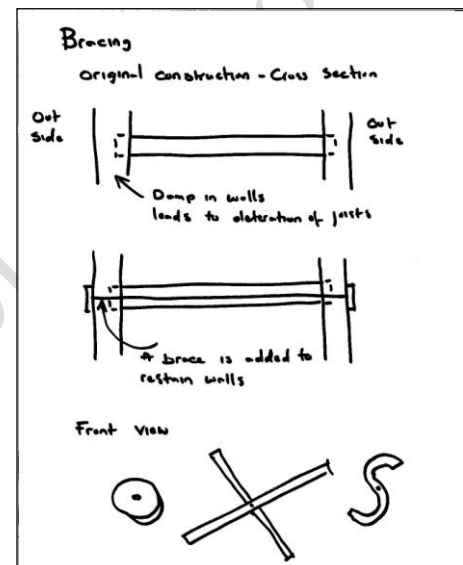
We have in the past where we have opened up the structure found that the tie bar that looked to be in place has broken or corroded or has never been put to use.

We would also add that it is quite unusual to have one tie bar as we can see in this instance.

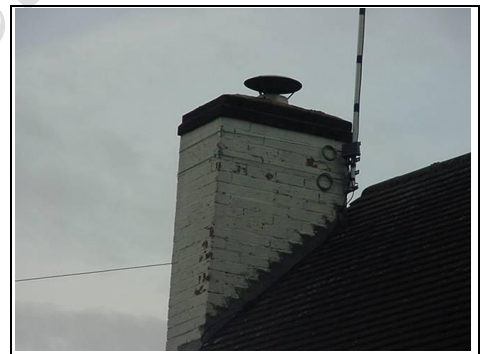
Chimney one

This chimney is a brick finished with a lead flashing and one flue. This is a very unusual chimney as it looks to have been completely re-built at ground level in quite recent times. We could see that the brickwork is weathered and suffering from damp/sulphate attack at higher level and there may be damage and deterioration to the lining, although, as mentioned, we can see a flue at the top which normally indicates that a new lining has been added. Unfortunately we were unable to see the flashing, we therefore cannot comment upon them.

**ACTION REQUIRED:** On the exterior it needs to be redecorated and the flashings checked, internally if the fire is used the flue needs to be checked.

**ANTICIPATED COST:** Re-painting is likely to be expensive as scaffolding will probably be required; quotations required.

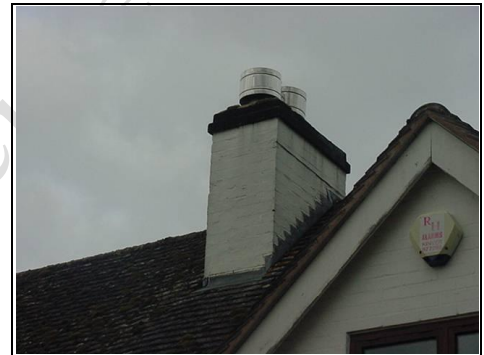
Chimney two

This chimney is a brick with a paint finish and a lead flashing. It is a relatively small chimney with numerous flues. From what we could see from ground level it looked in average condition considering its age, type and style. Unfortunately we were unable to see the flashing, we therefore cannot comment upon them.

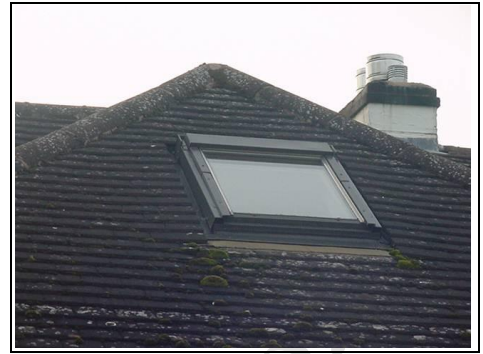
The roof window is located to the rear of the property and gives light to the rear room. It is a purpose made roof light, which looked in reasonable condition. The important factor with roof lights is the flashing around them, in this instance we would comment we could not see any defects with it (we could only see approximately fifty per cent of the flashings) however we would add that it seems inevitable with roof windows that they will sooner or later leak. If this doesn't occur then they seem prone to condensation. Keep a cloth handy!

Roof window to rear

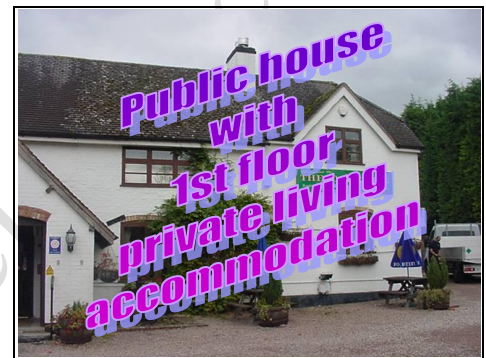
Main roof

The roof is pitched and clad with a small concrete tile and, from ground level, this looks in average condition considering the roofs age type and style. Quite unusually part of the concrete tiles are not covered with moss and part are covered with moss; there was no obvious visual reason for this at the time of the survey.

The roof sits relatively true and in line although there is quite a lot of moss and lichens to the valley gutter.

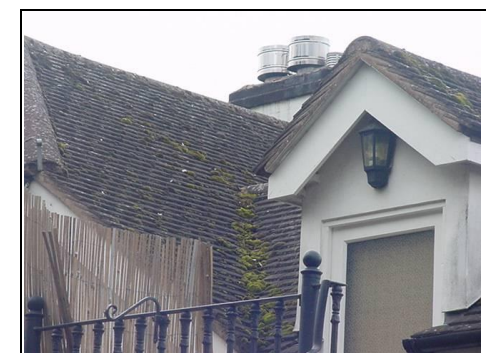
There is quite a lot of moss to the rear roof indicating that it does not get much sunlight and we find that it is best to remove the moss as it can cause deterioration to the roof tiles.

Moss to rear roof

**ACTION REQUIRED:** Remove moss and lichens together with carrying out periodic inspections and maintenance of the roof, as required.

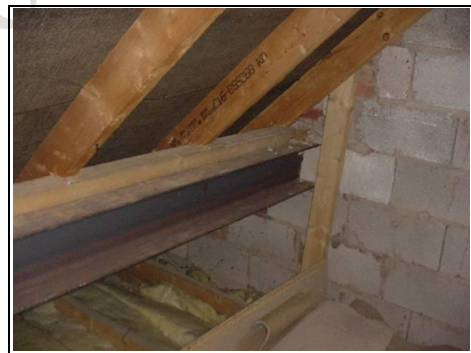
Sarking felt

We have accessed the main roof via three different loft hatches and have found a Hessian base Bitumen membrane to each. This type of membrane has been used since the 1960s. We generally found it to be in average condition, it is damaged in a few more places than we normally find.

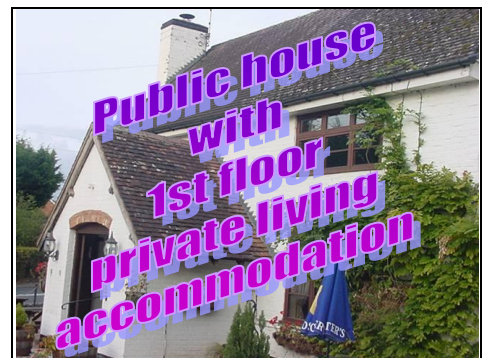
Porch roof

There is a single storey porch double pitched roof clad in clay tiles (our notes say it is a clay tile although from the photo it looks to be concrete tile) to the front of the property.

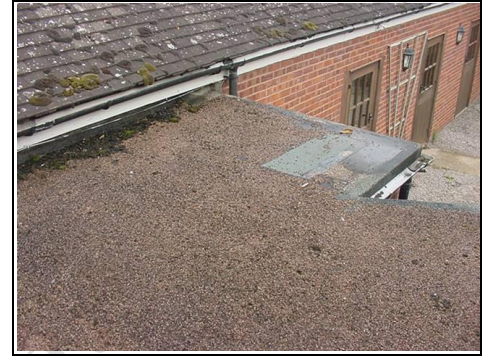
The flat roof to the rear is accessed from the domestic kitchen and is a large awkward flat roof. We have used the term awkward as it is a flat roof that looks to have been amended and extended over the years.

Some parts of the flat roof are poorer than others. Our general overall comment is the flatness of the roof and that there is some deflection when we stood on it.

Asphalt covered flat roof to rear with moss

**ACTION REQUIRED:** Please see our comments in the Executive Summary.

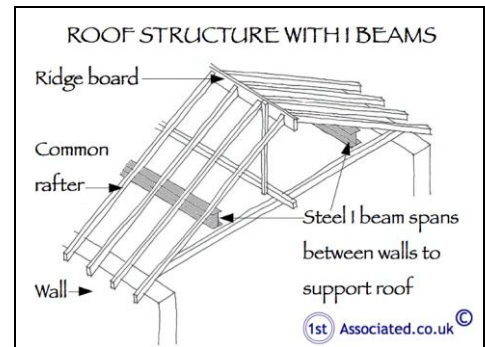
The “I” beams take support from the walls as far as we can see there are no pad stones to spread the load which we would normally expect and this has resulted in cracking down through the external side walls.

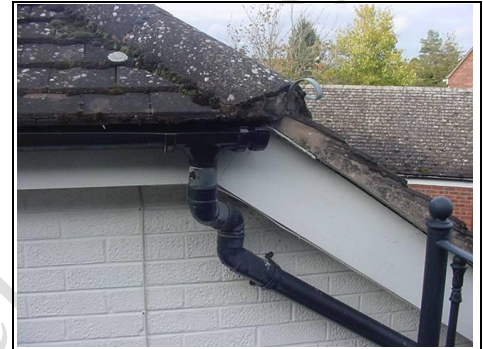
Gutters and downpipes

From ground level the gutters and downpipes looked to be plastic. There is a terrible detail to the rear where all of the rainwater from the rear roof is discharging onto and around the flat roof areas and then down a downpipe and into the cellar area as far as we can see, as you rightly drew to our attention.

**ACTION REQUIRED:** We would always recommend that the gutters and downpipes are cleaned out, the joints are checked and the alignment checked to ensure that the gutters fall towards the downpipes. Please see our comments in the Executive Summary.

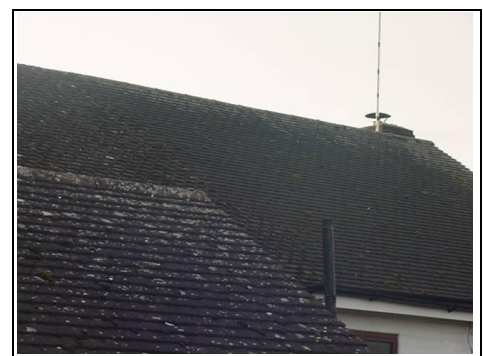
The soil and vent pipe is plastic indicating that it is relatively new (last thirty years) in this particular case.

Soil and vent pipe in the centre of the photo

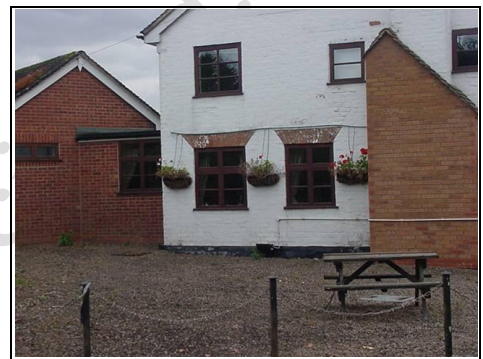
The vast majority of the property is finished in a painted brick. There is a mixture of several different types of brick bond including predominately Flemish Bond and Stretcher Bond brickwork indicating that work has been carried out over the last hundred years or so on this property; this is a very long term problem.

Painted and unpainted brickwork

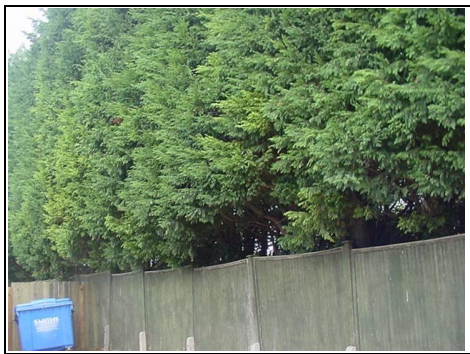
Conifers to rear

There are substantial conifer trees to the side of the property.

**ACTION REQUIRED:** We would recommend that you speak to the neighbours prior to purchasing to check that they are happy to maintain these trees.

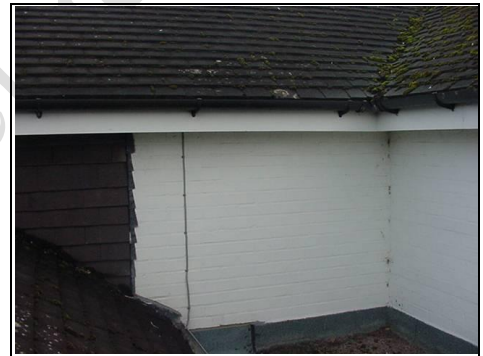
Fascias and soffits

The fascias and soffits are some timber and plastic. The timber ones are painted and we would comment they are in average condition for their age, type and style.

**ACTION REQUIRED:** Make sure gutters and downpipes are watertight before carrying out any work on fascias and soffits.

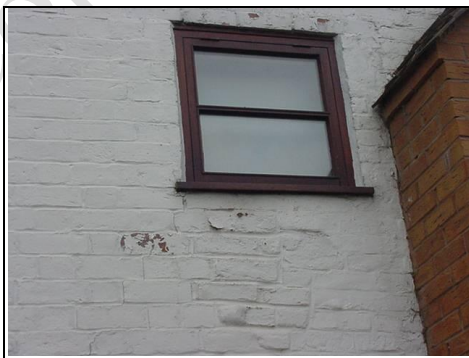
Timber window

The property has a mixture of single and double glazed timber windows. We would specifically comment that the windows are from the cheaper end of the market many of which have been replaced relatively recently.

**ACTION REQUIRED:** We would recommend redecoration in the summer of 2012 and also a review of the windows as these very much present the property on the front elevation.

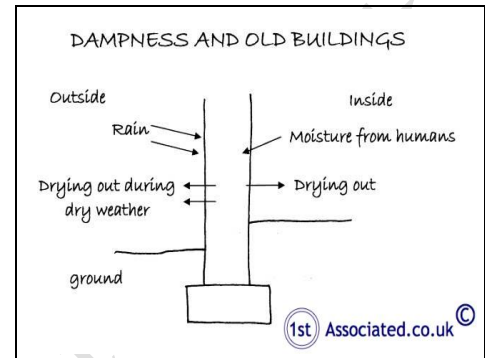
There is a lot of painted brickwork to this property, much has been painted, we believe, incorrectly in the wrong sort of paint that does not allow the property to breathe which has resulted in spalling brickwork.

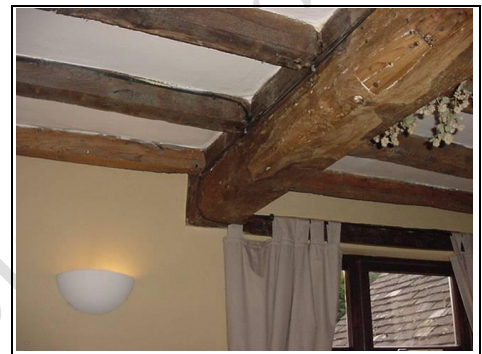
The ceilings have a mixture of finishes as well as feature timber beams. It is very difficult to tell if the feature timbers beams are original without opening up the structure, in our opinion they make a nice feature in a public house such as this.

Feature timbers to ceiling

**ACTION REQUIRED:** Please note our comments in the Executive Summary.

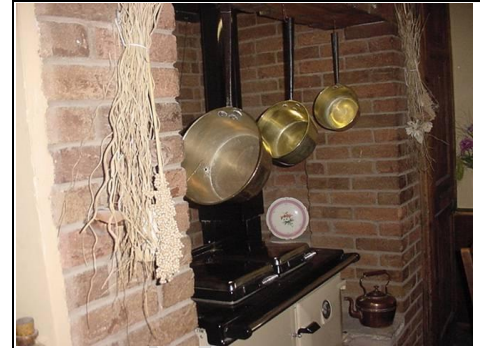
We could see that both the left and the central chimneys have had some rebuilding. This always concerns us as chimneys are an integral part of the structure and originally take the weight of the staircase or part of the floor structure.

Central fireplace ground floor

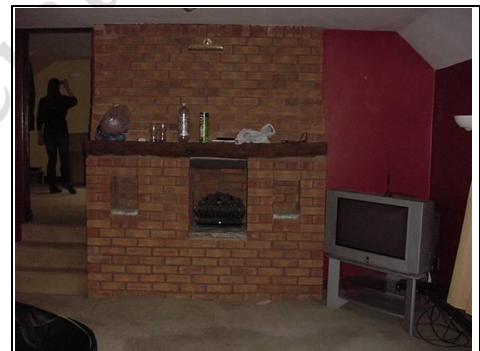
Fireplace first floor

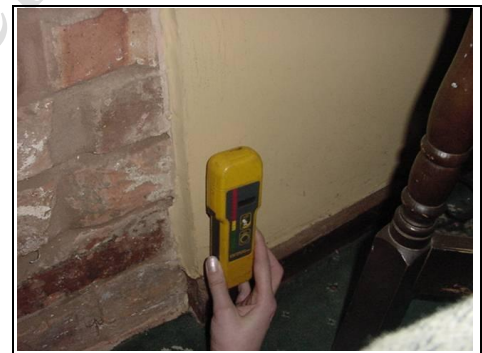
A random visual inspection and tests with a moisture meter have been taken to the perimeter walls and some internal walls. In this particular case we have found rising damp both internally and to external walls.

Testing for rising damp

**ACTION REQUIRED:** Please see the Executive Summary.

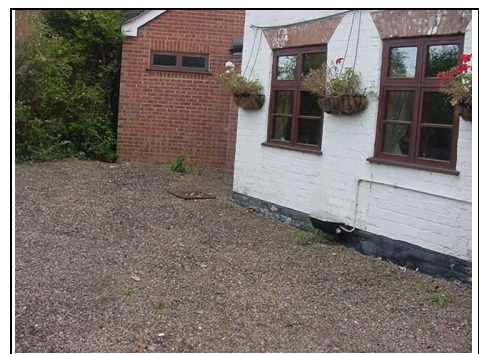
There is a tarred black plinth to the base of the property to the older part of the building. Often this is added as a semi damp proof course but we could not see any thickening of the mortar to indicate a slate damp proof course was present.

We feel as with many older properties if the paint and cement is removed the property will be allowed to breathe again. The dampness is likely to cause deterioration if left.

Black plinth at base

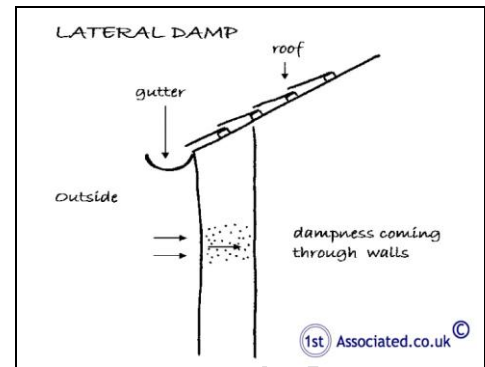
We used a damp meter on the external walls. We surprisingly did not find any lateral dampness however due to the spalling brickwork and the cracking in the structure we feel that there will be some if every part of the wall was checked.

**ACTION REQUIRED:** Please see our comments in the Executive Summary and in External decorations.

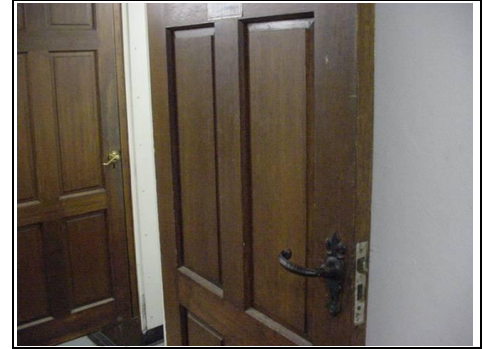
There is a mixture of door types including panelled doors.

Panelled doors

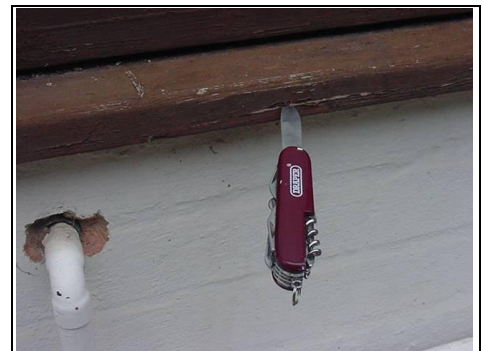
Again, we have not visually seen any wet rot during the course of our inspection. We have found that some of the windows are slightly soft when we carried out a knife test (literally sticking a knife into the timber windows).

Knife test to window

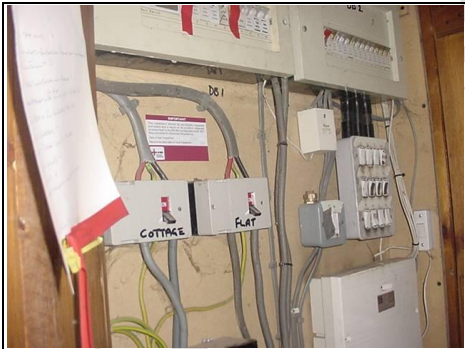
The electrics are likely to require complete renewal however we would recommend in the first instance a test by an NICEIC approved electrician or equivalent to Institute of Electrical Engineers (IEE) standard.

Ground floor electrics

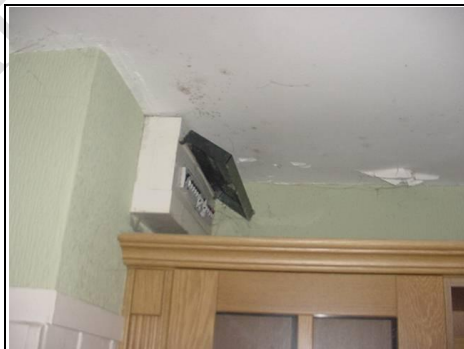
Electric fuse board first floor

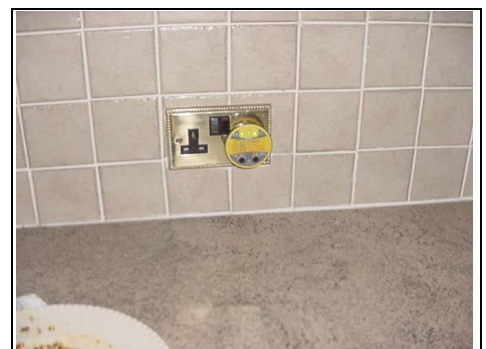
Earth Test domestic kitchen
