COMMERCIAL BUILDING SURVEY

xxxxxxxxxx,
xxxxxxxx, Lower Lydbrook,
Gloucestershire,
GL17 xxx

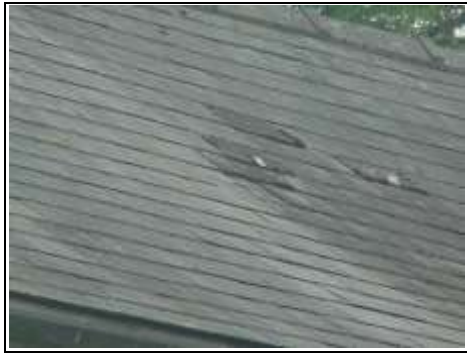
Main roof with some lead tingles

There is a possibility that the property has what is known as nail sickness. This is where the nail fixings have rusted and when you try to repair one section the entirety of that section will come away. We would base this on the fact that we can see lead tingles (please see our earlier photo and sketch).

ACTION REQUIRED: The purchase of a tower scaffold as soon as possible together with replacement slates for your roof. We would recommend that you repair the roof as and when necessary. At the start of the summer of 2013 you need to open up sections of the roof for a closer inspection. By then after having repaired the roof for a year you will have got to know and understand it a lot better.

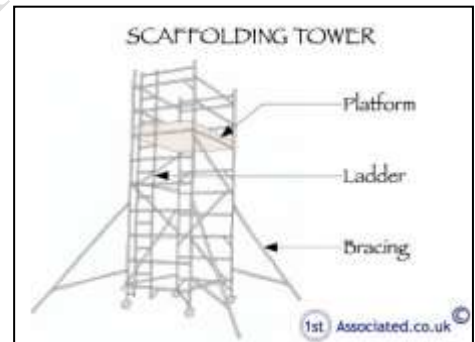
Scaffolding tower

This is a very difficult question to answer. We do feel that within the next two or possibly three years major work will be required if no work is carried out. However if you purchase a tower scaffold you could carry out repair work as and when problems occur.

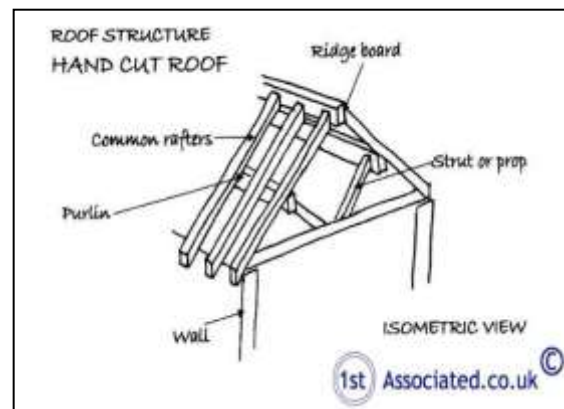
The shape of the roof indicates that the rafter feet (ends of the common rafters, the ones that form the pitch of the roof) have rotted/deteriorated. We were not able to physically see these as they are covered in spray foam and we had limited access into the roof.

Hand cut roof

ACTION REQUIRED: Two to three year plan - If you are looking in the short term you could probably get away with (if this is the right term) a purchase of a tower scaffold which gives you good access to the roof and carry out adhoc repairs. If you wish to be on the safe side with

a two/three year plan we would suggest you open up sections of the roof, particularly the front left hand side, to check the condition of the timbers and the nail fixings.

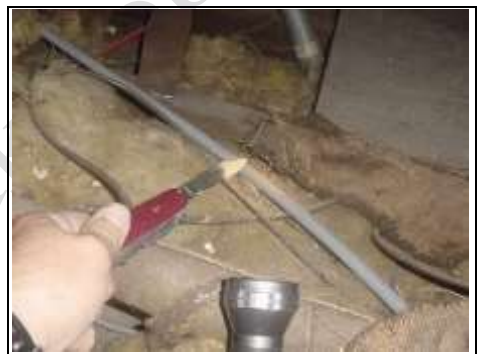
We can see active woodworm to the right hand side roof. We very rarely see active woodworm and we would comment that we feel that many of the woodworm companies blow woodworm out of all proportion regarding the problems it can cause. It takes a lot of woodworm holes to cause damage to a timber that we would term as significant structural damage.

Frass on the end of the knife

We would reiterate that we cannot see any of what we would term as structural woodworm problems to the modern timbers that have been put in the roof. We assume the modern timbers have been treated. Having said that the woodworm is still present in the older part of the roof structure in the areas we have viewed. Whilst we have viewed the timbers the best that we can and given the circumstances, i.e. we are in a roof, we have not viewed every single timber.

ACTION REQUIRED: In this roof we can see there is woodworm present. A chemical spray to the roof will be the best way forward. Although we don't normally recommend this it looks to be the best

course of action. We would also recommend the roof is vented. However this is very difficult where the roof has been spray foam insulated such as this one has. You will need to add this to the gable end of the roof.

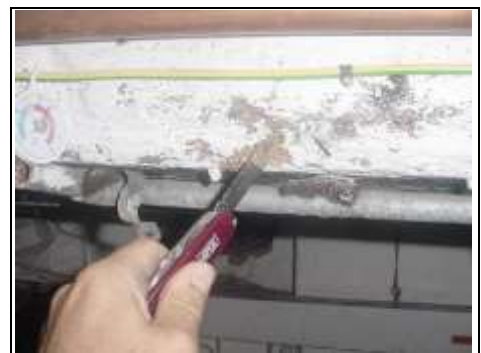
Much of the timber is covered up but we could see in certain sections active woodworm.

Active Woodworm in the cellar

ACTION REQUIRED: This needs to be inspected by a woodworm treatment company prior to purchasing the property. They need to open up areas of the cellar to check the timber.

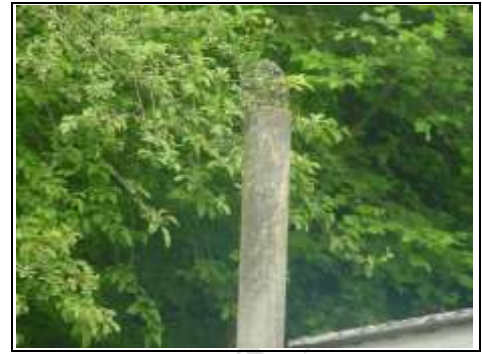
We have already spoken about the asbestos roof. There is also an asbestos flue visible to the rear. We suspect there is more asbestos within the property.

Asbestos flue

ACTION REQUIRED: The existing owner or yourself needs to have a full asbestos report on the property carried out. Our experience with asbestos reports is that you have to be hands on and literally have a meeting with the asbestos contractor at the end of the survey (make sure you tell them you are going to do this) and have a one to one discussion with them as to where the real problems are.

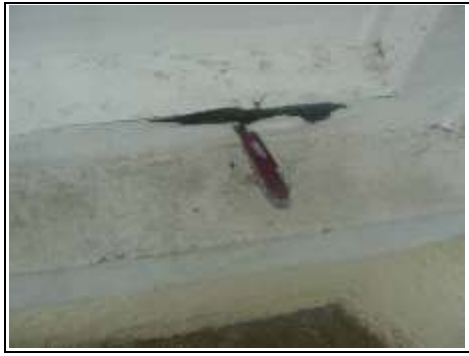
You have a lot of rot in the windows. Even the windows that looked in quite good condition simply gave way when we knife tested them.

Pushing a knife into the window

ACTION REQUIRED: Ultimately you will need to replace the windows. We suggest this is done in stages or by elevations of the property such as the front elevation first as this is the one that customers will see first.

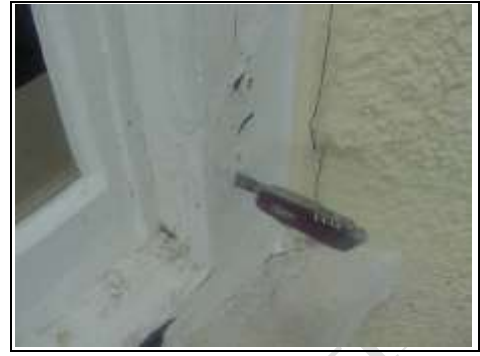
Rotten even when they do not look rotten

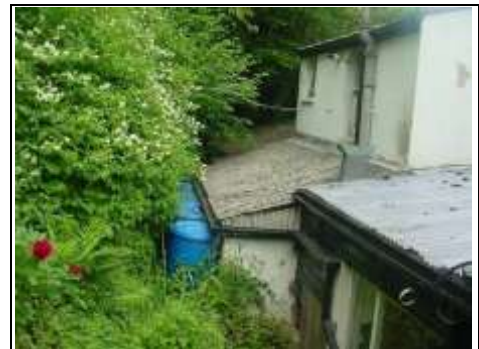
We would expect dampness to the rear of the property which is the kitchen area. We cannot see how this area will not be damp.

Area around the kitchen needs a path around the property rather than through it

ACTION REQUIRED: You need to have a one to one discussion with the existing owner to ask about the dampness. We feel the best option would be a French Drain type system around the property to give the water a direct path around the property.

ANTICIPATED COST: In the region of £10,000 - £15,000 (ten thousand pounds to fifteen thousand pounds); please obtain quotations.

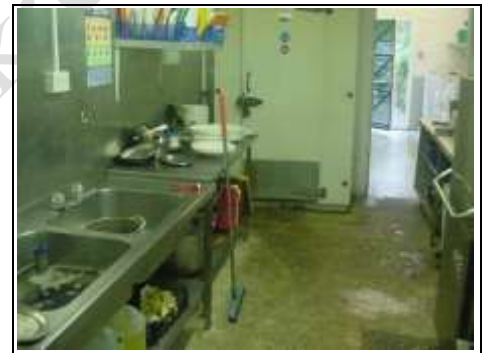
Floor will not meet
Environmental health standards

As we understand it you have spoken to the Environmental Health Officer. We would also invite them down to view the property.

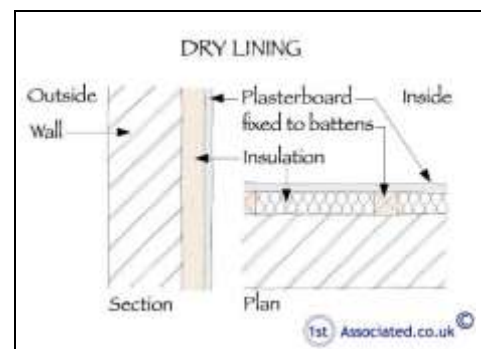
As with any property of this age there is a mixture of old and new construction. This may not be apparent to you as you walk round but, for example, the function room has been completely dry lined. This is where a wall is put in front of a wall and is known sometimes as a false wall. This means that we cannot see the real wall at all.

Dry lining

Often in older properties this system is used to avoid dampness and can also be used to add insulation or both! Without opening up the walls we cannot be certain.

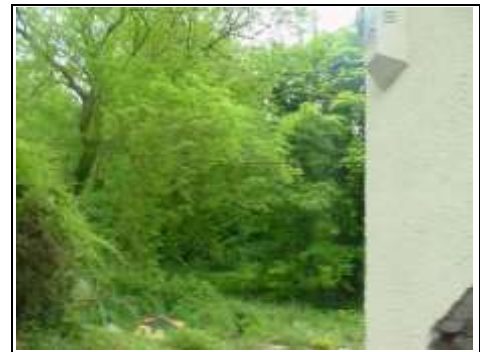
There are magnificent and mature trees surrounding the rear of the property. The root system is certainly within what insurance companies would term as influencing distance.

Mature trees to the rear of the property.

ACTION REQUIRED: Employ an Arboriculturalist (this is not a tree surgeon) to give advice on the trees.

ANTICIPATED COST: In the region of £250 - £500 (two hundred and fifty pounds to five hundred pounds); please obtain quotations.

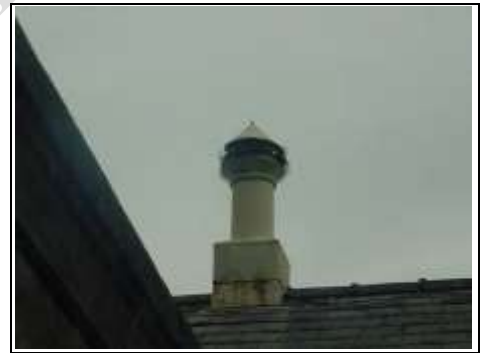
Left hand chimney

This is a metal built chimney/flue. We can see it is rusting to the base but we cannot see the reason for this.

ACTION REQUIRED: You need to trace back where this flue goes back to, bearing in mind you cannot go in the function room roof safely as it presently is.

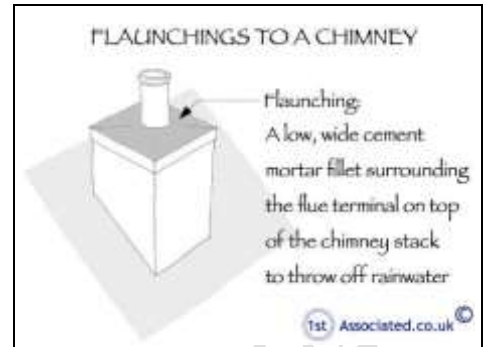
Flaunchings

Unfortunately we were unable to see the flaunching, we therefore cannot comment upon them.

ACTION REQUIRED: When the main roof is re-roofed this whole chimney needs to be checked and by the summer of 2013.

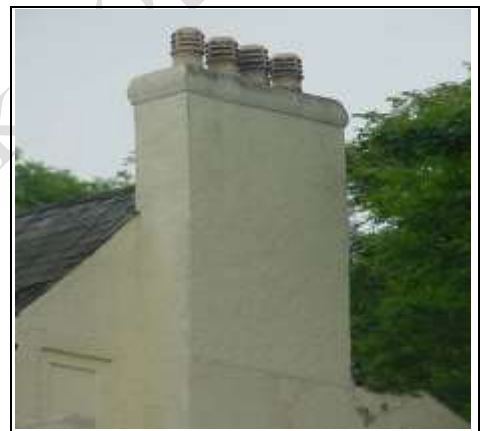
Right Chimney

This chimney is has a painted finish with four chimney pots.

Unfortunately we were unable to see the flaunching, we therefore cannot comment upon them.

ACTION REQUIRED: Please refer to our comments within the Executive Summary with regard to the chimney leaning and work required.

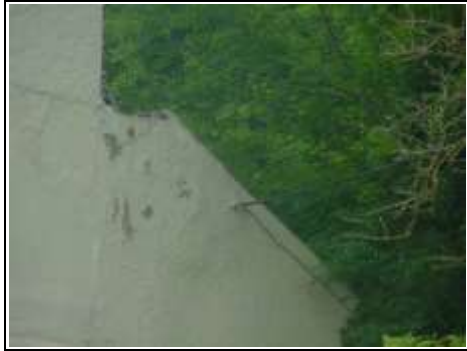
Ledge to the rear right hand side
and over grown trees.

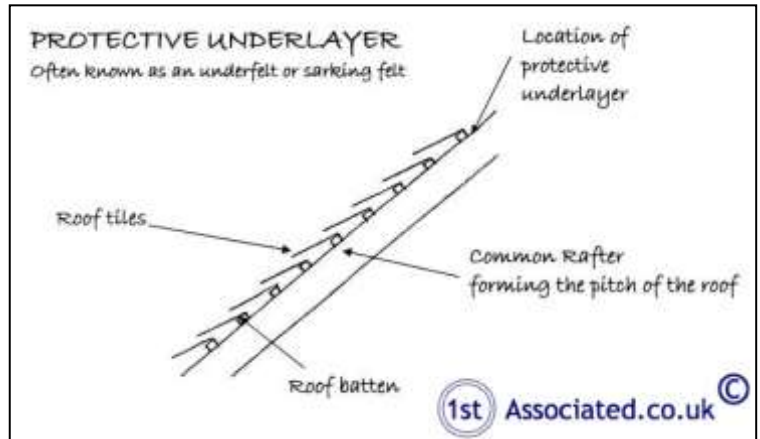
Spray Foam

We cannot see a protective underlayer as the underside of the roof is covered in spray foam. We think it's highly unlikely there is a protective underlayer as there is not usually spray foam where there is one.

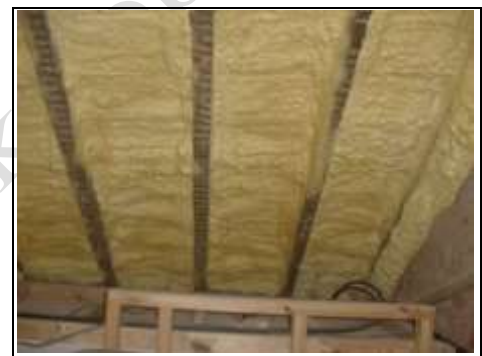
Spray foam in the roof

ACTION REQUIRED: Please see our comments within the Executive Summary with regard to the spray foam and the future problems.

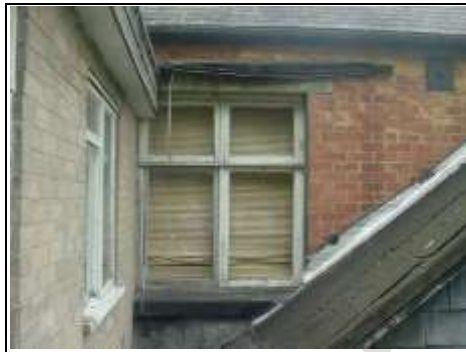
Bottom of felt roof

From our visual inspection we would recommend re-roofing, re-decking and new flashing. This looks to be the worst of the low level roofs.

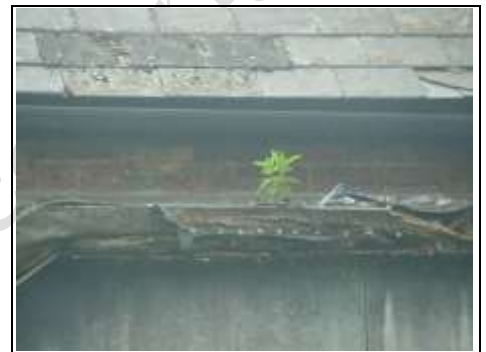
Close up of felt roof

This is a very flat felt roof. The Chef advised that it had leaks to the rear of his bedroom which is where the pitched roof meets this roof. We can see this is a flat felt roof as the moss is visible on it.

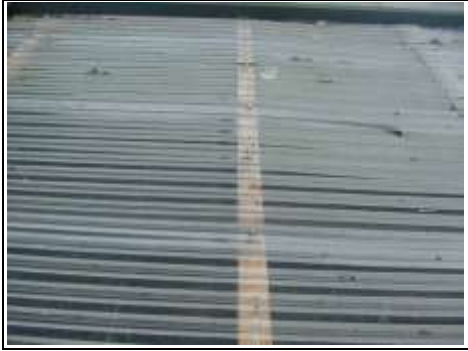
This is a plastic corrugated roof over a felt roof. Please see our comments within the Executive Summary. We believe the entirety of this roof will need to be re-roofed. You may be able add roof windows to it to help with the light in the work areas beneath.

Plastic has been put over the felt

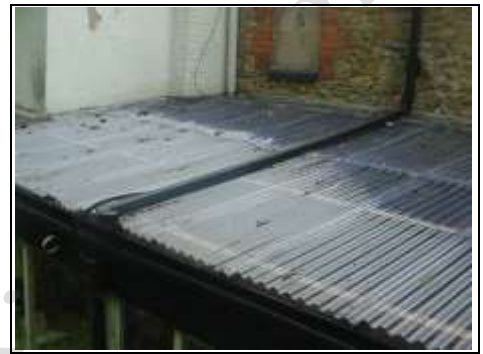
Plastic corrugated kitchen roof

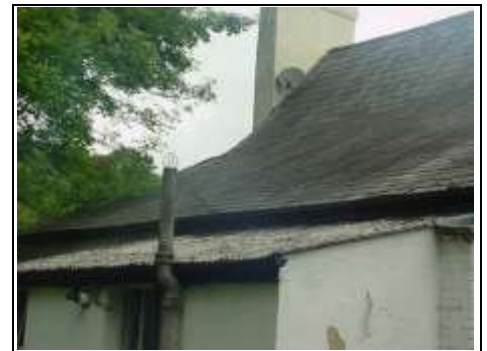
This is an asbestos roof. Please see our comments on asbestos and this particular within the Executive Summary.

Asbestos roof and flue

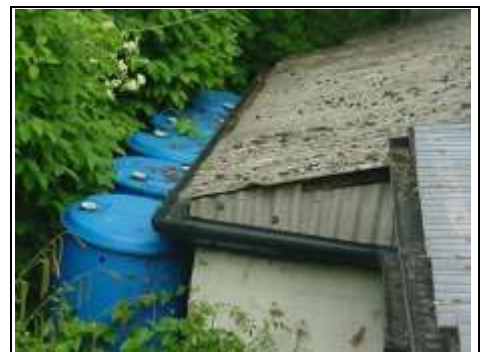
Asbestos has been used over the kitchen. This is the rear right side of the kitchen cooking area. We simply could not get close to this area. We would also ask what the blue barrels are?

Asbestos roof over the kitchen

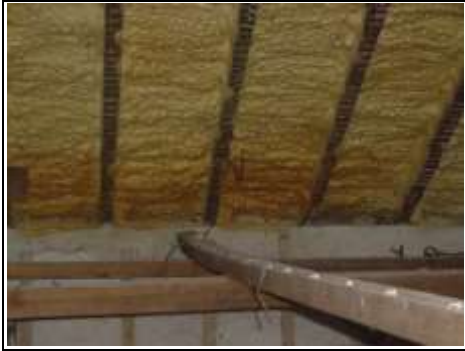
Left hand roof over the function room.

The darker areas are likely to be dampness

ACTION REQUIRED: It is likely that when you re-roof both roofs will need to have new timbers. This is a very difficult and messy job where spray foam has been added as in this case.

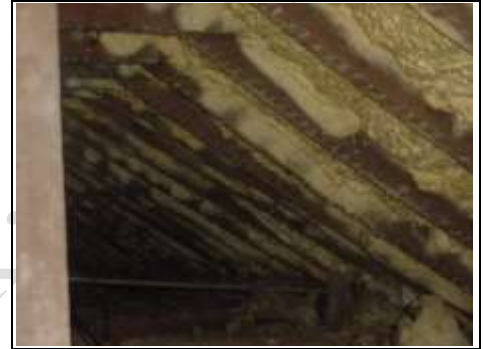
Spray foam in left hand roof

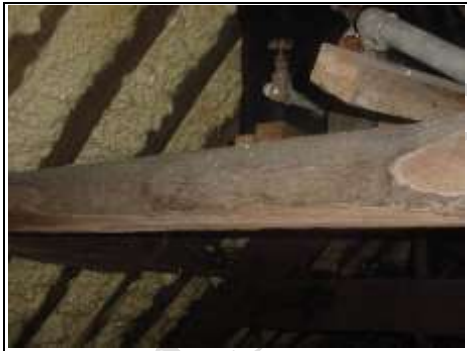
design details we cannot categorically confirm that there are no defects; this is with the exception of the right hand side roof where we can see an older roof structure within it. We mentioned this has timber bark and woodworm.

Bark timber and foam in the background

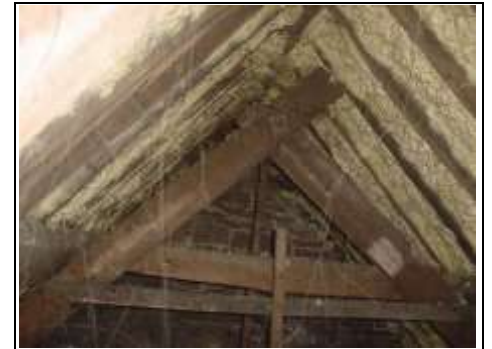
Roof over a roof – right hand roof

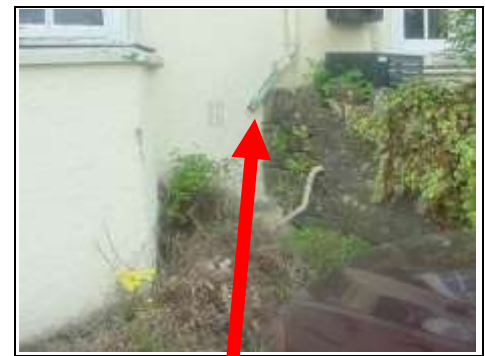
We would draw your attention to the rainwater disposal which we do not think has been thought through. We have noticed everything from rainwater discharging directly onto a wall, causing dampness to the area beneath, to several downpipes going to one place. No thought has been given to the drainage.

Rainwater discharging onto the wall, leaving the wall damp

ACTION REQUIRED: We would recommend that the joints are checked and the alignment checked to ensure that the gutters fall towards the downpipes and that they are initially cleaned out until the summer of 2012. We then recommend you set aside the sum of £3,000 (three thousand pounds) to realign and replace the gutters and downpipes.

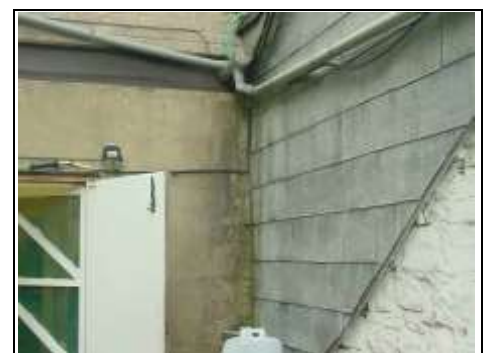
Water overflowing from staircase to function room area

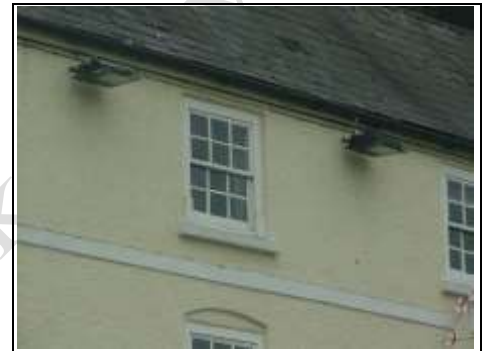
In this case we would comment that there are no drips to the render indicating that it is from the cheaper end of the market. There is also no bell mouth to the render. The render goes down to the ground meaning that capillary attraction will cause dampness at ground level and will bridge any damp proof course if there is one (which we doubt).

No drip detail to windows

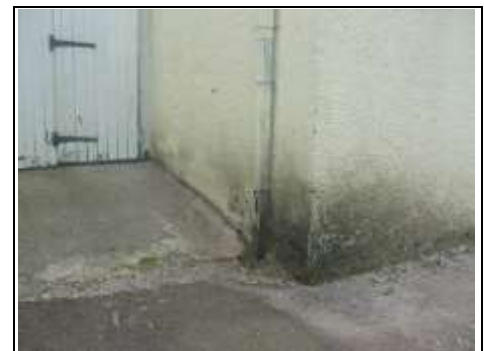
No bell mouth detail to base or render

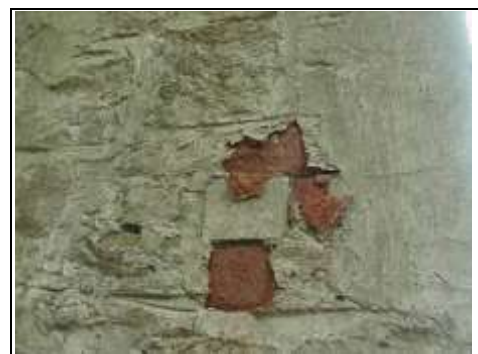
Other areas are painted brick and painted stone. This is stopping the brick and stone from breathing. As it is stopping it from breathing it is deteriorating.

Painted brick and stone wall

ACTION REQUIRED: Ideally we would remove the paint and see the condition of the property beneath. It may then need rendering.

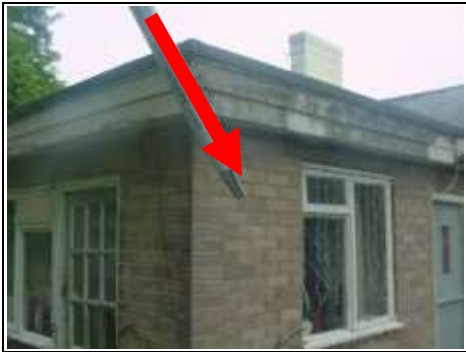
One of the newest areas is the brickwork building that is acting as the Chefs private living accommodation. It is stretcher bond brickwork with cement mortar bedding. We can see that there has been some movement in the brickwork which has been rebuilt. We believe this structure may have been built on a structural frame and if so the brick work may simply be a cladding around the structural frame.

Movement in the stretcher bond brickwork that has been rebuilt

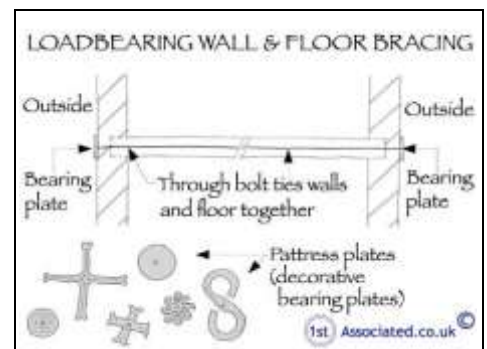
We can see the tie bar to the function room indicates that there has been movement in the walls which has been restrained by the tie bars. This has been hidden to the front of the property. There may be other areas of hidden structural repairs such as this which you will only be able to truly see once the property has been opened up. As mentioned earlier this tie bar may well have been put in place due to the roof defects that have perhaps caused roof spread.

Tie Bars

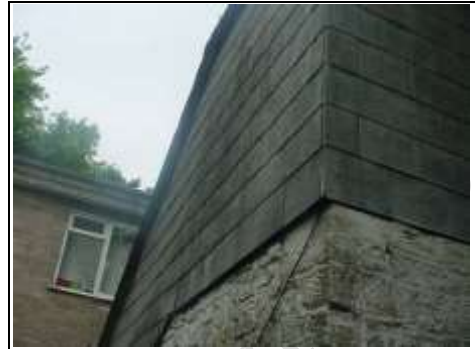
There is vertical tiling to the rear left hand side. We believe this has been added as a lightweight / economical form of construction and is likely to have a timber frame beneath. When the work is carried out to the felt roof over the stair you should also look into the construction of these walls.

Vertical tiling –rear left hand side

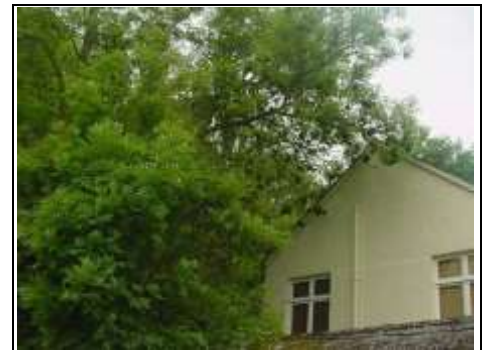
There are trees within what insurance companies would term as influencing distance of the property.

The trees located to the rear

ACTION REQUIRED: They need work. Please see our comments within the Executive Summary.

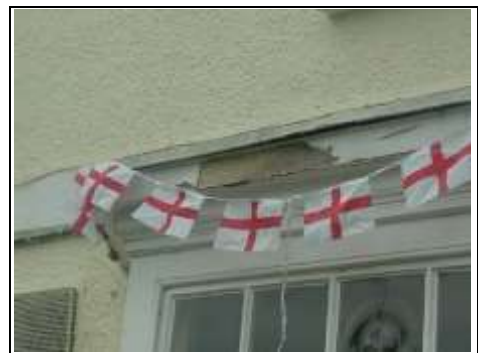
Fascia to bay windows timbers exposed

ACTION REQUIRED: You need to budget in your redecoration work to repair, replace and redecorate the fascia and soffit boards. Make sure gutters and downpipes are watertight before carrying out any work on fascias and soffits.

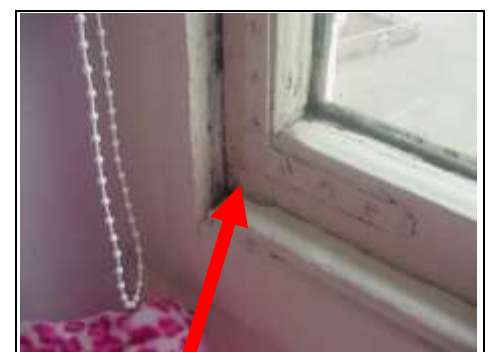
Angle bracket holding the window together on the second floor bedroom

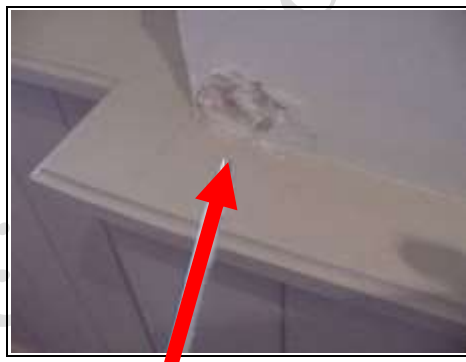
Close up of dampness

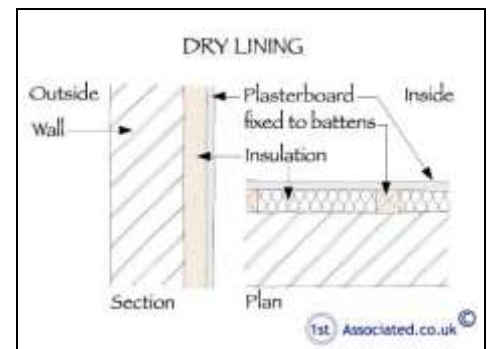
Dry lining

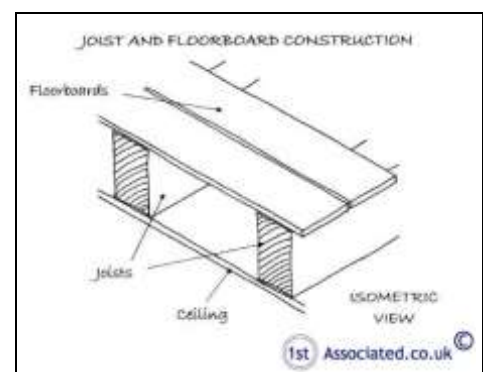
Joist and floorboard

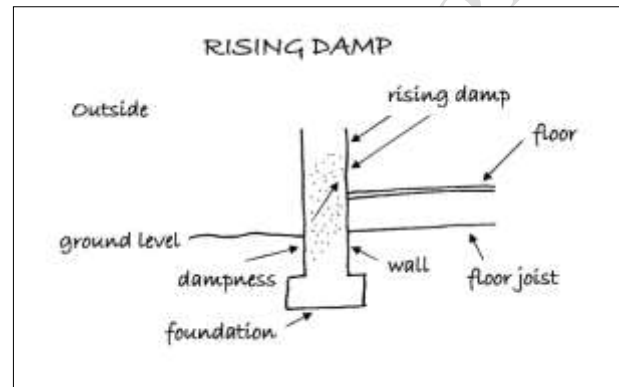
Rising damp

A random visual inspection and tests with a moisture meter have been taken to the perimeter walls. A property of this age will have rising damp. It is a feature and characteristic of a property of this age.

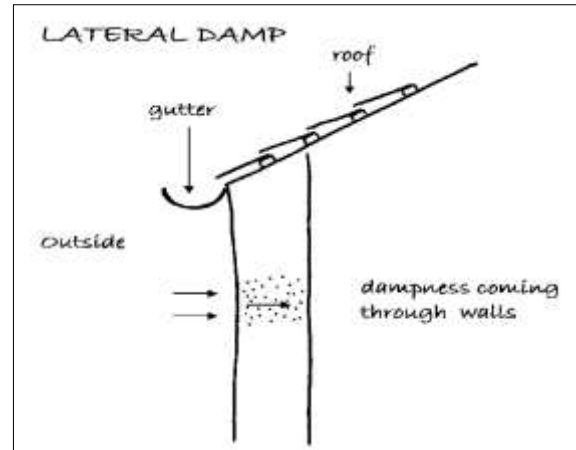
We used a damp meter on the external walls. The dampness readings are in line with what we would expect in an older property i.e. minor dampness.

Lateral dampness

ACTION REQUIRED: Please see our comments in the Executive Summary.

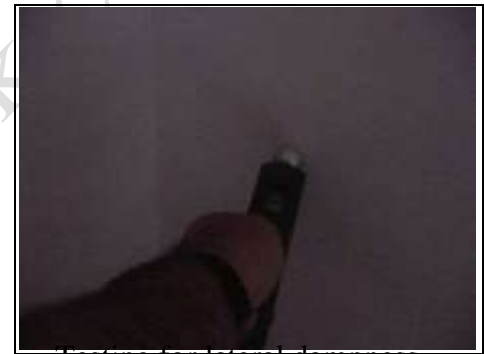
Testing for lateral dampness.

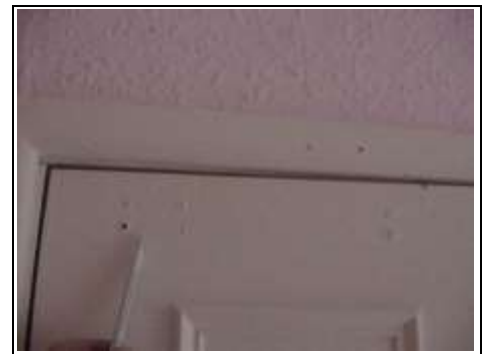
To reiterate our concern with this property regarding the fire doors. We can see doors where the door closers have been removed. We assume this was a requirement to have them on.

Door closers have been removed

ACTION REQUIRED: Please see our comments with regard to the property not meeting current Fire Regulations.

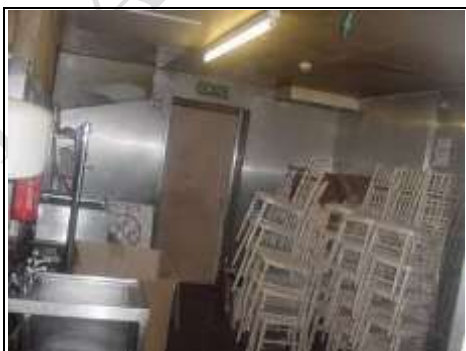
Kitchen for the function room on the first floor

We assume that this kitchen is no longer in use.

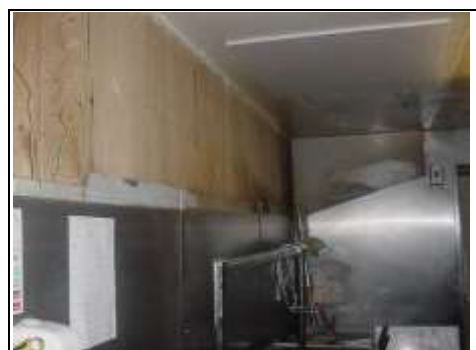
Wood exposed in kitchen

ACTION REQUIRED: You need to have a “cup of tea” meeting with the Environmental Health Officer before you commit to the purchase the property. You need as many of these meetings as it takes to ensure the Environmental Health officer is working with you on this property. We would also recommend having a meeting prior to committing to purchasing the property and ask them to record any issues they have and to bear these in mind when looking at costs as it is essential to keep your kitchen and your cellar open.

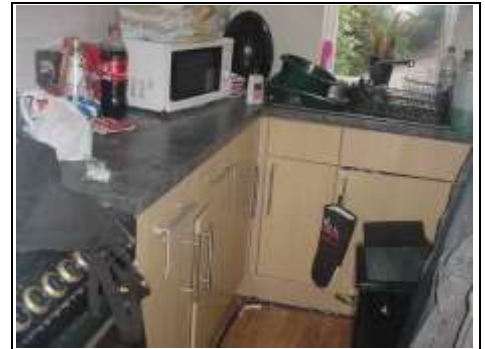
Chefs Accommodation kitchen

We found the Chefs kitchen in slightly below average condition and messy. Again we have not tested any of the kitchen appliances

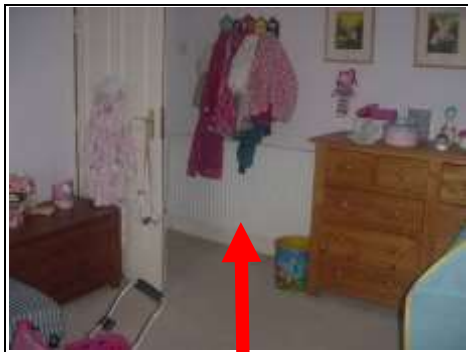
Radiator

We also noted in the private living accommodation that some of the rooms have internal radiators. These can lead to condensation.

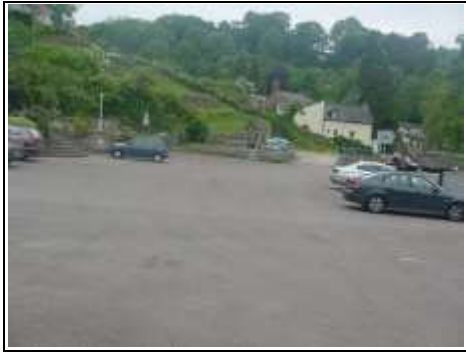
Car park

The boundary wall would benefit from work and the car park in general would benefit from being white lined with a drain also being added.

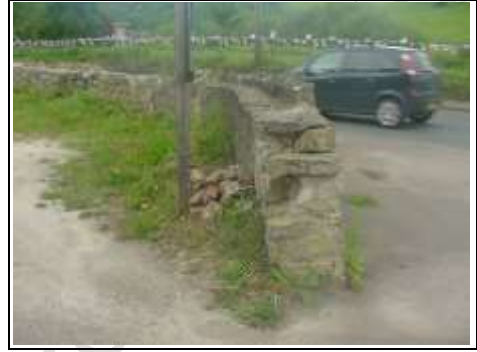
Car park wall could do with some work

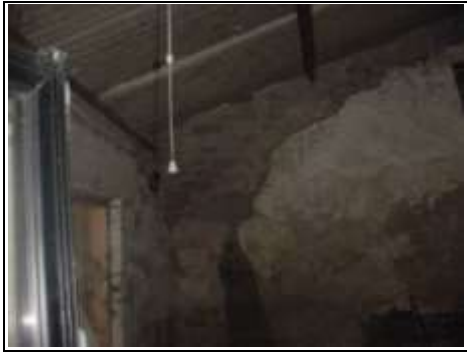
Left hand side of outbuilding

The outbuildings to the left hand side are generally in a dilapidated condition and they also have asbestos roofs. To the rear of the building which is close to the trees there is a large amount of cracking. We have classified this roof as being in a deteriorated condition.

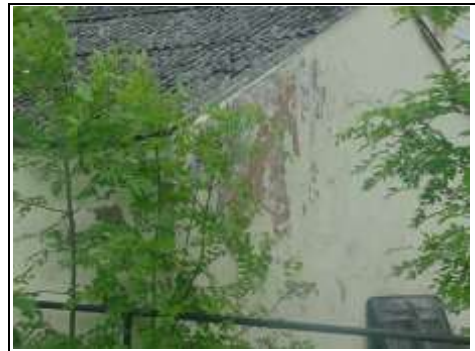
Dampness is getting in to the gable and we assume that the asbestos roofing is not covering that section.

Dampness getting into gable

ACTION REQUIRED: This is a useable space providing you do not want to store anything that has a value in it. At some point you will have to carry out work to tie the building back together.

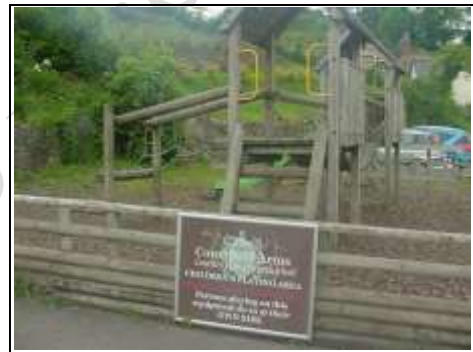
Childrens play area

This needs to be checked to RoSPA safety standards. Please see our comments within the Executive Summary.

ACTION REQUIRED: Check the RoSPA standards if not you are liable.

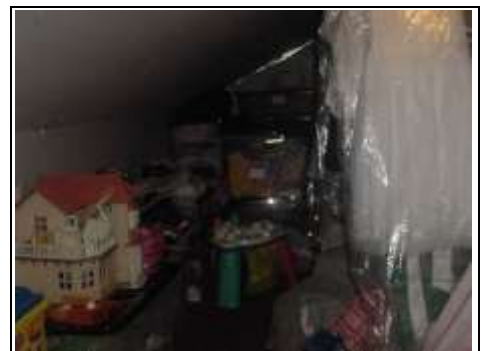
Unfortunately in this instance our inspection has been very limited due to us not opening up the floors and due to us only being able to view the roof from the loft space. The cupboards were also full of stored items.

Cupboard full of stored items

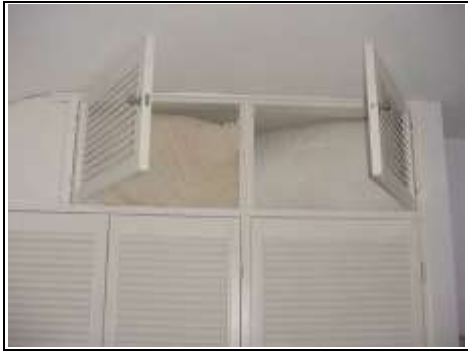
Cupboards full of bed linen

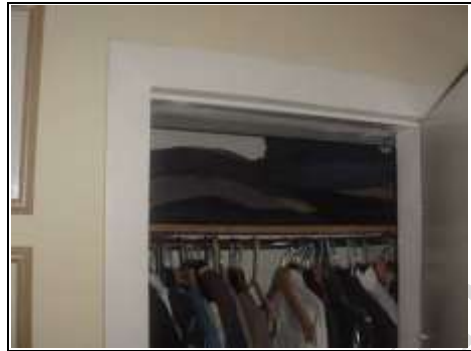
Cupboards full of clothes
