SCHEDULE OF CONDITION

Swanley

We have been instructed to inspect and prepare a Schedule of Condition for XXXX, Swanley, Kent. BR8 XXX.

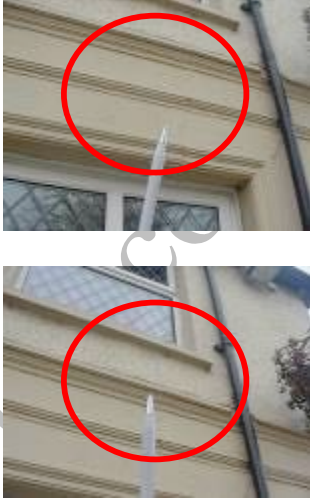
<p>Gutters and Downpipes:</p> <p>Cast Iron/Plastic</p> <p>We viewed the gutters and downpipes from ground level.</p>	<p>Leaks visible.</p>	<p>Ensure all gutters are watertight and falling towards the downpipe and clear.</p> <p>Repair downpipes and secure as necessary, ensure downpipes are clean and clear.</p>
<p>Walls:</p> <p>Painted brickwork</p> <p>Painted render</p>	<p>Dated</p> <p>Cracking</p>

<p>Dated.</p>	<p>Repair, prepare and redecorate.</p> <p>Landlord/property owner to make an insurance claim. Any cracking to be excluded from the lease.</p> <p>Repair, prepare and redecorate.</p>

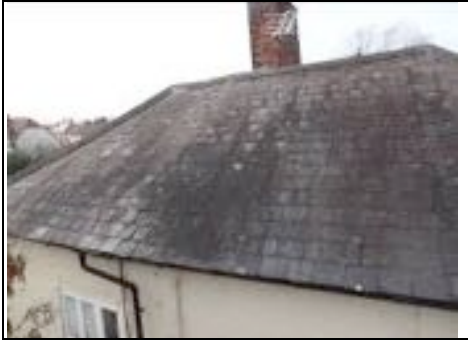
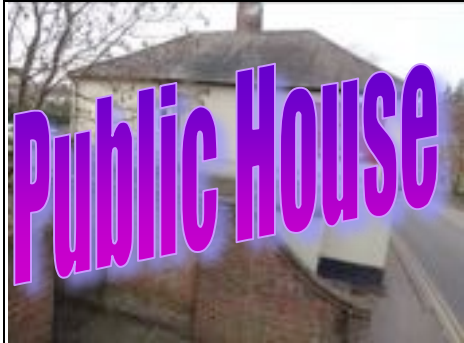
Left External Elevation

DESCRIPTION	CONDITION	ACTION REQUIRED
Chimneys:		See Front Elevation
Roofs: Hipped, clad with slates Limited view of roof from ground level	Deteriorating, numerous lead tingles used and also dips and undulations in the roof.  	See Front Elevation and Exclude from lease
Flat roofs: Flat felt roof  		See Front elevation

Gutters and Downpipes: Cast Iron/Plastic	Leaks visible	<p>Ensure all gutters are watertight and falling towards the downpipe and clear.</p> <p>Repair downpipes and secure as necessary, ensure downpipes are clean and clear.</p>
Walls: Painted brickwork	<p>Dated</p> <p>Dip in bricks</p>

<p>Repair, prepare and redecorate.</p> <p>Landlord/property owner to make an insurance claim</p>
External Detailing: Windows: Painted	<p>Poor condition</p>

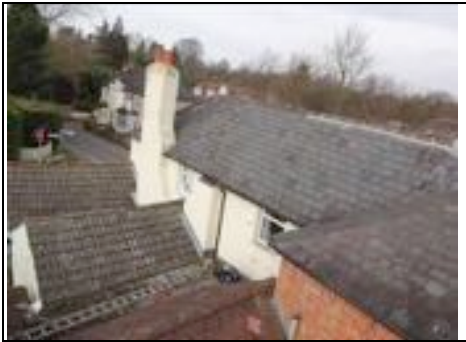
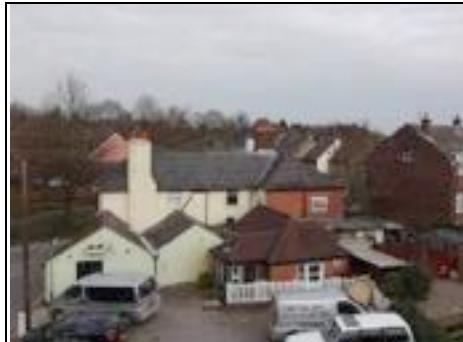
Rear External Elevation

<p>Deflection and undulations in the roof Deterioration to timber structure beneath roof</p>  	<p>Work required to roof structure.</p>
<p>Low level Roofs: Hipped, clad with concrete tiles to rear left</p>  		
<p>Hidden flat roof to middle</p>  	<p>Flat flat roof with moss sitting on it which will accelerate deterioration. Dampness coming into toilet area which may be via hidden flat roof/adjoining pitched roofs.</p>    	<p>Repair/renew</p>
<p>Shallow pitched roof, clad with concrete tiles to middle</p>	<p>Repairs to flashing</p>

<p>Rear left flat roof</p>  	<p>Flat flat roof with moss sitting on it which will accelerate deterioration.</p>  	<p>Repairs/major work required within the next few years.</p>
<p>Low level concrete tile roof with valley gutter to rear right</p>  	<p>Leaking box gutter with paint sealer on top of lead</p>  	<p>Renew/repair lead box gutter.</p> <p>Current sealer does not seem to be working and one of the toilets was closed off due to dampness.</p>
<p>Gutters and Downpipes:</p> <p>Plastic</p>  	<p>Average</p>	<p>Ensure all gutters are watertight and falling towards the downpipe and clear.</p> <p>Repair downpipes and secure as necessary, ensure downpipes are clean and clear.</p>

Recommend re-roofing to rear of property. See Front Elevation and Exclude from lease

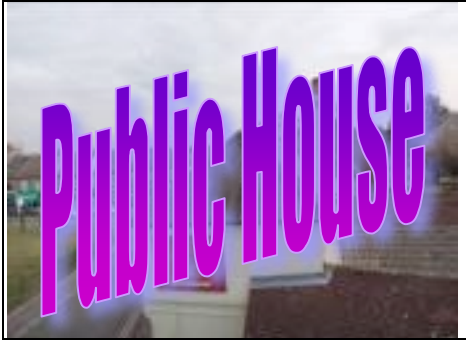
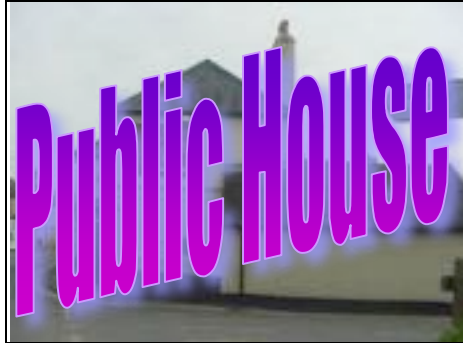
Right External Elevation

DESCRIPTION	CONDITION	ACTION REQUIRED
Chimneys:		See Rear Elevation
Roofs: Hipped, clad with slates Low level pitched roof clad with concrete tiles	General deterioration to main hipped roof including nail sickness. Problems with flashing

Exclude from lease Make watertight
Gutters and Downpipes: Cast Iron/Plastic	Leaks visible	Ensure all gutters are watertight and falling towards the downpipe and clear. Repair downpipes and secure as necessary, ensure downpipes are clean and clear.

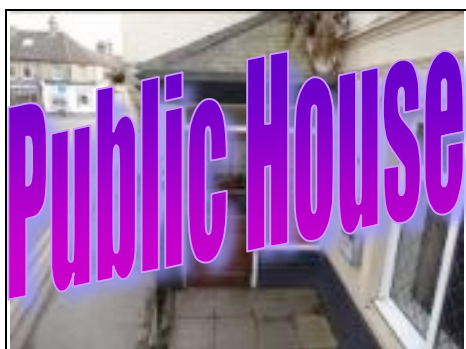
Front Entrance

DESCRIPTION	CONDITION	ACTION REQUIRED
Ceiling: Painted	Hairline cracking	Repair, prepare and redecorate.
Walls: Painted	Dated	Repair, prepare and redecorate.
Dado	Dated	Repair, prepare and redecorate.
Floors: Carpet	Average	Clean/replace
Detailing: Windows: Two timber windows with glass panels	Dated	Repair, prepare and redecorate
Doors: Timber	Dated	Repair, prepare/sand and re-stain
Services:		See Services Section

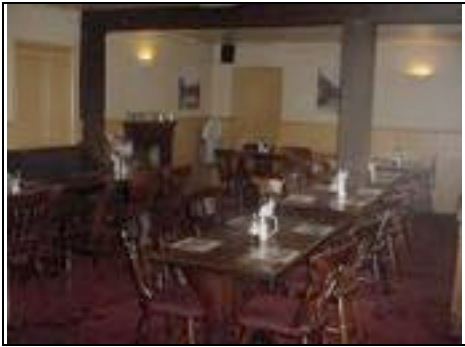
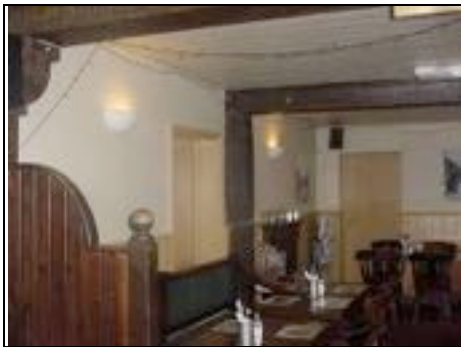
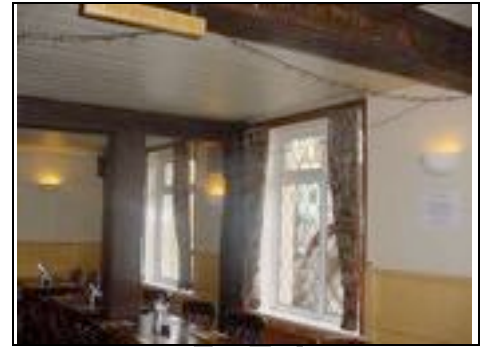
Right Bar/Restaurant

Dated	Repair, prepare and redecorate.
Walls: Painted Dado	Dated and Marked Dated	Repair, prepare and redecorate. Repair, prepare and redecorate.
Floors: Carpet	Undulating suspended timber floor

Clean/replace and open up floor to check condition. This floor sits over the cellar area.

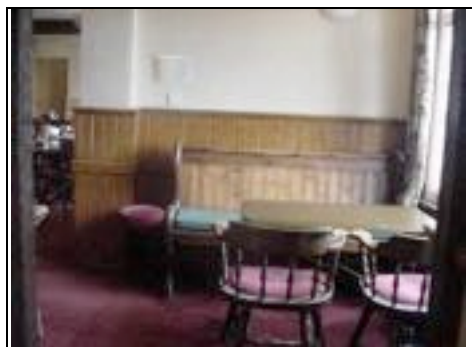
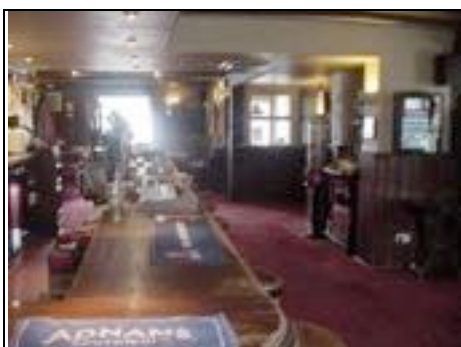
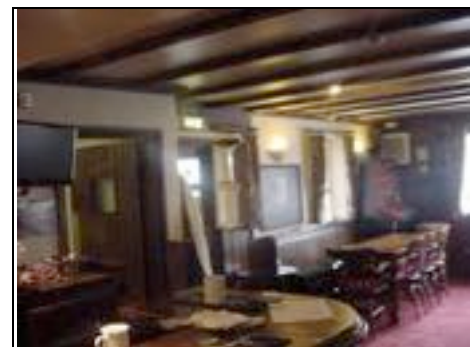
Central Bar

DESCRIPTION	CONDITION	ACTION REQUIRED
Ceiling: Variety of ceiling finishes including: Boarded ceiling Modern exposed timber Modern painted	Dated	Repair, prepare and redecorate.
Walls: Textured paint Brickwork	Minor dampness Dated	Resolve dampness Repair, prepare and redecorate.
Floors: Carpet	Average	Clean or replace
Detailing: Windows: Painted	Dated	Repair, prepare and redecorate

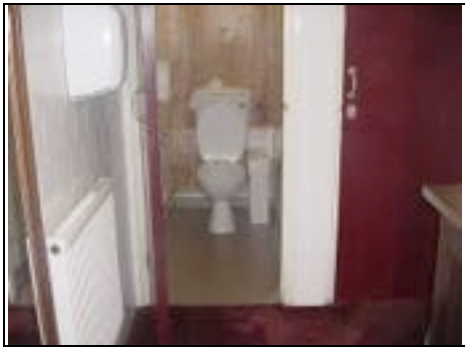
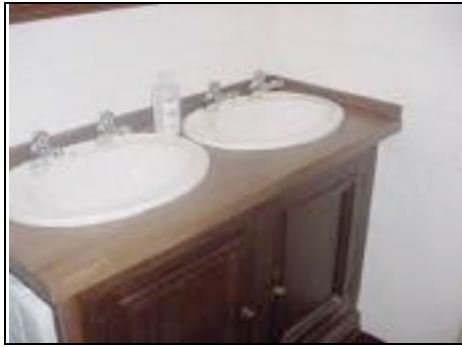
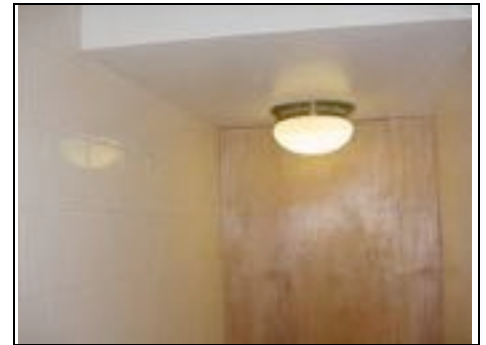
Ladies Toilets

DESCRIPTION	CONDITION	ACTION REQUIRED
Ceiling: Painted	Dampness	Resolve dampness Repair, prepare and redecorate.
Walls: Tiled Within W.C.	Dirty Wood panel to rear of left w.c.	Deep clean Repair, prepare and redecorate.
Floors: Carpet Safety style flooring to W.C.s	Average Marked	Clean or replace Deep clean
Detailing: Doors: Timber veneer entrance door	Marked	Clean Clean/replace ironmongery

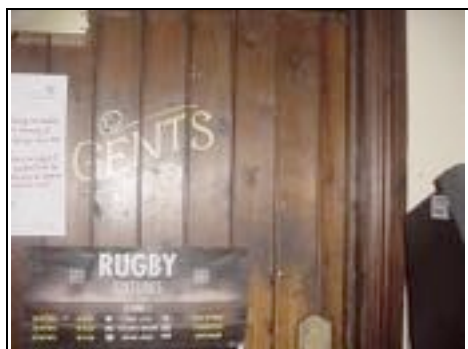
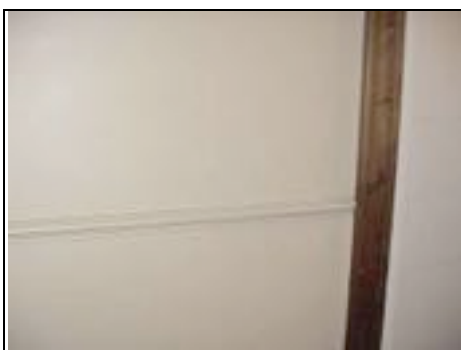
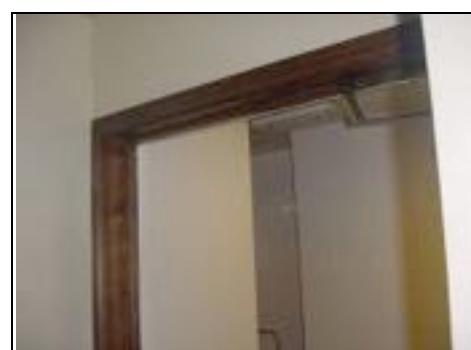
Lobby to Gents Toilets

DESCRIPTION	CONDITION	ACTION REQUIRED
Ceiling: Painted	Dated	Repair, prepare and redecorate.
Walls: High level: Painted modern plaster Dado Low level: Painted	Dated Dampness	Resolve dampness Repair, prepare and redecorate.
Floors: Safety style flooring	Marked	Deep clean/replace
Detailing: Doors: Stained timber door	Worn	Repair, prepare/sand and re-stain
Services:		See Services Section

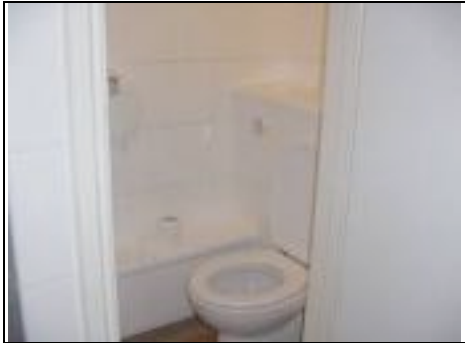
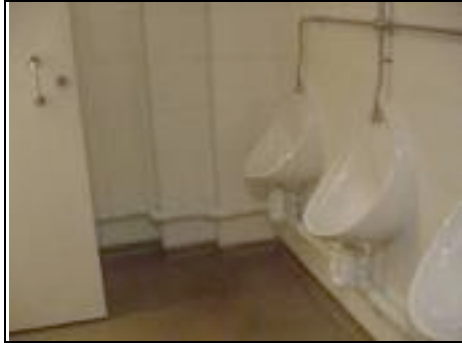
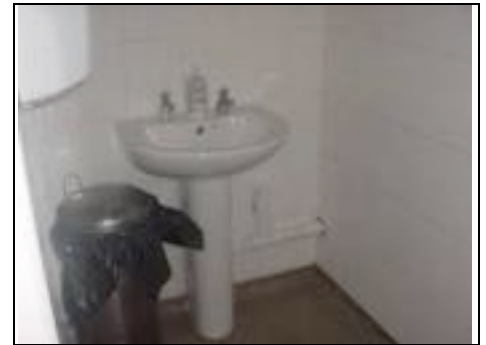
Gents Toilets

DESCRIPTION	CONDITION	ACTION REQUIRED
Ceiling: Painted Loft hatch	Marked and stained Dampness coming though from roof above

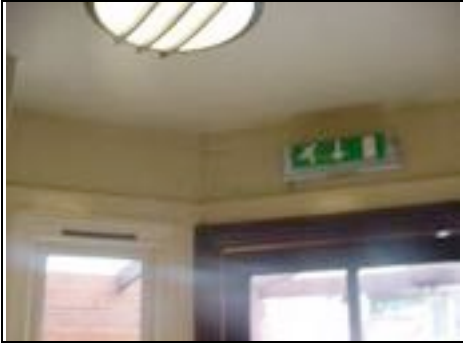
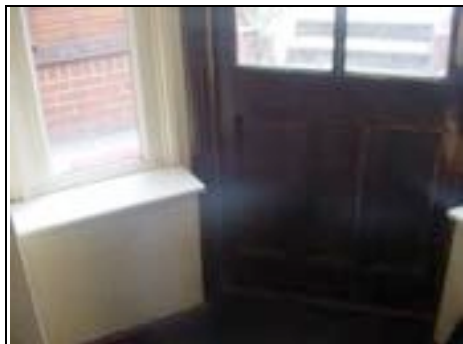
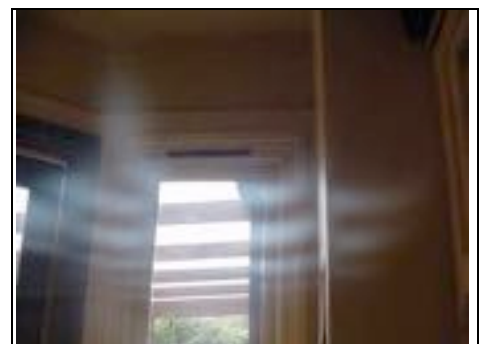
Lobby Rear Left to Smokers Area

DESCRIPTION	CONDITION	ACTION REQUIRED
Ceiling: Painted	Dated	Repair, prepare and redecorate.
Walls: Painted modern plaster, painted embossed paper and dado rail	Dampness and dated.	Resolve dampness Repair, prepare and redecorate.
Floors: Carpet	Marked	Clean or replace
Detailing: Windows: Painted timber	Dated	Repair, prepare and redecorate

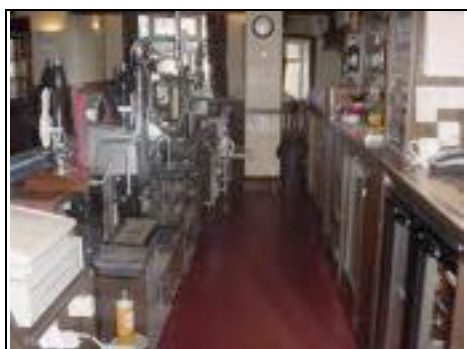
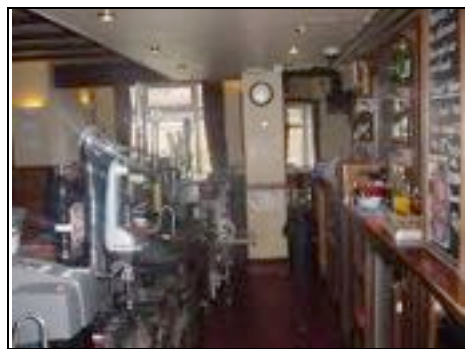
Bar Servery Area

DESCRIPTION	CONDITION	ACTION REQUIRED
Ceiling: Painted with ceiling lights	Hairline cracking	Repair, prepare and redecorate
Walls: Painted	Dated	Repair, prepare and redecorate
Floors: Safety style altro flooring	Marked and damaged	Clean/repair/replace
Detailing: Back bar Front bar	Heavily marked Heavily marked	Sand and re-stain Sand and re-stain
Services:		See Services Section

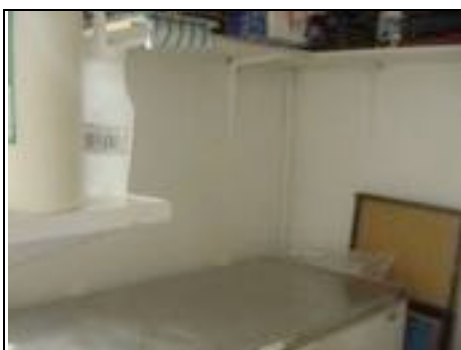
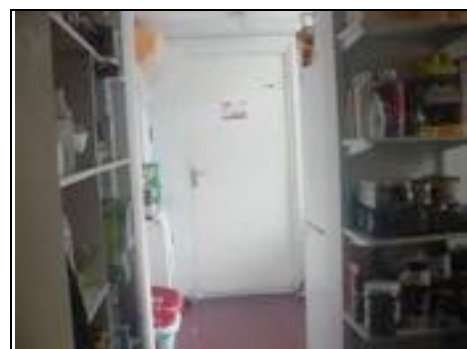
Entrance lobby

Entrance lobby to catering kitchen

DESCRIPTION	CONDITION	ACTION REQUIRED
Ceiling: Painted	Dated	Repair, prepare and redecorate.
Walls: Painted	Dated	Repair, prepare and redecorate.
Floors: Safety style flooring	Grease stained	Deep clean
Detailing: Windows: Painted timber	Dated	Repair, prepare and redecorate
Doors: Painted door to private living accommodation	Dated	Repair, prepare and redecorate
Stained timber door with vision panel to kitchen	Dated	Sand and re-stain
Services:		See Services Section

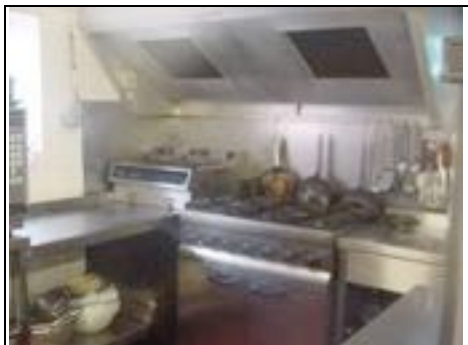
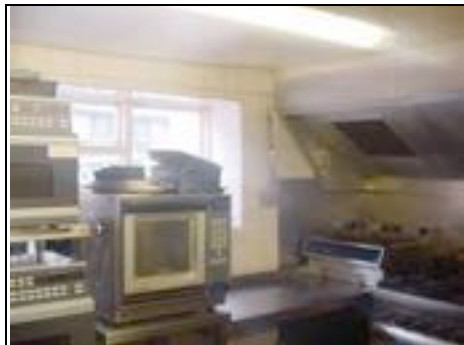
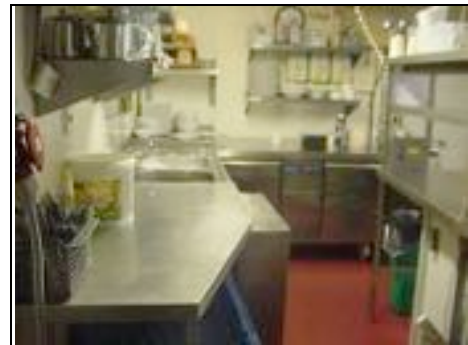
Catering Kitchen

Catering kitchen cooking area

Catering kitchen

DESCRIPTION	CONDITION	ACTION REQUIRED
Ceiling: Painted	Hairline cracking Ingrained grease and dirt	Repair, prepare and redecorate.
Walls: Painted	Ingrained grease and dirt	Repair, prepare and redecorate.
Floors: Safety style flooring	Marked, damaged and dirty

Deep clean/repair/replace
Detailing: Windows: Casement window	Dated	Repair, prepare and redecorate.
Doors: Painted timber	Dated	Repair, prepare and redecorate

Equipment: Stainless steel sink and drainer Kitchen units:	The equipment has not been inspected. We have assumed that the equipment meets the appropriate Local Authority approval and standards.	
Services: Extract fan Cooker line extractor hood Fuse board	Dirty Dirty, grease visible	See Services Section Clean and service Deep clean

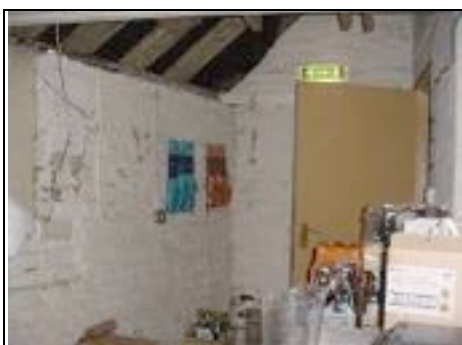
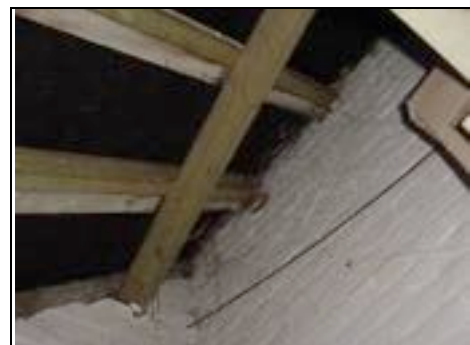
Open ceiling

Cellar right

DESCRIPTION	CONDITION	ACTION REQUIRED
Ceiling: Open ceiling, common rafters visible	Common rafters backed to backed (additional support) Dampness staining to common rafters

Signs of woodworm	Resolve dampness and woodworm.
Walls: Painted	Dampness deteriorating and Cracking visible to external of the walls	Resolve dampness Repair, prepare and redecorate. Property owner to place insurance claim
Floors: Concrete	Marked	Make good

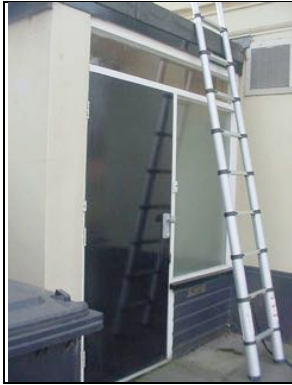
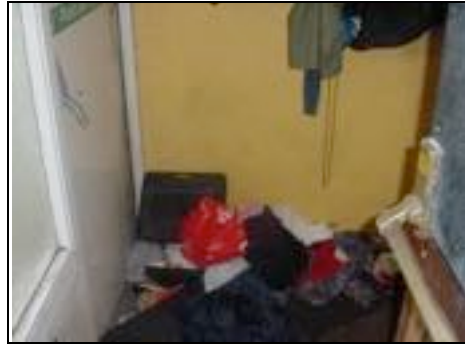
Inner Entrance Hall Left
giving access to Private Living Accommodation

Entrance

Inner entrance hall

Door damaged

DESCRIPTION	CONDITION	ACTION REQUIRED
Ceiling: Embossed paper	Hairline cracking and damaged  	Repair, prepare and redecorate.
Walls: Painted bright yellow  	Dampness Dirty and marked	Resolve dampness Repair, prepare and redecorate.
Floors: Carpet	Marked	Deep clean/replace

Detailing: Doors: Access door from pub Door to upstairs; painted white Fire exit door: painted white Skirting	Dirty and marked Dirty and marked Dirty and marked Damaged

Repair, prepare and redecorate Repair, prepare and redecorate Repair, prepare and redecorate Repair, prepare and redecorate
Services: Two ceiling lights	One light removed, one light not working	See Services Section Replace/repair

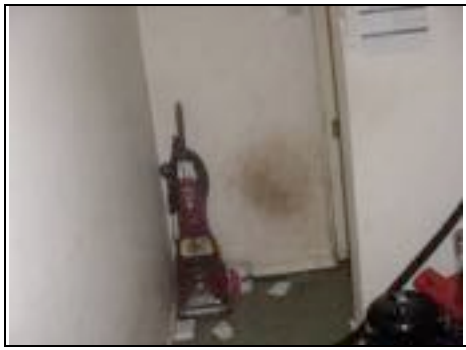
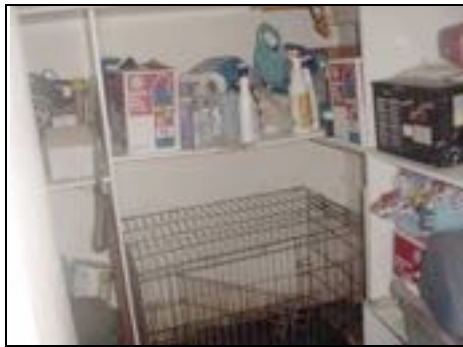
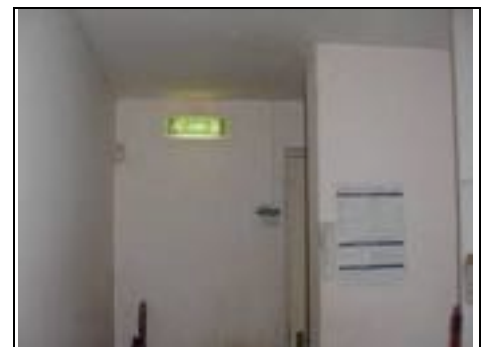
Storage Area/Hallway at Bottom of Stairs

Hallway

Storage area

DESCRIPTION	CONDITION	ACTION REQUIRED
Ceiling: Painted	Marked Undulating Signs of dampness/black staining from flat roof above	Resolve dampness Repair, prepare and redecorate
Walls: Painted	Heavily marked Hairline cracking	Repair, prepare and redecorate.
Floors: Carpet	Worn	Replace
Detailing: Doors: Painted	Heavily marked	Repair, prepare and redecorate
Shelving: Melamine covered shelving	Damaged and dirty	Deep clean
Services:		See Services Section

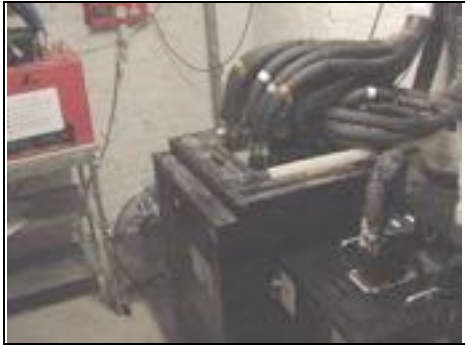
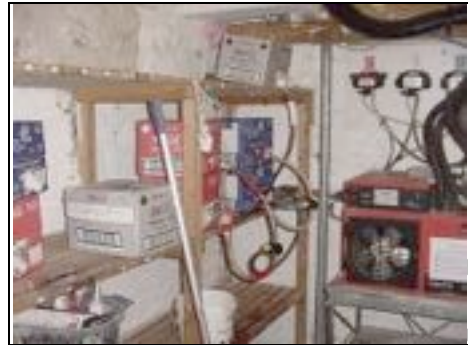
Cellar – Left (Pythons and Soft Drinks)

Cellar left

DESCRIPTION	CONDITION	ACTION REQUIRED
Ceilings: Boarded ceiling	Unfinished	Repair, prepare and redecorate.
Walls: Painted	Dampness

Columns repaired

Resolve dampness Repair, prepare and redecorate.
Floors: Concrete	Marked	Make good

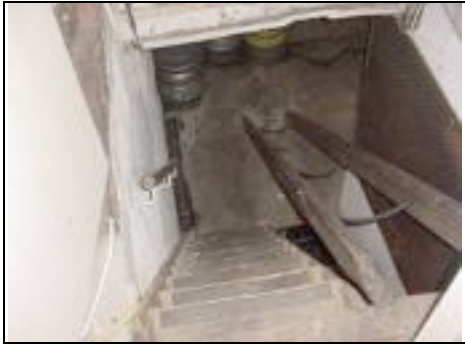
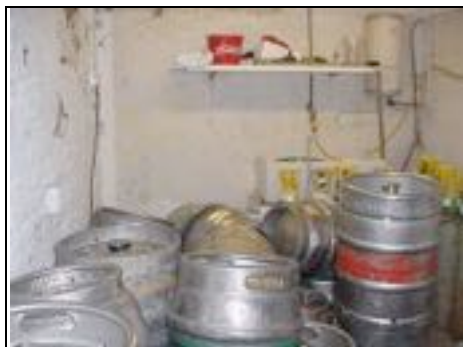
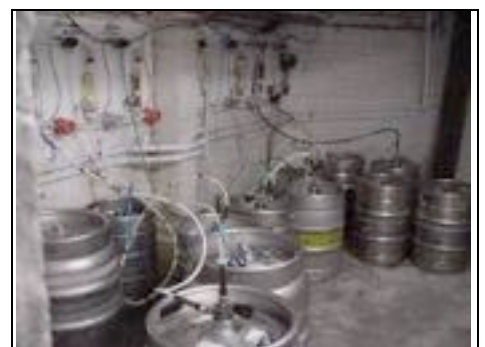
Cold Cellar

Drop to cold cellar

Cold cellar

General view

DESCRIPTION	CONDITION	ACTION REQUIRED
Ceiling: Painted boarded	Dated	Repair, prepare and redecorate.
Walls: Painted brick Supporting column situated against the walls	Dampness

Resolve dampness Repair, prepare and redecorate. Check for Environmental Health notices with regards to the condition of cellar area generally.

Floors: Concrete	Marked and cracked

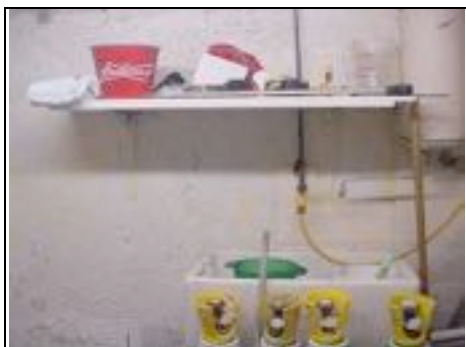
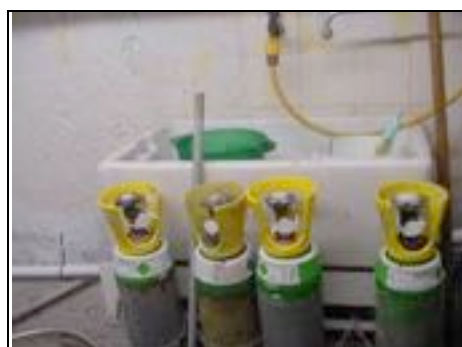
Cellar – Right

Cellar right

DESCRIPTION	CONDITION	ACTION REQUIRED
Ceilings: Painted	Dated	Repair, prepare and redecorate.
Walls: Partly tiled wall	<p>Dampness coming in both laterally and from air bricks.</p> <p>Tiles coming away</p>

Cracking

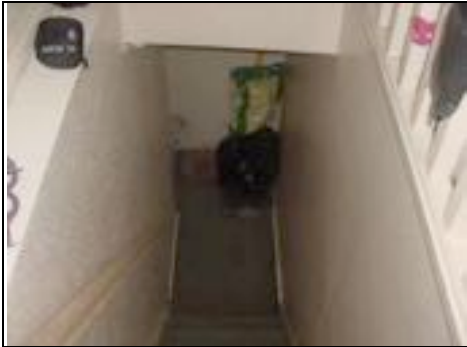
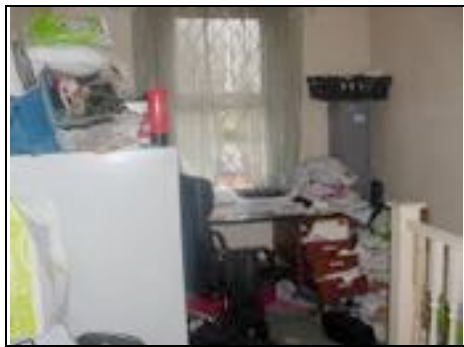
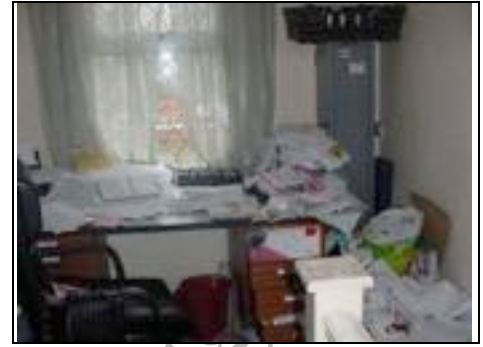
Stairs, Landing and Office

Stairs

Landing/office

Office area

DESCRIPTION	CONDITION	ACTION REQUIRED
Ceilings: Embossed paper	Dated	Repair, prepare and redecorate
Walls: Woodchip paper Dry lining	Heavily marked and dirty, cobwebs visible Wallpaper coming off/torn off wall

Dry lining indicating that dampness is a problem.	Repair, prepare and redecorate
Floors: Green carpet	Worn	Replace

Detailing: Windows: Painted Doors: Access door to private living accommodation Staircase: Underside lined	Dated Marked	Repair, prepare and redecorate Repair, prepare and redecorate and make good ironmongery
Services:		See Services Section
Other: Stored items	Stored items limited inspection	Remove

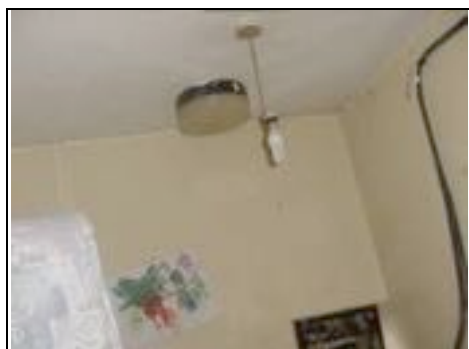
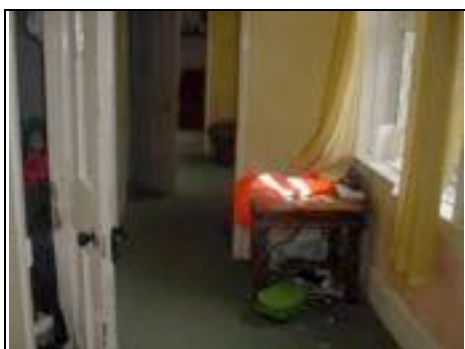
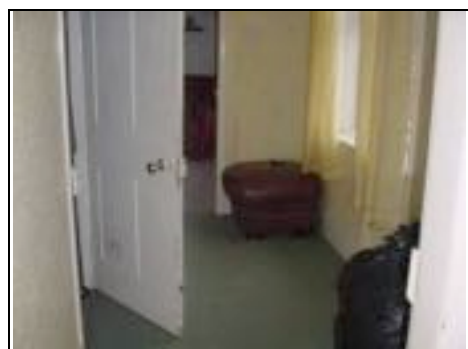
Corridor left

Corridor right

DESCRIPTION	CONDITION	ACTION REQUIRED
Ceiling: Painted	Undulating and dampness

Resolve dampness Repair, prepare and redecorate.
Walls: Embossed paper (painted yellow) Older style dry lining	Heavily marked	Repair, prepare and redecorate.
Floors: Green carpet	Worn Uneven	Clean/replace
Detailing: Windows: Painted	Dated	Repair, prepare and redecorate

Doors: Painted white panel doors	 Dated and heavily marked	 Repair, prepare and redecorate and make good ironmongery
Services: Socket points Factory lagged boiler in airing cupboard

Socket points coming off wall	 See Services Section Replace Electrical test required.

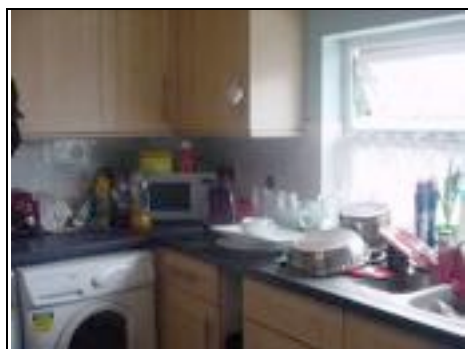
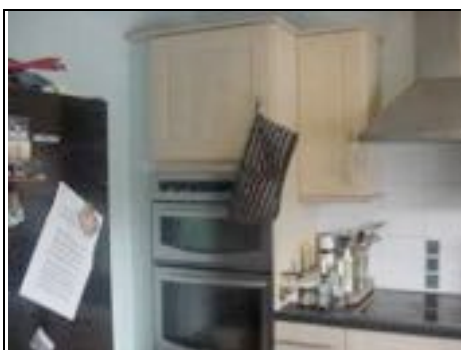
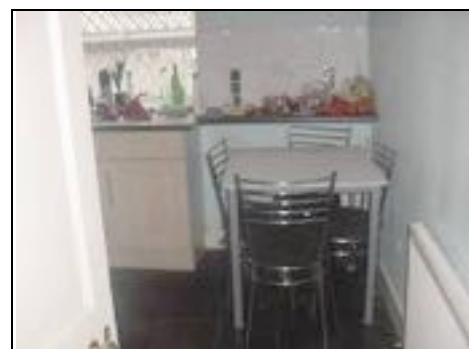
Domestic Kitchen Rear Left

Kitchen

DESCRIPTION	CONDITION	ACTION REQUIRED
Ceiling: Painted	Hairline cracking Undulations in ceiling particularly over the window area	Repair, prepare and redecorate.
Walls: Painted woodchip Dry lining	Marked

Dry lining indicating possible dampness in the area	Repair, prepare and redecorate.
Floors: Vinyl	Marked	Deep clean

Replace
Doors: Painted panel door	Dated	Repair, prepare and redecorate and make good ironmongery
Services: Internal radiator		See Services Section

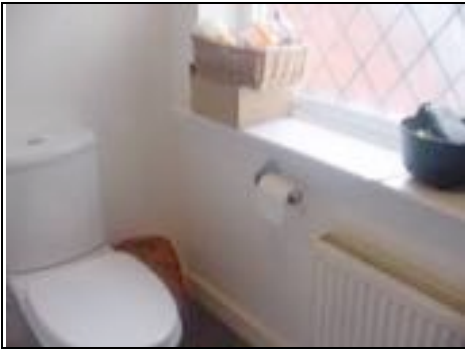
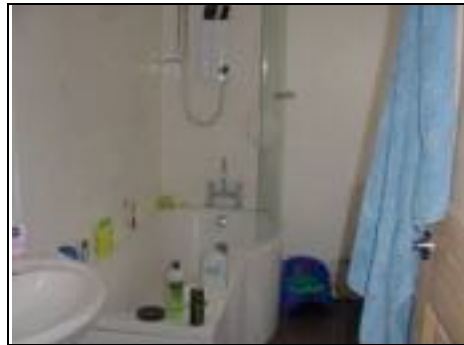
Bathroom Rear Middle

W.C.

Bathroom

DESCRIPTION	CONDITION	ACTION REQUIRED
Ceiling: Modern plaster finish painted ceiling	Dated	Repair, prepare and redecorate.
Walls: Modern plaster finish painted Tiled around bath Dry lining	Dated Tiles missing behind wash hand basin	Repair, prepare and redecorate. Replace missing tiles
Floors: Carpet	Marked	Clean/replace
Detailing: Windows: Painted	Dated	Repair, prepare and redecorate

Doors:		
Timber	Heavily marked	Repair, prepare and redecorate and make good ironmongery
Sanitary Ware:		
WC	Worn	Deep clean
Wash hand basin	Worn Mould to mastic	Deep clean
'P' shaped Bath	Worn	Deep clean
Services:		See Services Section
Electric heater shower

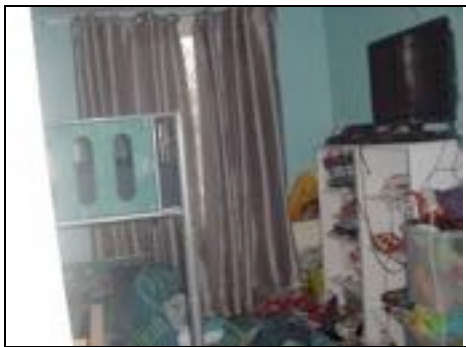
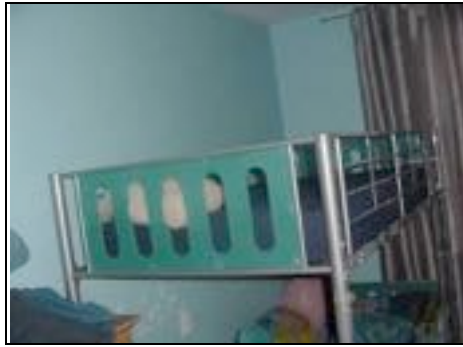
Bedroom One Front

Bedroom one

DESCRIPTION	CONDITION	ACTION REQUIRED
Ceiling: Painted	Dated	Repair, prepare and redecorate.
Walls: Painted Dry lining	Dated	Repair, prepare and redecorate.
Floors: Carpet	Worn and marked Floors uneven	Clean or replace
Detailing: Windows: Plastic double glazed windows	Dated	Deep clean

Doors: Painted panel door	Damaged, backing put to back of it

Repair, prepare and redecorate and make good ironmongery
Services: Radiator under window	Rusting and leaking	See Services Section Replace
Other: Stored items limited inspection		Remove

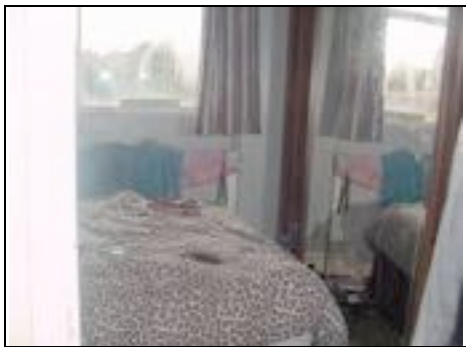
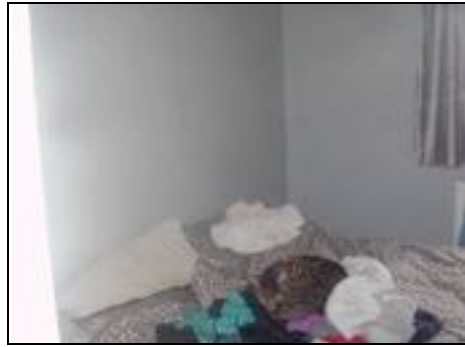
Bedroom Two Rear Right

Bedroom two rear right

DESCRIPTION	CONDITION	ACTION REQUIRED
Ceiling: Painted	Undulating Signs of dampness around windows	Resolve dampness Repair, prepare and redecorate.
Walls: Modern plaster Timber boarded partition rather than studwork partition Dry lining	Marked	Repair, prepare and redecorate. Possible dampness problem.
Floors: Carpet	Worn Floors uneven	Replace
Detailing: Windows: Plastic double glazed	Dated	Clean

Doors: Painted panel	 Dated	 Repair, prepare and redecorate and make good ironmongery
Services: 	 	See Services Section
Other: Stored items limited inspection	 	Remove

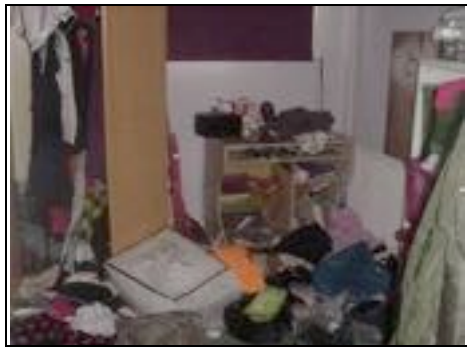
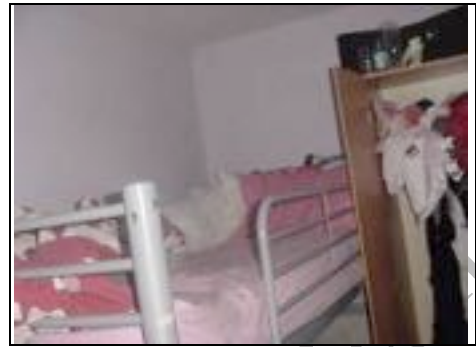
Bedroom Three Right Rear

Bedroom thee

Bedroom three

DESCRIPTION	CONDITION	ACTION REQUIRED
Ceiling: Painted plaster	Average	Repair, prepare and redecorate.
Walls: Painted Dry lining	Marked	Repair, prepare and redecorate. Possible dampness problem.
Floors: Carpet	Worn Uneven floor	Replace
Detailing: Windows: Plastic double glazed Doors: Painted panel	Dirty Heavily marked and stickers to door	Deep clean Repair, prepare and redecorate and make good ironmongery

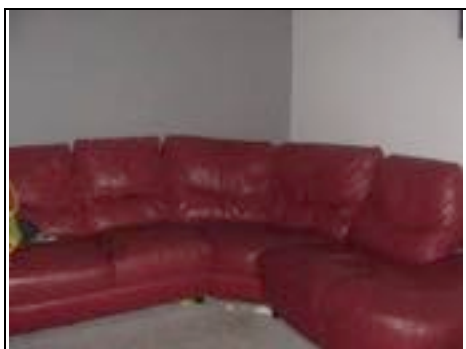
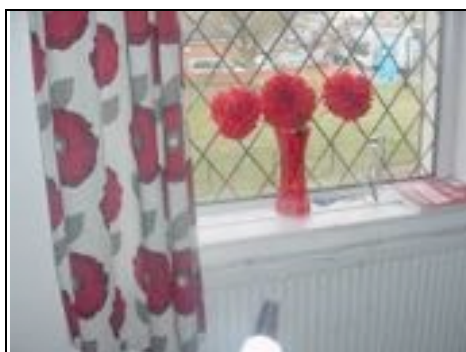
Lounge Right

Lounge

DESCRIPTION	CONDITION	ACTION REQUIRED
Ceiling: Modern painted plaster	Marked, some dampness visible	Resolve dampness Repair, prepare and redecorate.
Walls: Modern painted plaster Dry lining	Marked	Repair, prepare and redecorate. Possible dampness problem.
Floors: Carpet	Worn Uneven floor	Replace
Detailing: Windows: Plastic double glazed	Dirty	Deep clean

Doors: Painted panel door	Marked  	Repair, prepare and redecorate and make good ironmongery
Services:		See Services Section
