PROPERTY REPORT AND NEGOTIATION DOCUMENT

INDEPENDENT CHARTERED SURVEYORS

The XXX Public House
XXX
XXXX
Swanley,
Kent, BR8 XXX

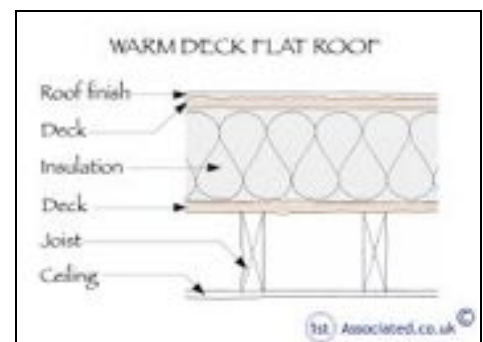
Warm roof

Left flat roof

ACTION REQUIRED: Reduction in the lease based on the future maintenance requirements/replacement.

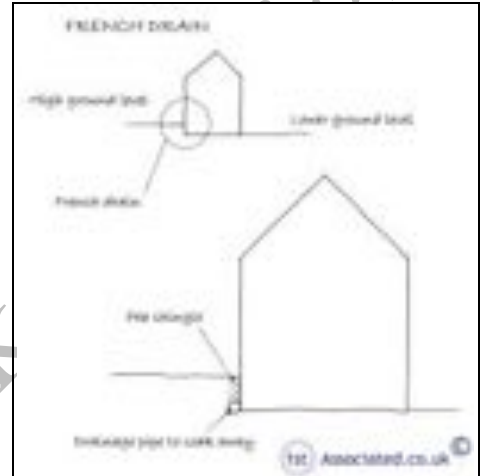
ACTION REQUIRED: A very difficult problem to resolve and you may have to consider it a characteristic of this property. We believe you can reduce the amount of dampness in the following ways:

- 1) Add a French drain that has a perforated drain discharging into the main drainage system. We would also recommend a running gulley is added around the outside of the base of the property as we showed you has been added to the rear left kitchen entrance area.

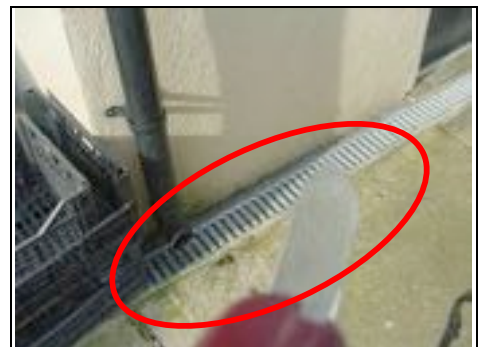
Running gulley to rear left

- 2) Allow the property to dry out as much as possible.
- 3) Currently the plaster is wet and the walls beneath and the paint/paper is coming off the walls in some areas for example in the toilets and in the rear entrance area. Once this area is dry you can re-plaster and redecorate.

ANTICIPATED COST: £2,500 - £7,500; please obtain quotations.

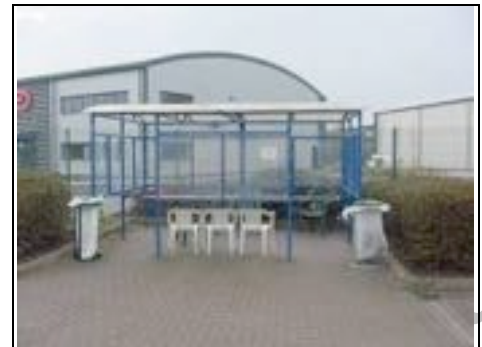
Example of a smoker's shelter
(not your property)

ACTION REQUIRED: Replace smoker's shelter.
