SCHEDULE OF CONDITION

Public House, West Berkshire

We have been instructed to inspect and prepare a Schedule of Condition for XXXX

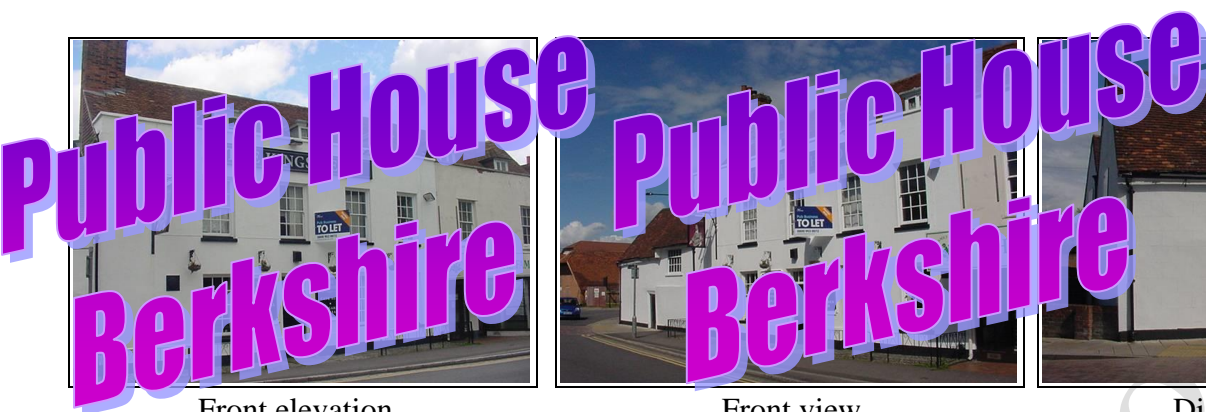
Front External Elevation

Deteriorating and spalling brickwork	Joint high level inspection with the landlord's surveyor to be carried out prior to signing of the lease or legal completion of the lease from high level cherry picker or equivalent.
Roofs: Pitched roof clad with clay peg tiles

Undulating and tiles missing

<p>Parapet wall and box gutter viewed from dormer windows as well as ground level.</p>	<p>Plant growing out of front box gutter/hopperhead and dampness noted to some of the rooms, believed to be from the box gutter</p>

<p>Box gutter flashing coming away slightly</p>	<p>Clear and ensure watertight. Likely to require re-bedding of lead and coping stones to be lifted and re-bedded and repointed or possibly changed as the drip detail may not be correct. It simply wasn't possible to view from the window properly and we believe it unsafe to go out onto the box gutter.</p> <p>Joint high level inspection with the landlord's surveyor to be carried out prior to signing of the lease or legal completion of the lease from high level cherry picker or equivalent.</p>
<p>Dormer windows:</p> <p>Three dormer windows with lead finish</p>	<p>Flat roofs viewed from ground level.</p>	<p>Joint high level inspection with the landlord's surveyor to be carried out prior to signing of the lease or legal completion of the lease from high level cherry picker or equivalent.</p>

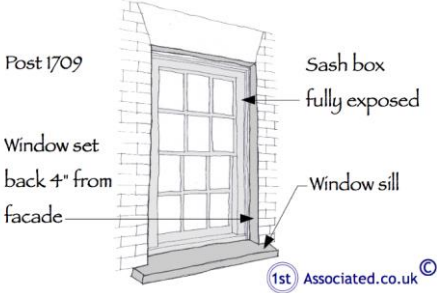
<p>External Detailing:</p> <p>Windows:</p> <p>Single glazed sliding sash windows, majority are 6x6</p> <p>EARLY 18TH CENTURY SASH WINDOW</p>

<p>Doors:</p> <p>Door to left side into disused part of building</p> <p>Door to main bar lobby</p> <p>Signage:</p> <p>Swing sign</p> <p>Three signs, one at high level, two at low level</p>	<p>Minor wet rot</p>

<p>Average externally, dilapidated internally</p> <p>Marked and dated</p> <p>Average</p> <p>Average</p>	<p>Clean. Repair, prepare and redecorate.</p> <p>Repair, prepare and redecorate</p> <p>Repair, prepare and redecorate</p> <p>Clean</p> <p>Clean</p>
<p>Other:</p> <p>Two extract fans:</p> <p>Hanging baskets</p>	<p>Dated</p> <p>Rusting</p>	<p>Clean and service</p> <p>Repair, prepare and redecorate</p>

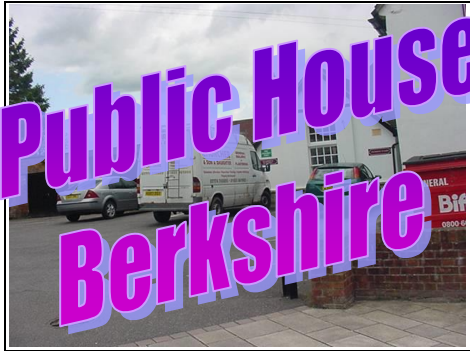
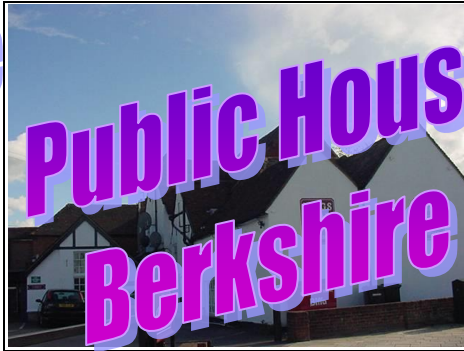
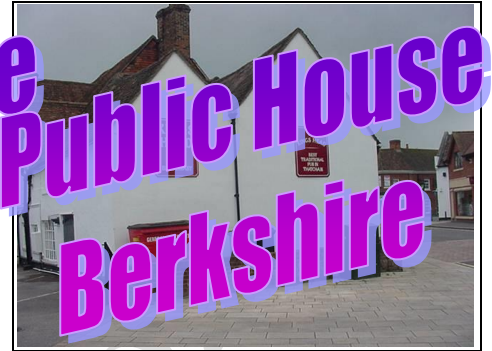
Left External Elevation

DESCRIPTION	CONDITION	ACTION REQUIRED
<p>Roofs:</p> <p>Pitched clay tile roof</p> <p>Valley Gutter:</p> <p>VALLEY GUTTERS - common problems</p> <p>1st Associated.co.uk ©</p>	<p>Hidden valley gutter within disused part of the building is letting in water</p>	<p>See Front Elevation</p> <p>Recommend exclude from lease.</p> <p>Joint high level inspection of the guttering with the landlord's surveyor to be carried out prior to signing of the lease or legal completion of the lease from high level cherry picker or equivalent.</p>

Hopperheads, Gutters and Downpipes: Cast Iron and plastic	Downpipes discharge directly onto ground, dampness likely in these areas.	Ensure all gutters are watertight and falling towards the downpipe and clear. Repair downpipes and secure as necessary, ensure downpipes are clean and clear.
Walls: Painted render	Areas of blown render. Note internally the disused section of the property has movement to the front and rear walls	Repair, prepare and redecorate
External Detailing: Signage: Two timber painted signs	Average	Clean.

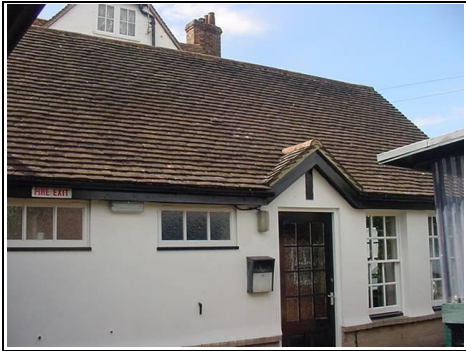
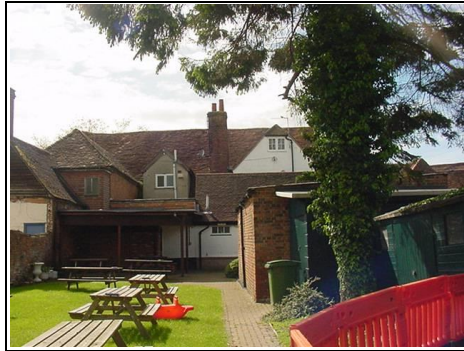
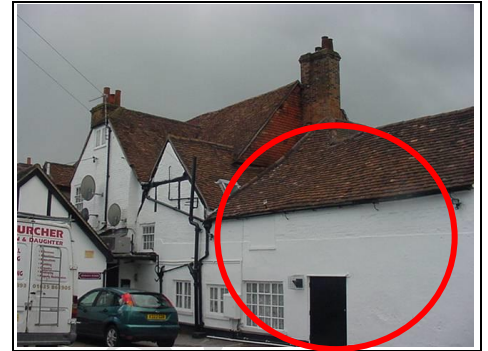
Rear External Elevation

DESCRIPTION	CONDITION	ACTION REQUIRED
<p>Chimneys:</p> <p>Rear chimney</p> <p>Substantial rear far right hand chimney (all directions given as you face the front) with three chimney pots, partly rebuilt, lead and concrete flashing</p> <p>Chimney to rear central looks to have been partly rebuilt</p>

Displaced tiles and missing tiles

<p>Rusting cast iron</p>

<p>Leaking connection cast iron to plastic</p>

<p>Tie bar indicates there has been movement in the walls previously normally due to joist ends rotting</p>	<p>Repair</p>

<p>Replace tiles on edge with lead flashing.</p> <p>Monitor</p>

<p>Repair, prepare and redecorate cast iron.</p> <p>Ensure all gutters are watertight and falling towards the downpipe and clear.</p> <p>Repair downpipes and secure as necessary, ensure downpipes are clean and clear.</p>
<p>Walls:</p> <p>Painted render</p> <p>One 'S' shaped tie bracket</p>

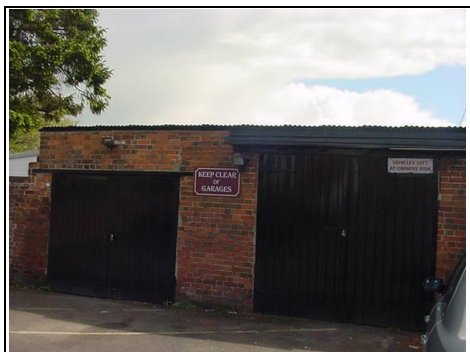
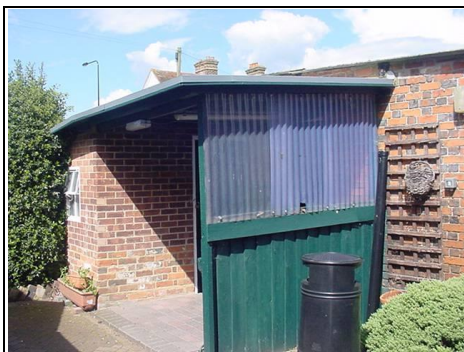
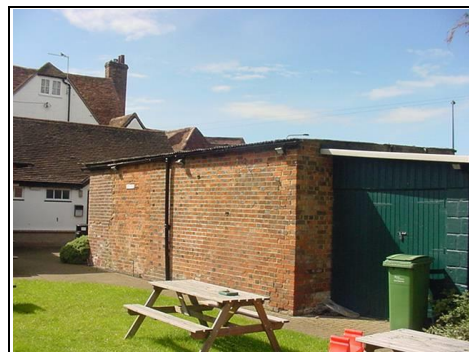
Garage

DESCRIPTION	CONDITION	ACTION REQUIRED
Roofs: Asbestos

<p>Walls:</p> <p>Flemish bond brickwork</p>	<p>Cracking around lintel</p>

<p>Cracking around timber lintel internally</p>

Asbestos report. See Test Certificates Section. We are not asbestos surveyors.
Gutters and Downpipes: Cast Iron and Plastic	Leaking	Ensure all gutters are watertight and falling towards the downpipe and clear. Repair downpipes and secure as necessary, ensure downpipes are clean and clear.

<p>Monitor. Likely to require repair of deterioration to timber lintel</p> <p>Repoint.</p>
<p>External Detailing:</p> <p>Doors: Two double doors</p>	<p>Cracking around garage doors</p> <p>Timber lintels visible</p>	<p>Repair, prepare and redecorate.</p>

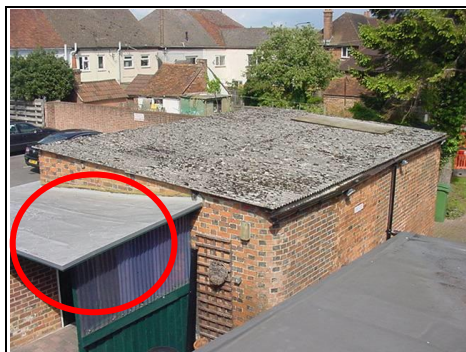
Store Area next to garage

DESCRIPTION	CONDITION	ACTION REQUIRED
Roofs: Plastic corrugated porch area Rot

Rot to timbers

Repair.
Walls: Timber		Repair, prepare and redecorate.
External Detailing: Doors: Ledge and brace door		Repair, prepare and redecorate.

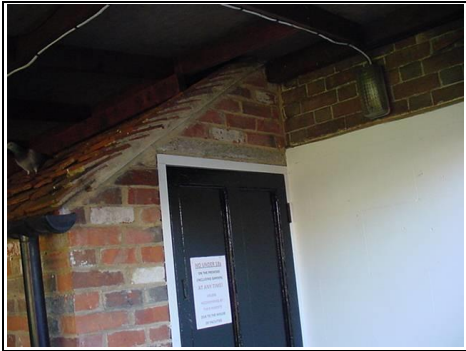
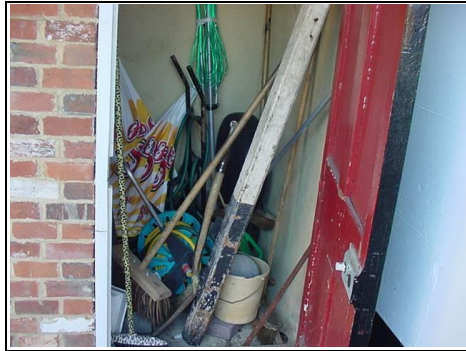
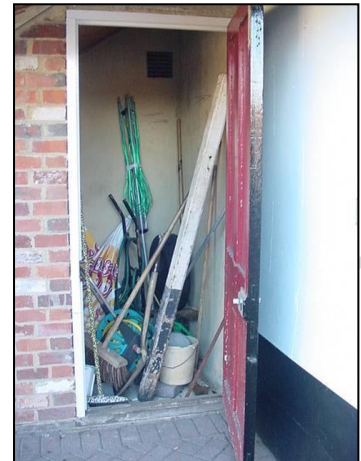
Store Area to Rear

DESCRIPTION	CONDITION	ACTION REQUIRED
Roofs: Single tiled pitched roof

Walls: Stretcher bond brickwork		
Detailing: Doors: Painted	Dated	Repair, prepare and redecorate.
Other: Stored items limited inspection		Remove

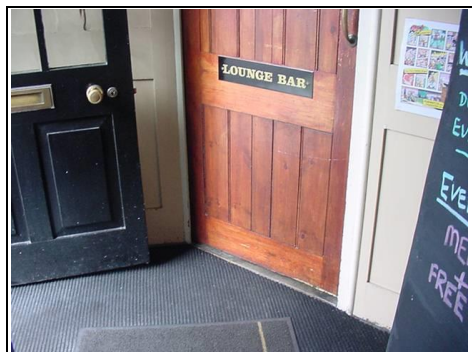
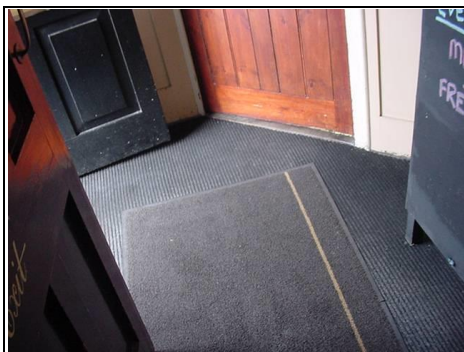
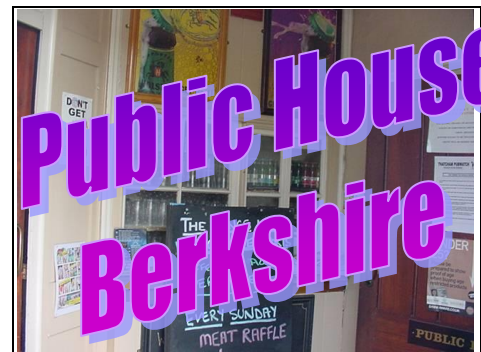
Entrance Lobby

DESCRIPTION	CONDITION	ACTION REQUIRED
Ceilings:		
Painted	Hairline cracking	Repair, prepare and redecorate.
Walls:		
Painted	Average	Repair, prepare and redecorate.
Boarding	Average	Repair, prepare and redecorate.
Floors:		
Hippo carpet	Worn	Clean/replace
Detailing:		
Doors:		
Stained timber	Marked and damaged	Repair, prepare and re-stain.
Glazed entrance door painted black	No mark indicating it is not safety glass	Add safety glass. Repair, prepare and redecorate.

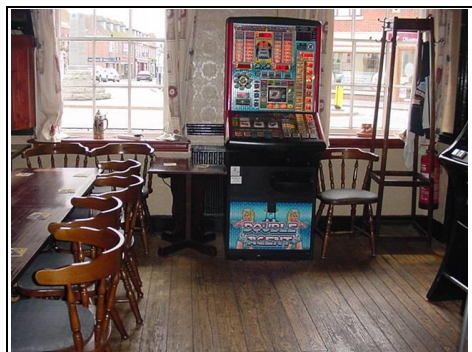
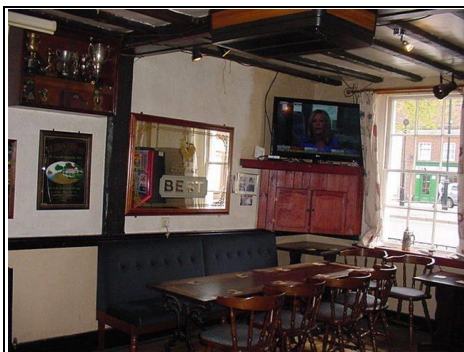
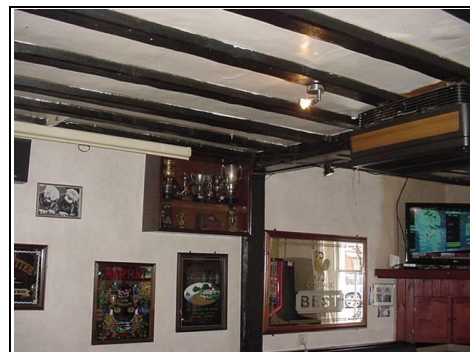
Public Bar Right

DESCRIPTION	CONDITION	ACTION REQUIRED
Ceilings: Painted with feature timbers	Dated Undulating ceiling

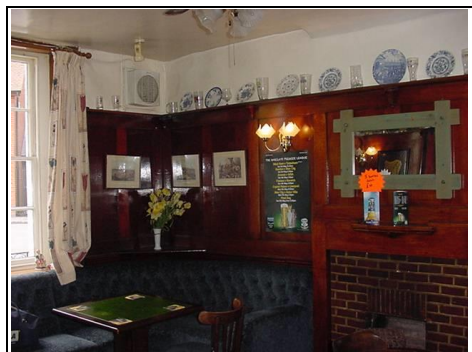
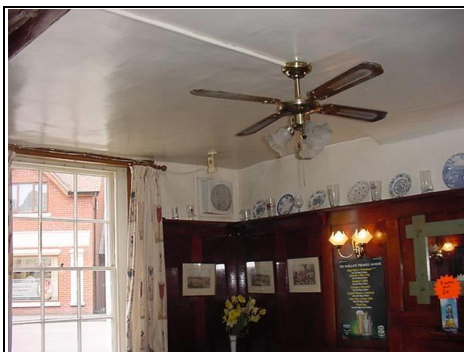
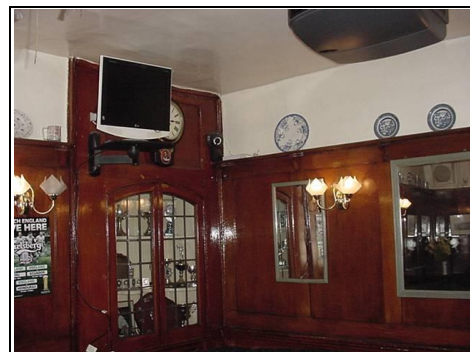
Lounge Bar Left

DESCRIPTION	CONDITION	ACTION REQUIRED
Ceilings: Painted with false beam	Dated	Repair, prepare and redecorate.
Walls: 1930's style panelled walls Chimney breast on left side	Average	Repair, prepare and redecorate.
Floors: Carpet	Dated	Clean or replace
Detailing: Windows: Sliding sash windows Doors: Timber	Dated Marked	Clean. Repair, prepare and redecorate. Repair, prepare and redecorate.

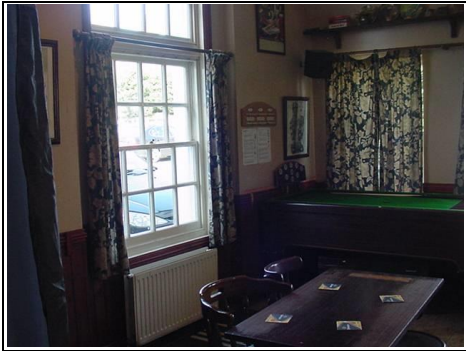
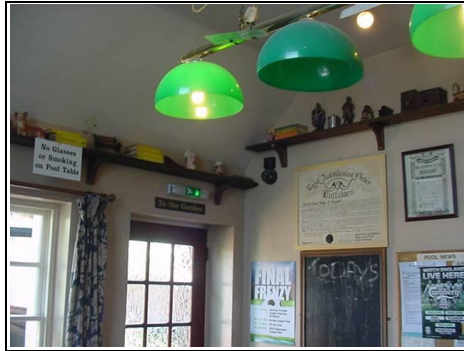
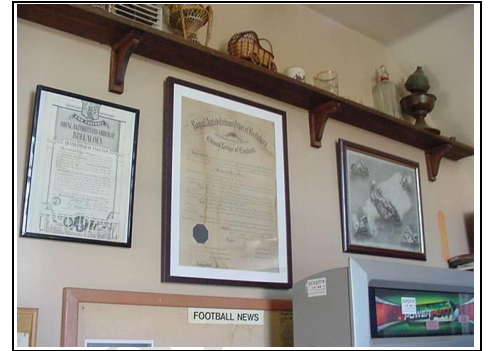
Bar/Pool Room Rear

DESCRIPTION	CONDITION	ACTION REQUIRED
Ceilings: Painted plaster cathedral ceiling	Dated and marked	Repair, prepare and redecorate.
Walls: Painted Timber dado	Dated and marked Old fixing points Dated and marked	Repair, prepare and redecorate. Repair, prepare and redecorate.
Floors: Timber	Marked and worn particularly near exit to garden

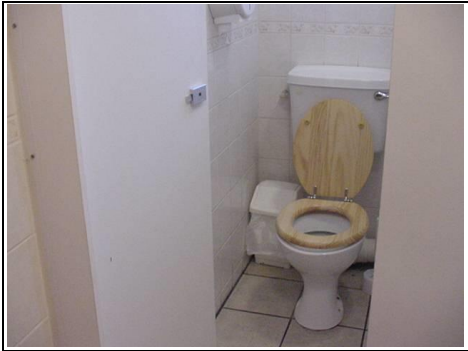
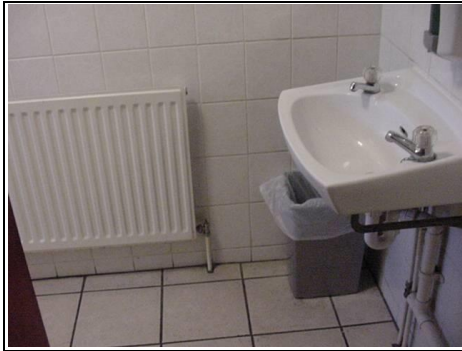
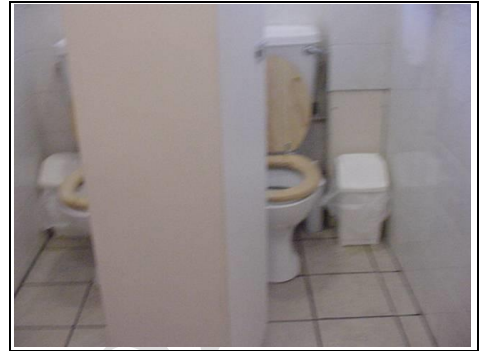
Ladies Toilets

DESCRIPTION	CONDITION	ACTION REQUIRED
Ceiling: Painted Roof access hatch	Dated	Repair, prepare and redecorate
Walls: Tiled from floor to ceiling	Dated Rising damp	Clean Resolve dampness
Floors: Tiled	Ingrained dirt	Deep clean.
Sanitary Ware: Two WC One wash hand basin	Dated Dated	Deep clean Deep clean

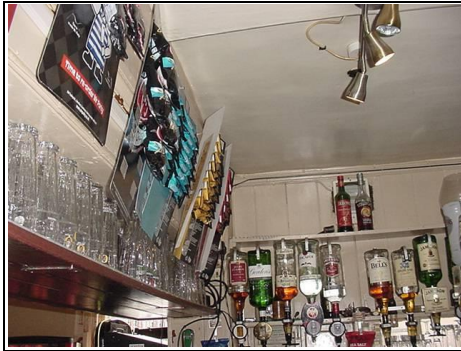
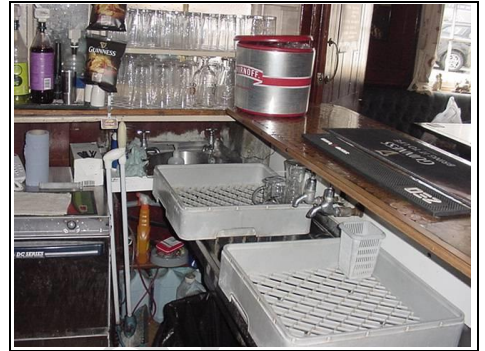
Bar servery

DESCRIPTION	CONDITION	ACTION REQUIRED
Ceiling: Painted	Dated	Repair, prepare and redecorate.
Walls: Painted	Dated	Repair, prepare and redecorate.
Floors: Altro style flooring	Marked	Clean or replace
Detailing: Bar top: Glass bar top with coins underneath

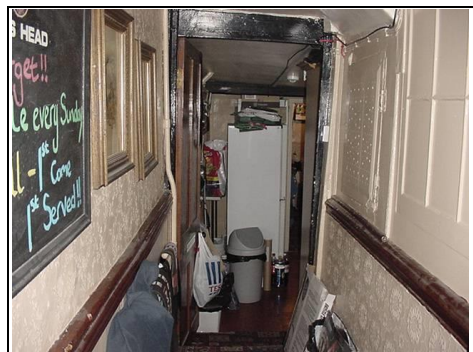
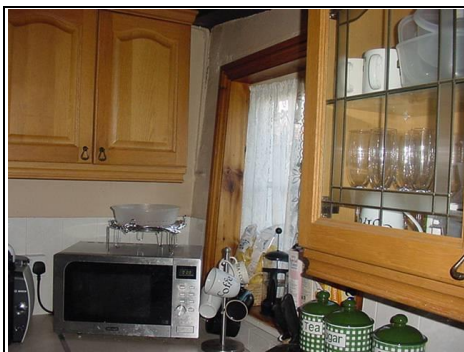
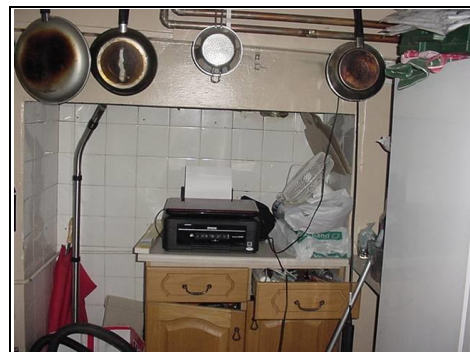
Kitchen and access corridor

DESCRIPTION	CONDITION	ACTION REQUIRED
Ceiling: Painted with feature timbers	Dated	Repair, prepare and redecorate.
Walls: Painted Chimneybreast tiled Tiles above kitchen units	Dated Dated Dated	Repair, prepare and redecorate. Clean Clean
Floors: Quarry tile	Ingrained dirt

Detailing: Windows: Two timber windows Doors: Timber	Dated Marked	Clean. Repair, prepare and redecorate Repair, prepare and redecorate
Equipment: Domestic quality equipment not to current Environmental Health standards. Wall and floor kitchen units		
Services: Lighting	Diffuser missing to fluorescent light	Replace

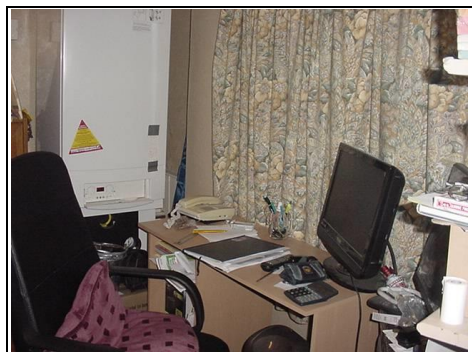
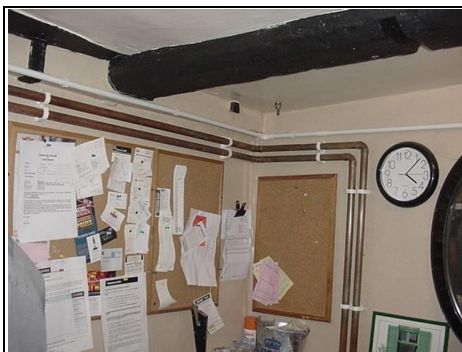
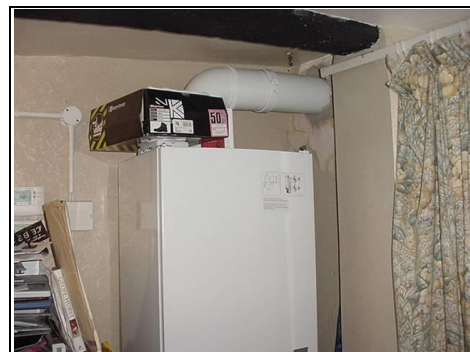
Office

DESCRIPTION	CONDITION	ACTION REQUIRED
Ceilings: Painted with feature timbers	Dated	Repair, prepare and redecorate.
Walls: Painted embossed paper	Marked	Repair, prepare and redecorate.
Timber dado	Dated	Repair, prepare and redecorate.
Floors: Carpet	Dated	Clean or replace
Detailing: Windows: Metal casement window	Dated	Clean. Repair, prepare and redecorate.
Doors: Timber	Marked	Repair, prepare and redecorate.
Services: Worcester boiler	Average	See Services Section

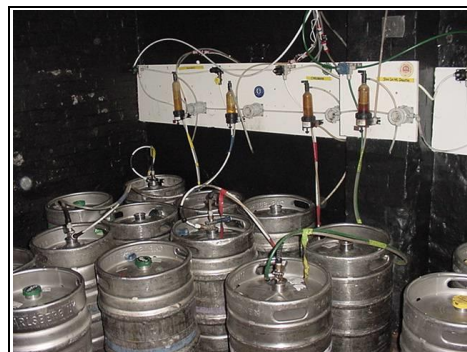
Door worn

DESCRIPTION	CONDITION	ACTION REQUIRED
Ceilings: Exposed timber	Woodworm and dampness	Resolve woodworm and splice in new timber on any deteriorating sections.
Walls: Tarred brick	Dampness

Resolve dampness Repair, prepare and redecorate.
Floors: Concrete	Marked	Make good and clean.
Detailing: Doors: Timber	Heavily marked	Replace or repair, prepare and redecorate.

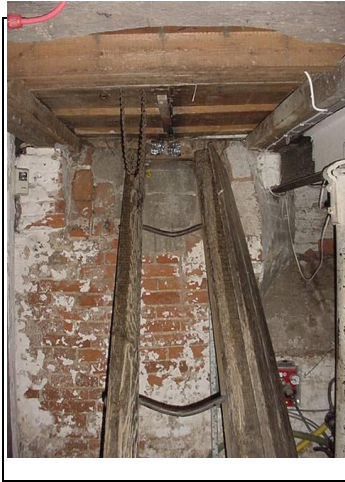
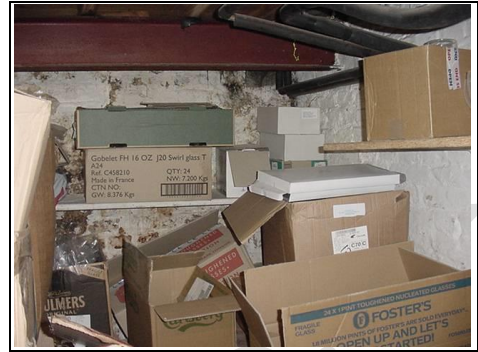
Cellar Drop Area and Spirits Store

DESCRIPTION	CONDITION	ACTION REQUIRED
Ceilings: Exposed timber Cut RSJ on a cast iron column

Resolve woodworm and splice in new timber on any deteriorating sections.
Walls: Painted brick (white)	Old marks, etc	Repair, prepare and redecorate

Painted render	Cracking around doorway leading to stairs	Repair, prepare and redecorate.
Painted boarding	Damp throughout	Resolve dampness
Floors:		
Concrete	Generally stained	Make good
Detailing:		
Doors:	Possibly lined with asbestos	Asbestos report We are not asbestos surveyors
Stairs:		
Timber with nosing

Worn

We would recommend a non-slip altro style floor Add handrail.

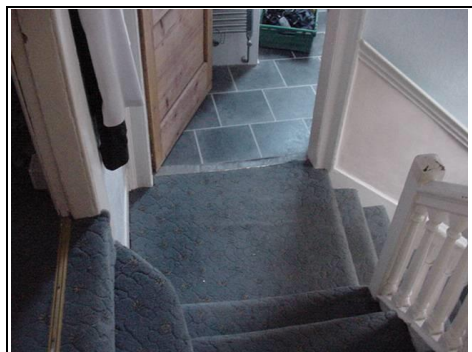
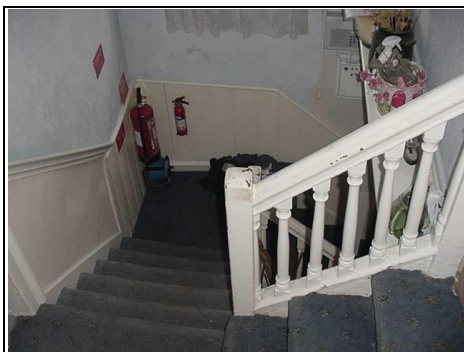
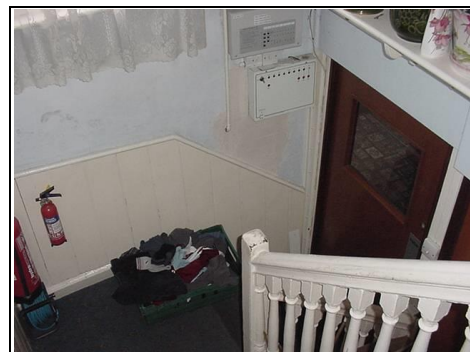
Stairs/Landing/Corridor

DESCRIPTION	CONDITION	ACTION REQUIRED
Ceilings: Painted	Cracking	Repair, prepare and redecorate
Walls: Painted embossed paper Dado to part	Dampness, blown plaster and cracking to rear wall

Cracking between bathroom and rear left bedroom

Floors: Carpet	 Dated	 Clean or replace.
Detailing: Doors: Stained timber Skirtings: Stairs: Balustrade	 Dated and damage to architraves Damaged Worn and dirty Handrail to steps worn	 Clean. Repair, prepare and re-stain Repair, prepare and redecorate Clean.
Services: Fire detector Alarm system Emergency lighting		 See test certificates section. See services section See services section

Resolve dampness. Repair, prepare and redecorate

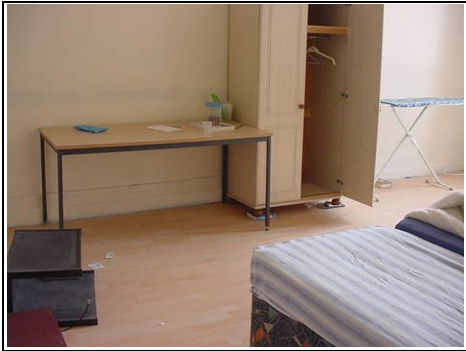
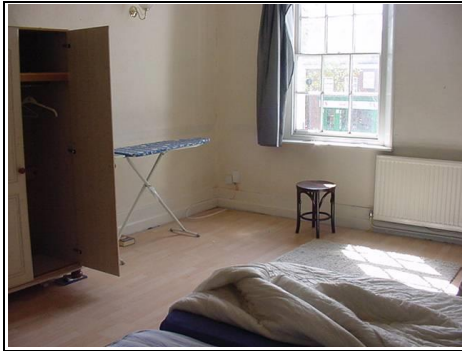
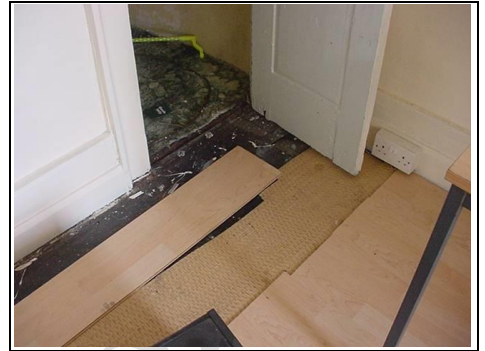
Reception Room Front Right

DESCRIPTION	CONDITION	ACTION REQUIRED
Ceilings: Painted with central beam	Poorly painted	Repair, prepare and redecorate
Walls: Painted embossed paper Chimneybreast to rear section	Diagonal cracking to left wall indicating front wall is moving away from the structure Dampness coming in around chimneybreast	Repair, prepare and redecorate Resolve dampness
Floors: Laminate hiding floorboards	Original flooring visible to rear right showing that joists run from front to back of property Deflection and uneven	Remove badly installed laminate, expose areas of rafter ends (likely to be embedded timbers) and cut out any rot and make good.

Detailing: Windows: Two 6x6 Georgian sliding sash windows Doors: Painted panel door Skirtings: Painted	Dated Dated Poorly painted	Clean. Repair, prepare and redecorate Repair, prepare and redecorate Repair, prepare and redecorate.
Store cupboard: Sloping ceiling Painted walls Carpet	Deterioration, paint peeling Worn	Repair, prepare and redecorate Replace
Services: One radiator between windows One internal radiator	Dated Dated	Clean Clean

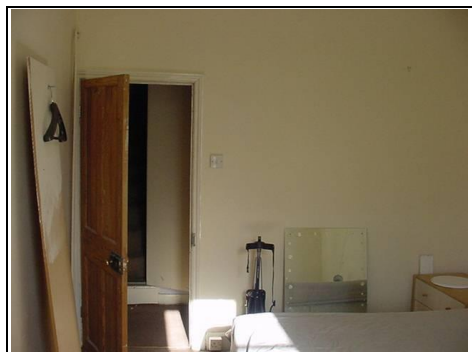
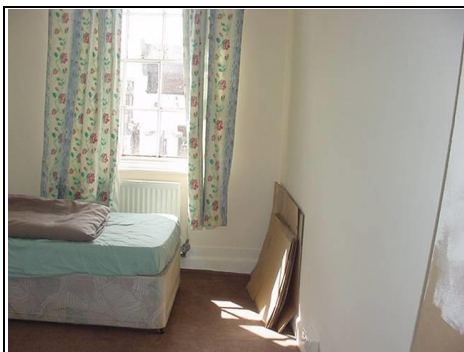
Bedroom Front Middle

DESCRIPTION	CONDITION	ACTION REQUIRED
Ceilings: Plasterboard	Dated	Repair, prepare and redecorate
Walls: Timber framing within right hand wall Timber lintel visible over window	Hairline cracking	Repair, prepare and redecorate
Floors: Carpet	Worn Deflection and uneven	Replace Remove carpet and investigate dampness, cut out any rot and make good.

<p>Dated</p>	<p>Clean. Repair, prepare and redecorate</p> <p>Repair, prepare and redecorate</p>
<p>Services:</p> <p>Fire detector</p>		<p>See test certificates section.</p>

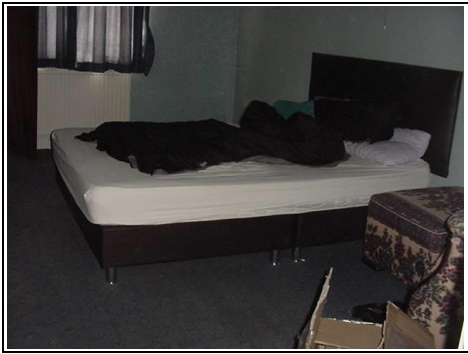
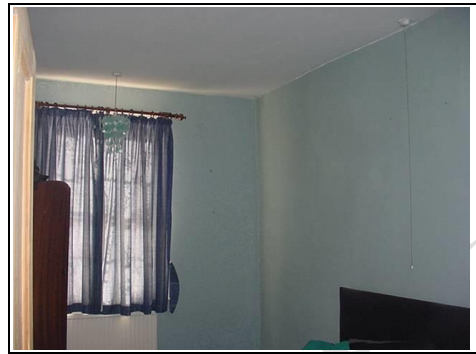
Bedroom Front Left

DESCRIPTION	CONDITION	ACTION REQUIRED
Ceilings: Painted	Hairline cracking	Repair, prepare and redecorate
Walls: Painted blue	Hairline cracking Kink in left wall Timber visible in right wall at ceiling level	Repair, prepare and redecorate
Floors: Blue carpet	Deflection and uneven	Clean or replace carpet. Remove carpet and investigate dampness, cut out any rot and make good.
Detailing: Windows: Sliding sash windows	Dated Black mould	Clean. Repair, prepare and redecorate

Doors:		
Modern timber door	Dated	Repair, prepare and redecorate
Services:		
Fire detector		See Services Section
Radiator under window	Dated	Clean

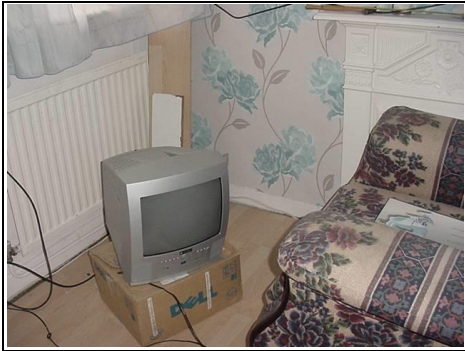
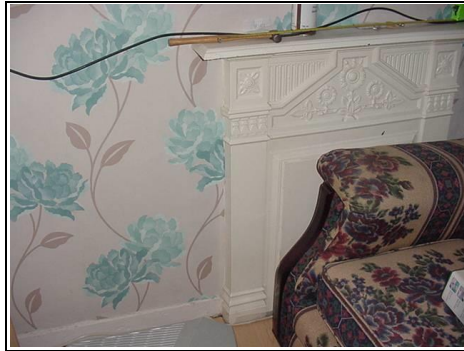
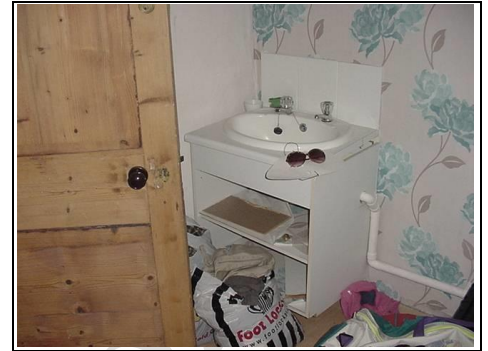
Rear Right Small Room

DESCRIPTION	CONDITION	ACTION REQUIRED
Ceilings: Painted paper Underside of stairs	Dated	Repair, prepare and redecorate
Walls: Painted and wallpaper Chimneybreast, blocked up chimney	Dated and old fixing points Dampness	Repair, prepare and redecorate Resolve dampness
Floors: Laminate hiding floorboards Under laminate at door entrance area we can see that joists run from side to side	Deflection	Remove badly installed laminate, expose areas of rafter ends (likely to be embedded timbers) and cut out any rot and make good.

<p>Detailing:</p> <p>Windows:</p> <p>6x6 Georgian sliding sash window EARLY 18TH CENTURY SASH WINDOW</p>

<p>Doors:</p> <p>Timber panel door</p>	<p>Black mould</p>

<p>Average</p>	<p>Clean. Repair, prepare and redecorate</p>
<p>Equipment:</p> <p>Wash hand basin with vanity unit underneath</p>	<p>Damage to unit</p>	<p>Repair/replace</p>
<p>Services:</p> <p>Fire detector</p> <p>Single panel radiator under window</p>		<p>See services section.</p> <p>Clean</p>

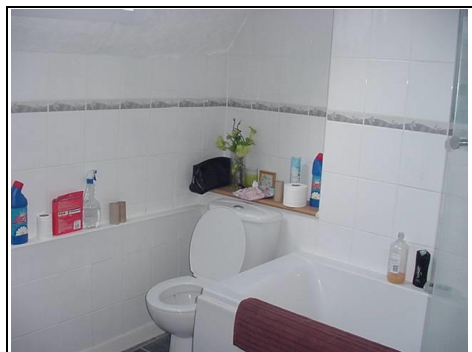
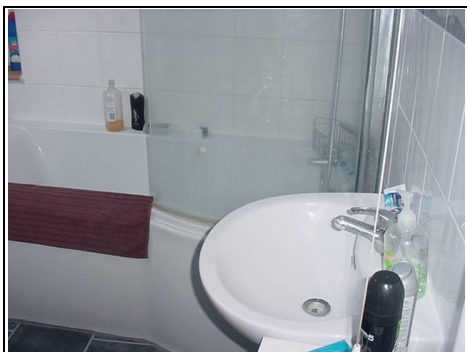
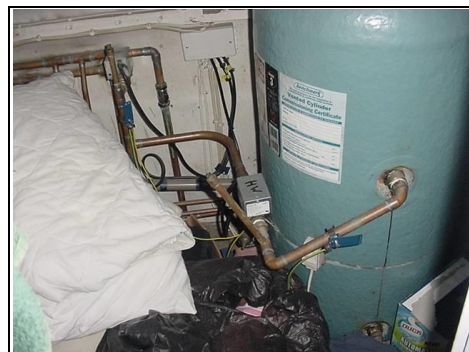
Bathroom

DESCRIPTION	CONDITION	ACTION REQUIRED
Ceilings: Vaulted ceiling Roof window with Georgian wire polished plate glass	Dated Leaking to base, staining can be seen	Repair, prepare and redecorate Resolve leak
Walls: Painted paper	Dated	Repair, prepare and redecorate
Floors: Vinyl	Deflection and uneven	Clean or replace vinyl Remove vinyl and investigate dampness, cut out any rot and make good.
Detailing: Windows:	Dated	Clean. Repair, prepare and redecorate

Doors: Old style timber door	Dated	Repair, prepare and redecorate
Cupboards: Cupboard with central shelf and timber doors	Dated	Repair, prepare and redecorate.
Sanitary Ware: 'P' shaped bath with shower W.C. Wash hand basin	Dated Dated Dated	Deep clean Deep clean Deep clean
Services: Factory insulated cylinder	Average	See Services Section.

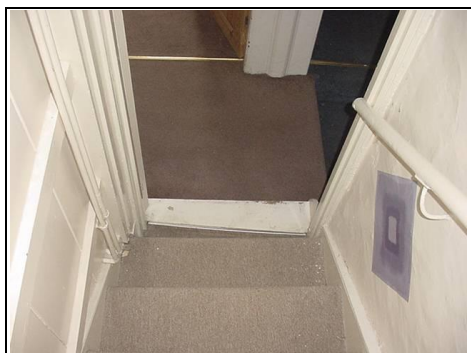
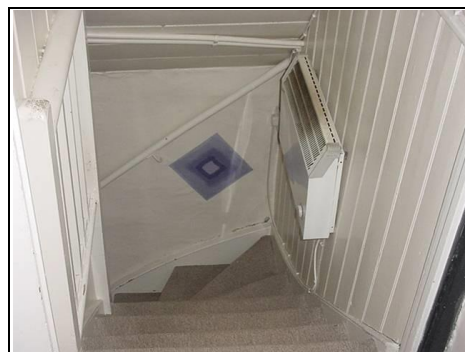
Stairs from First Floor to Top Floor

DESCRIPTION	CONDITION	ACTION REQUIRED
Ceilings: Painted Reduced head height, sloping ceiling	Dated	Remove transfers. Repair, prepare and redecorate
Walls: Painted and boarded with stick on blue square transfers	Dated	Remove transfers, repair, prepare and redecorate
Floors: Carpet	Worn	Clean or replace
Detailing: Doors:	Marked	Repair, prepare and redecorate
Services: Electric radiator GL2N	Advised not working	Test report required. Repair or replace.

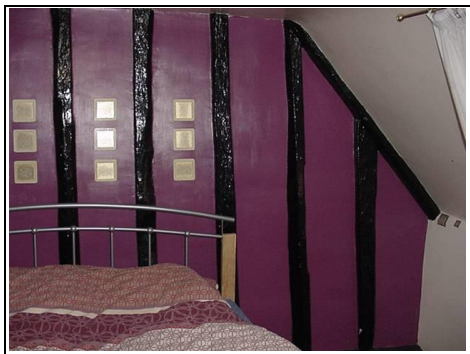
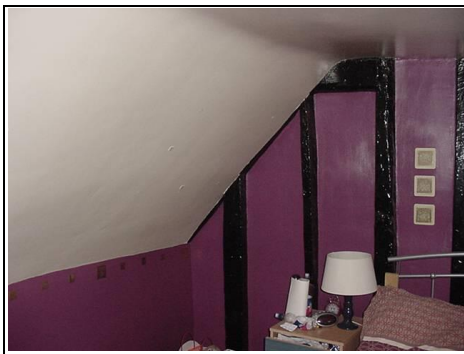
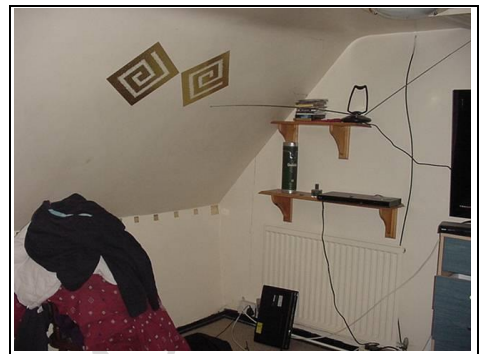
Bedroom Front Right

DESCRIPTION	CONDITION	ACTION REQUIRED
Ceilings: Painted plaster cathedral ceiling Access hatch to roof	Cracking to front left side Marked	Repair, prepare and redecorate
Walls: Painted purple with black timbers	Dated and marked with old fixing points	Repair, prepare and redecorate
Floors: Carpet	Deflection and uneven	Clean/replace carpet Remove carpet and investigate dampness, cut out any rot and make good.

<p>Detailing:</p> <p>Windows:</p> <p>Sliding sash window</p> <p>Doors:</p> <p>Black painted ledge and brace door</p>	<p>Wet rot and black mould</p>

<p>Dated</p>	<p>Clean. Repair, prepare and redecorate</p> <p>Repair, prepare and redecorate</p>
<p>Services:</p> <p>One internal single panel radiator</p> <p>Fire detector</p>	<p>Dated</p>	<p>Clean</p> <p>See test certificate section.</p>

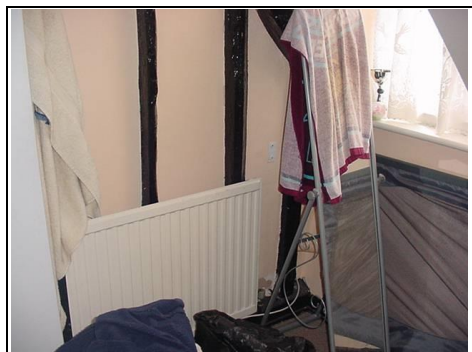
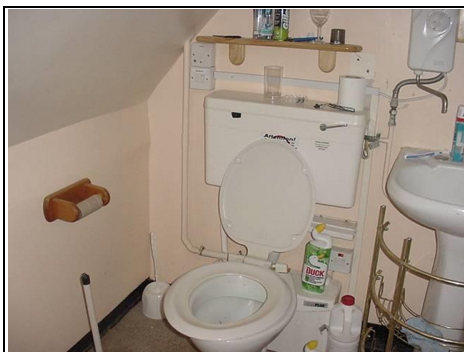
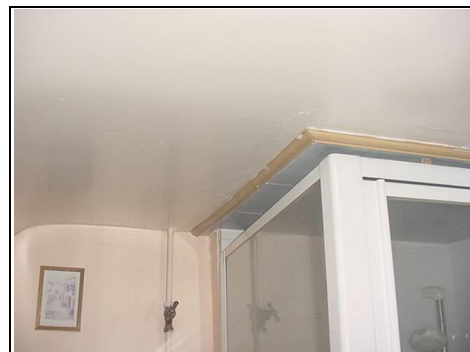
Walk through shower area

DESCRIPTION	CONDITION	ACTION REQUIRED
Ceilings: Painted cathedral ceiling	Hairline cracking	Repair, prepare and redecorate
Walls: Plasterboard and timbers	Dampness	Resolve dampness Repair, prepare and redecorate
Floors: Carpet	Dated Deflection and uneven	Clean or replace Remove carpet and investigate dampness, cut out any rot and make good.
Detailing: Windows: Sliding sash window	Wet rot and black mould	Clean. Repair, prepare and redecorate

Doors: Ledge and brace door	Marked	Repair, prepare and redecorate
Cupboards: Divided using cupboards		
Sanitary Ware: W.C. - saniflo Wash hand basin Instantaneous heating shower	Dated Dated Dated	Deep clean Deep clean Deep clean
Services: Internal radiator	Marked	Clean

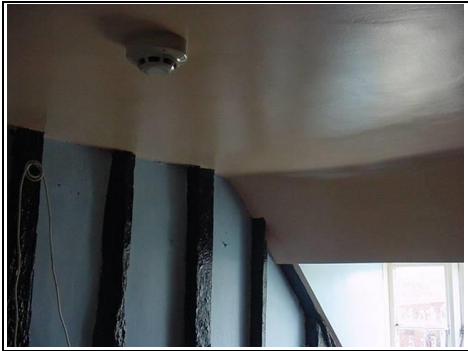
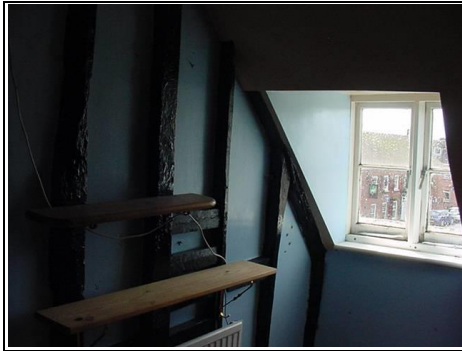
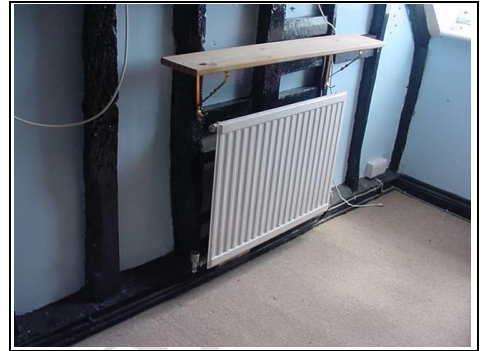
Bedroom Front Left

DESCRIPTION	CONDITION	ACTION REQUIRED
Ceilings:		
Painted cathedral ceiling	Dated and marked	Repair, prepare and redecorate
Dormer window	Signs of black mould	Clean.
Walls:		
Painted	Some popping of the plaster, impact damage and old fixing points	Repair, prepare and redecorate
Timber		Repair, prepare and redecorate.
Floors:		
Carpet	Dated	Clean or replace
	Deflection and uneven	Remove carpet and investigate dampness, cut out any rot and make good.

<p>Detailing:</p> <p>Windows:</p> <p>Sliding sash window</p> <p>Doors:</p> <p>Timber</p>	<p>Wet rot and black mould</p>

<p>Dated</p>	<p>Clean. Repair, prepare and redecorate</p> <p>Repair, prepare and redecorate</p>
<p>Services:</p> <p>Fire detector</p>		<p>See Services Section</p>

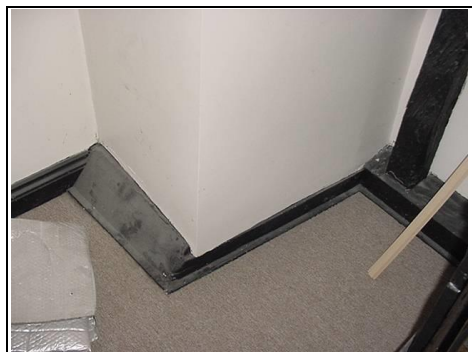
Rear Walk-through Room leading to first floor stairs

DESCRIPTION	CONDITION	ACTION REQUIRED
Ceilings: Painted cathedral ceiling	Dated	Repair, prepare and redecorate
Walls: Painted with stick on border Metal strap to timber	Minor dampness to rear wall	Resolve dampness Repair, prepare and redecorate
Floors: Carpet	Deflection and uneven	Remove carpet and investigate dampness, cut out any rot and make good.
Detailing: Windows: Double glazed	Black mould	Clean. Repair, prepare and redecorate

Doors: Ledge and brace door into room Modern ledge and brace door to stairway	Dated	Repair, prepare and redecorate
Services: Plastic water tank in cupboard   Red pressurised unit  		See Services Section. See Services Section.

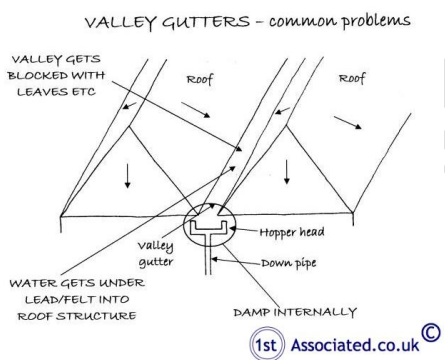
<p>Valley gutter</p>

<p>Valley gutter detail with sterling board. In our experience sterling board is not an ideal material for a valley gutter as it deteriorates when it gets damp and a WBP board should have been used or equivalent.</p>   <p>Extract not connected in toilets</p>

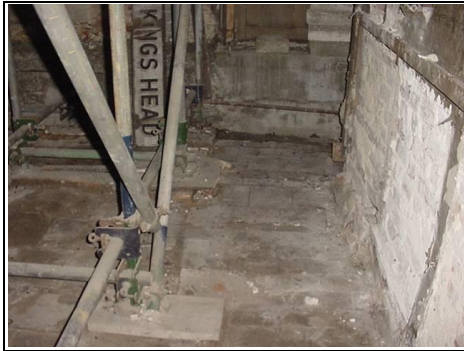
Front right held up with scaffolding

DESCRIPTION	CONDITION	ACTION REQUIRED
Scaffolding: The scaffold structure within the building we believe is giving support to the roof, valley gutters, first floor and some internal walls.		We need to know the history behind this and understand why it has been installed before we can comment further.
Ceilings: Many ceilings missing if not most.		Exclude from lease

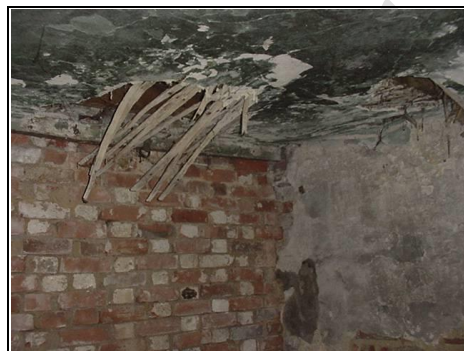
Rear left Room, lath and plaster coming down due to old age and dampness

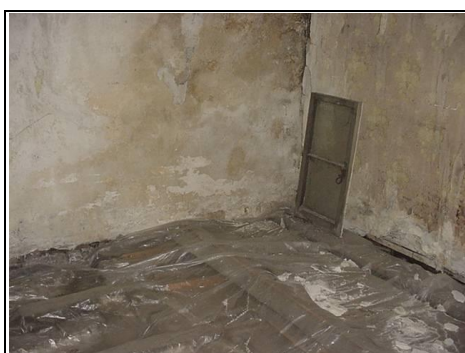
Rear middle room

<p>Many ceilings missing if not most. Damaged in some cases by water coming in through the roof</p> <p>Ceiling in middle rear room</p>
