PUB SCHEDULE OF CONDITION

XXXXXXXXXXXXXXXXXX

We have been instructed to inspect and prepare a Schedule of Condition for xxxxxxxxxxxxxxxxxxxx. We inspected the property on xxxxxxxx.

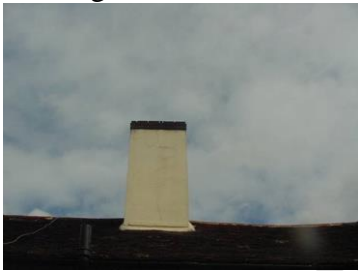
DESCRIPTION	CONDITION	ACTION REQUIRED
<p>Chimneys:</p> <p>Chimney One Central rendered chimney painted with a cement render and cement flashing</p>

<p>Allowing some dampness in, visible within the roof space.</p>	<p>Make watertight</p>
<p>Chimney Two Right brick chimney – brick built with one chimney pot, braced at high level with an aerial.</p>

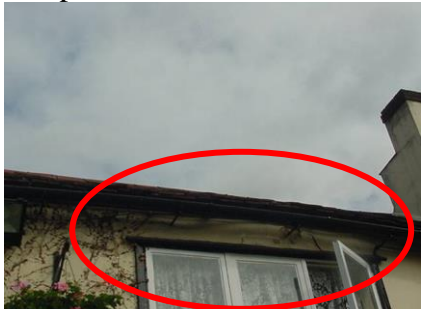
<p>Joint high level inspection with the landlord's surveyor to be carried out prior to signing of the lease or legal completion of the lease from high level cherry picker or equivalent.</p> <p>ACTION REQUIRED: Recommend exclude from the lease.</p>
<p>Hopperheads, Gutters and Downpipes:</p> <p>Plastic and cast iron gutters and downpipes</p> <p>Cast iron soil and vent pipe</p>	<p>Rusting cast iron and debris filled gutters/poorly functioning gutters.</p> <p>Signs of long term dampness to the front rooms we believe relates to displaced guttering/poorly functioning guttering or defects within the roof.</p> <p>Poorly functioning guttering/roof allowing dampness in</p>

<p>Make watertight by existing tenants/landlord.</p> <p>ACTION REQUIRED: Recommend exclude from the lease.</p>

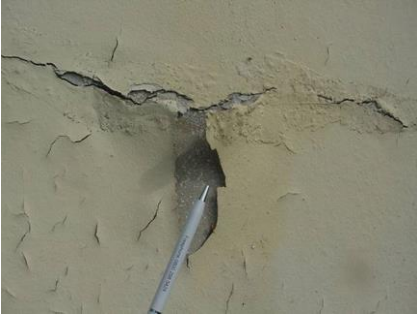
<p>Walls:</p> <p>Painted render.</p> <p>Cement based render Affecting any timbers forming the structure of the building.</p> <p>Peeling paint and render visible</p>

<p>Repair/removal of existing paint. Apply correct paint.</p>
---	---	---

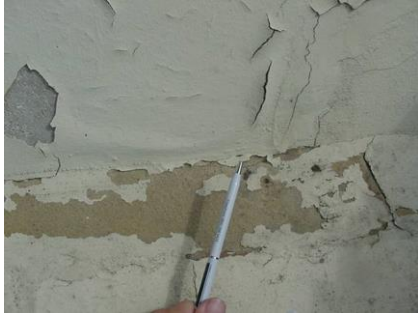
<p>Dated</p> <p>Original paint applied to distemper and general loss of bonding and flaking in many areas.</p>

<p>Paint peeling at low level relating to high ground level and dampness coming into the property as well as the previous mentioned issues with regards to paint</p>

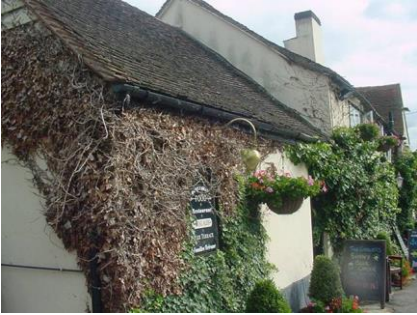
<p>Ivy:</p> <p>Large areas of ivy some of which we can see has recently been cut back as walls have ivy marks on them</p> <p>Deterioration and damage from ivy</p>

<p>General deterioration and damage from the ivy</p> <p>Ivy</p>

<p>Remove ivy from building and repair any damage.</p> <p>If ivy to be reinstated we would recommend that it is on trellis work and kept away from the walls.</p>
<p>External Detailing:</p> <p>Windows:</p> <p>Painted timber casement windows</p> <p>Doors:</p> <p>Timber doors</p> <p>Signage:</p>	<p>Dated</p> <p>Dated</p> <p>Dated</p>	<p>Repair, prepare and redecorate.</p> <p>Repair, prepare and redecorate</p> <p>Repair, prepare and redecorate</p>

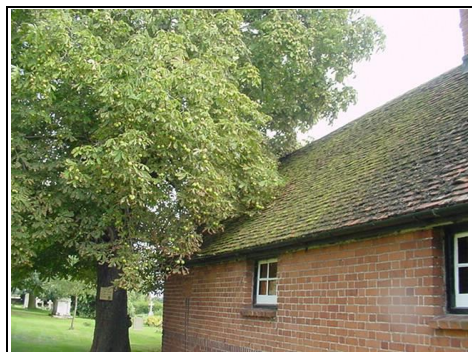
Tree overhanging and moss
rear left

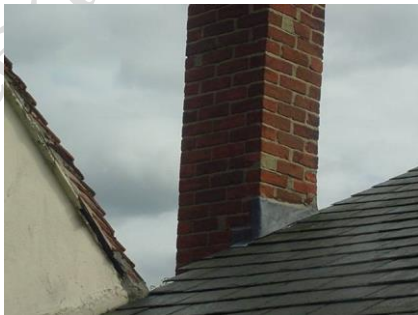
Areas of cement repairs to brickwork. Dampness coming in at base.

Make appropriate repairs and make watertight.
Chimney Four: Rear left chimney

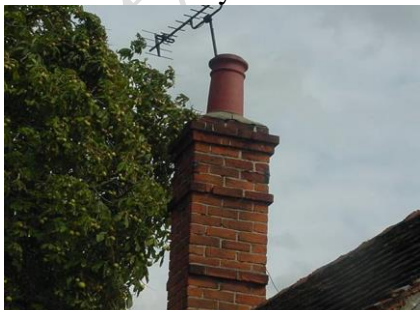
Repairs to brickwork.	Minor repointing.

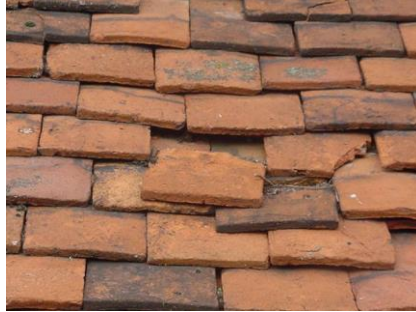
Undulating, broken and missing tiles allowing dampness in.

Spalling to tiles

Joint high level inspection with the landlord's surveyor to be carried out prior to signing of the lease or legal completion of the lease from high level cherry picker or equivalent.

ACTION REQUIRED:
Recommend exclude from the lease.

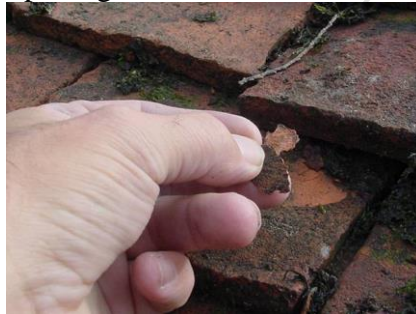
Moss and poor repairs to tiles

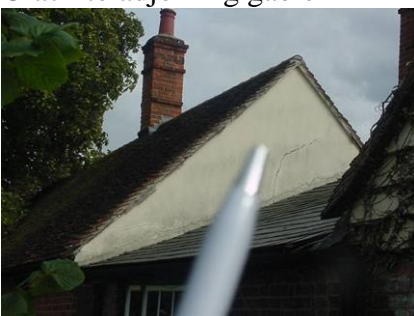
<p>Walls:</p> <p>Shiplap boarding</p>  	<p>Paint flaking and deteriorating</p>  	<p>Repair, prepare and redecorate.</p>
<p>Painted render</p>	<p>Crack to adjoining gable</p>

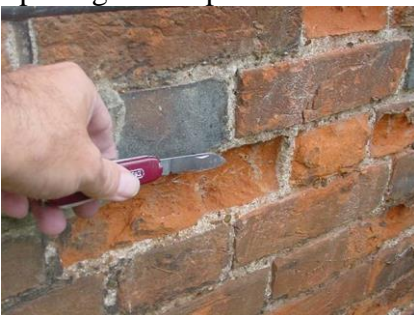
<p>Repair, prepare and redecorate.</p>
<p>Brickwork</p> <p>Red bricks in a Flemish bond pattern wrongly repointed in a cement mortar</p> <p>Wrongly repointed in cement mortar</p>  	<p>Spalling to brickwork</p>   <p>Spalling close up</p>

<p>Remove cement mortar and repoint in a lime based mortar.</p>

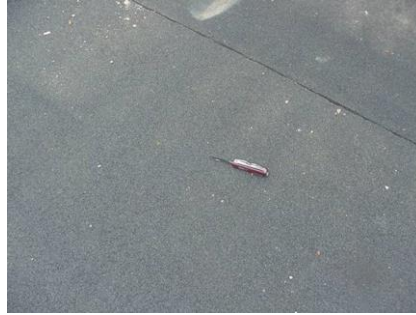
Lack of fall to flat roof

Monitor roof and cut back ivy.

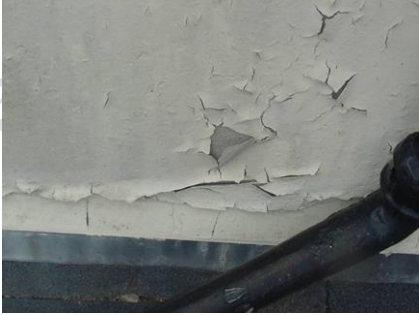
<p>Flaking paint to rear of property</p>

<p>Paint coming off wall</p>

<p>Remove existing paint and carry out associated repairs, prepare and redecorate.</p>

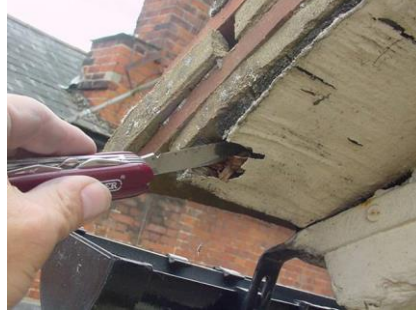
Rot to verge board on right side
which we believe relates to long
term leaking gutters

Resolve leaking gutters, repair, prepare and redecorate.

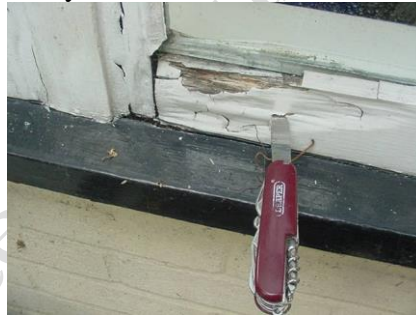
Dated.
Rot to window of rear entrance
lobby

Repair, prepare and redecorate.

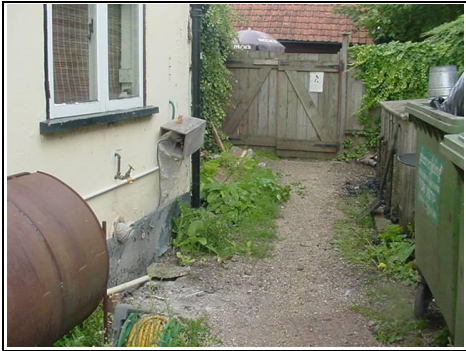
Joins residential property and
used as bin store

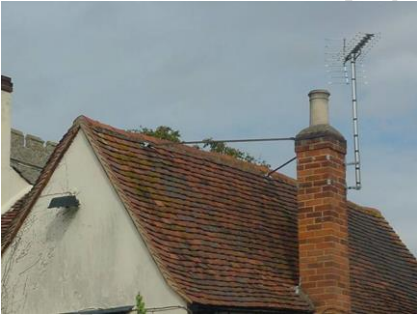
Average.	Confirmation required that the repair work/re-roofing is acceptable for the building/conservation officers.

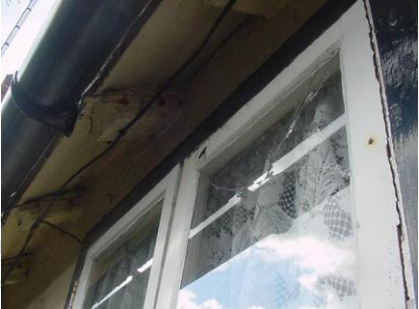
<p>Broken window pane which could indicate movement in property</p>

<p>Repair, prepare and redecorate.</p> <p>Replace glass.</p>
---	---	--

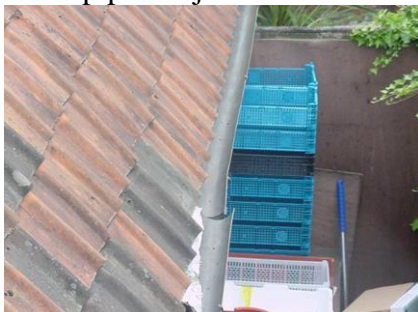
Remove and ensure roof is left watertight.
Gutters and Downpipes: Plastic	Leaking to rear of prep area making wall damp Downpipe not joined

General overhaul of guttering required. Ensure all gutters are watertight and falling towards the downpipe and clear. Repair downpipes and secure as necessary, ensure downpipes are clean and clear.

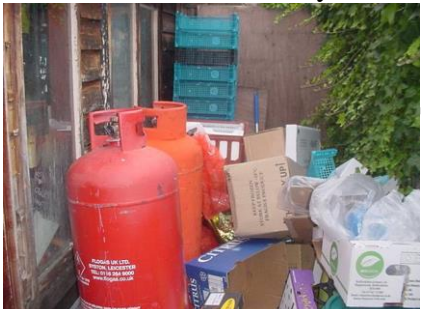
<p>External Detailing:</p> <p>Windows: Timber</p> <p>Doors: Timber</p> <p>External area:</p>	<p>Dated</p> <p>Dated</p> <p>Rubbish stored externally</p>

<p>Repair, prepare and redecorate.</p> <p>Repair, prepare and redecorate.</p> <p>General clearing of stored materials is required around the building and within the building</p>
--	--	---

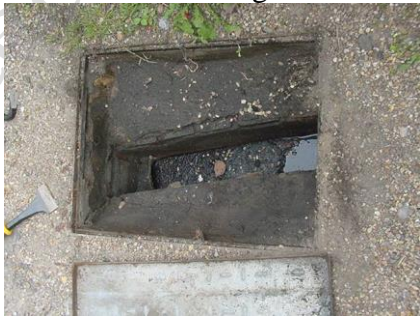
<p>General repointing required and cutting back of trees, ivy, etc.</p>
<p>Drainage</p>	<p>Blocked drain on right side</p>

<p>Second drain on right side</p>

<p>Clear.</p> <p>Recommend close circuit tv camera report.</p>

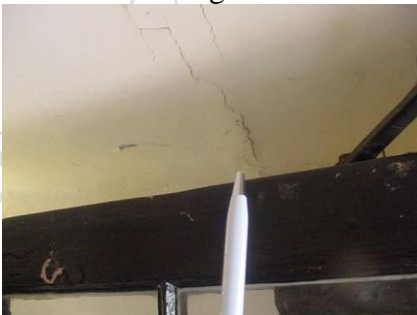
Rear of corridor

DESCRIPTION	CONDITION	ACTION REQUIRED
Ceilings: Painted	Dated Hairline cracking

Repair, prepare and redecorate.
Walls: Painted Timber dado	Dated. Marked and dated.	Repair, prepare and redecorate.
Floors: Quarry tiles Stone floor	Ingrained dirt. Ingrained dirt	Deep clean Deep clean.

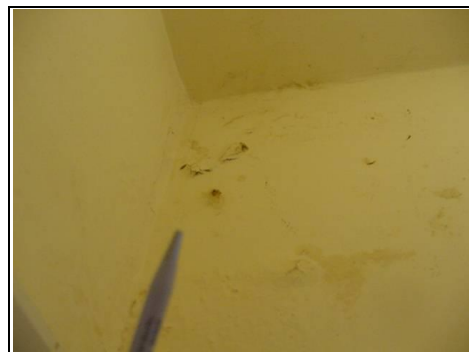
Dampness

DESCRIPTION	CONDITION	ACTION REQUIRED
Ceiling: Painted	Dated Hairline cracking	Repair, prepare and redecorate.
Walls: Painted Tiles to approx 1.5m	Dampness, hairline cracking from damp from roof above.

Parts of tiles painted over	Resolve dampness. Repair, prepare and redecorate.
Floors: Quarry tile	Worn	Deep clean.

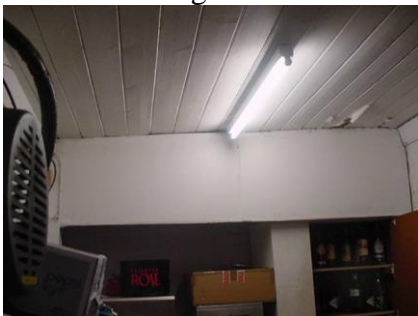
DESCRIPTION	CONDITION	ACTION REQUIRED
Ceilings: Boarded ceiling

Clean. Repair, prepare and redecorate
Walls: Painted brickwork		Repair, prepare and redecorate
Floors: Concrete	Deteriorating	Make good and seal with a floor paint.

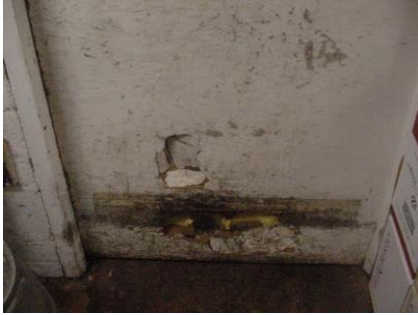
Detailing: Doors: Timber	Damaged

Replace
Services: Extract fan

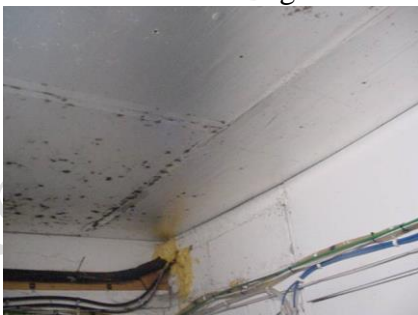
<p>Black mould to ceiling</p>

<p>Clean. Repair, prepare and redecorate.</p>

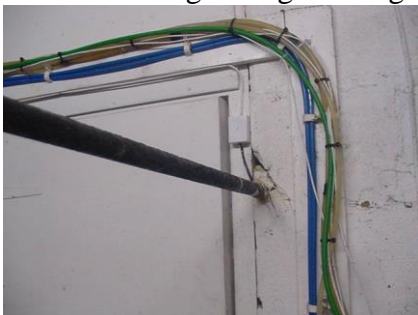
<p>Tie bar running through ceiling</p>

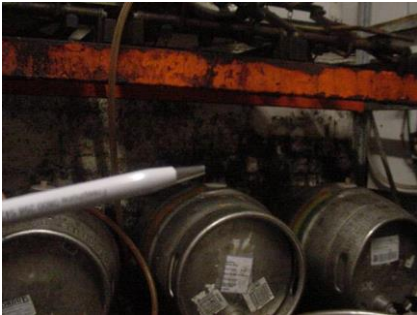
<p>Walls:</p> <p>Painted brickwork</p>	<p>Black mould</p>

<p>Paint coming off walls</p>	<p>Clean. Repair, prepare and redecorate.</p>
<p>Floors:</p> <p>Exposed aggregate concrete floor</p>	<p>Deteriorating</p>	<p>Make good and seal with a floor paint.</p>
<p>Detailing:</p> <p>Doors:</p> <p>Door to bar</p>	<p>Dated and marked</p>	<p>Repair, prepare and redecorate or replace.</p>
<p>Services:</p> <p>Piping</p>		<p>See Services section at rear of report.</p>

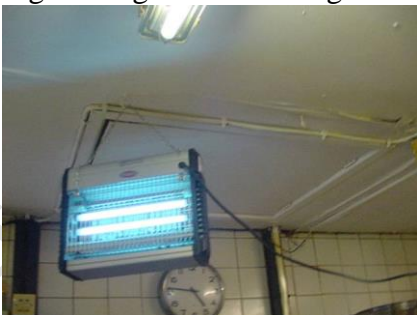
DESCRIPTION	CONDITION	ACTION REQUIRED
Ceiling: Painted	Ingrained grease to ceiling

Deep clean Repair, prepare and redecorate.
Walls: Tiled floor to ceiling	Old fixing points	Make good and deep clean.
Floors: Altro style flooring	Openings in altro floor near freezer room	Deep clean
Detailing: Doors: Timber	Missing handle	Repair/replace door.

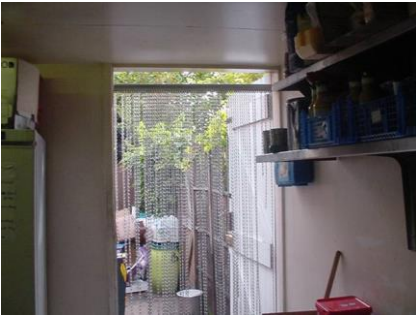
<p>Handle missing</p>	<p>Replace handle, repair, prepare and redecorate.</p>
<p>Equipment:</p> <p>Stainless steel units</p>		<p>The equipment has not been inspected. We have assumed that the equipment meets the appropriate Local Authority approval and standards.</p>

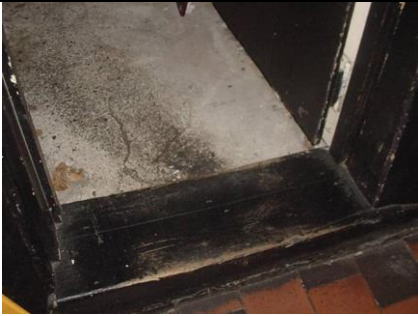
Entrance dirty and dated	Repair altro style flooring

Detailing: Windows: Timber Doors: Timber	Dated Marked	Repair, prepare and redecorate. Repair or replace.

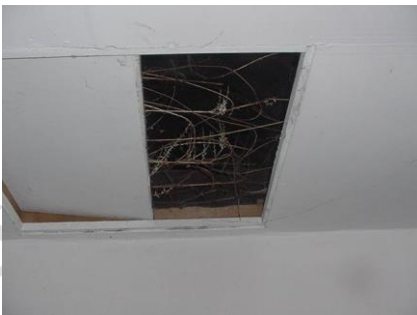
DESCRIPTION	CONDITION	ACTION REQUIRED
Ceilings: Painted plaster	Plant life in roof

Remove plant life
Walls: Painted	Dampness

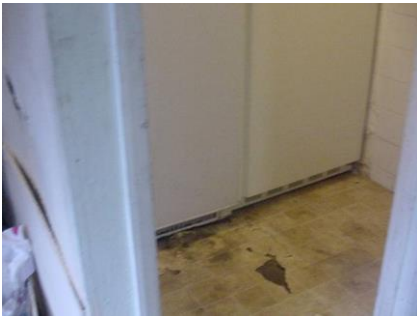
DESCRIPTION	CONDITION	ACTION REQUIRED
Ceilings: Painted	Dated	Repair, prepare and redecorate
Walls: Painted	Dated	Repair, prepare and redecorate
Floors:	Deterioration

Repair/replace
Detailing: Doors: Timber	Dated	Repair, prepare and redecorate

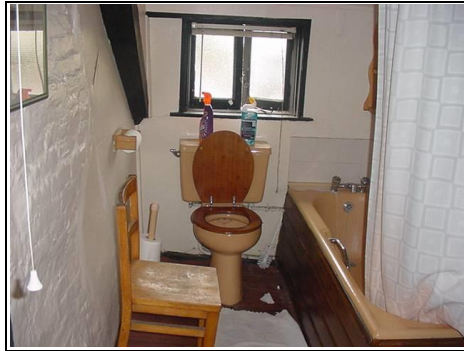
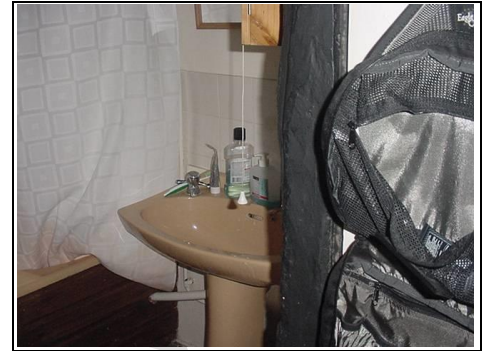
Bathroom

DESCRIPTION	CONDITION	ACTION REQUIRED
Ceilings: Vaulted ceiling Feature timbers	Dated	Repair, prepare and redecorate
Walls: Painted plaster Painted brickwork	Dated	Repair, prepare and redecorate
Floors: Vinyl/Laminate style flooring	Worn	Replace
Detailing: Windows: Timber	Dated	Repair, prepare and redecorate

Doors:		
Ledge and brace door	Dated	Repair, prepare and redecorate
Sanitary Ware:		
Peach bathroom suite with shower within bath	Dated	Replace

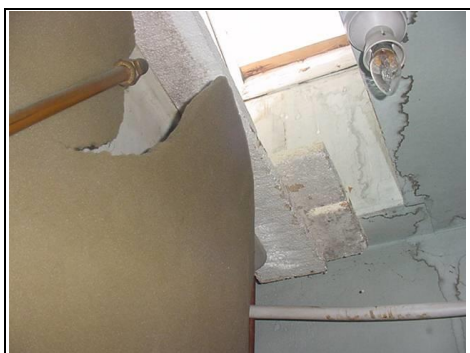
Airing cupboard rear

Damp coming through roof window

DESCRIPTION	CONDITION	ACTION REQUIRED
Ceilings: Roof window Painted	Leak from roof window and valley gutter

Resolve leak Repair, prepare and redecorate
Walls: Painted fibreboard	Damage from ceiling and pipework

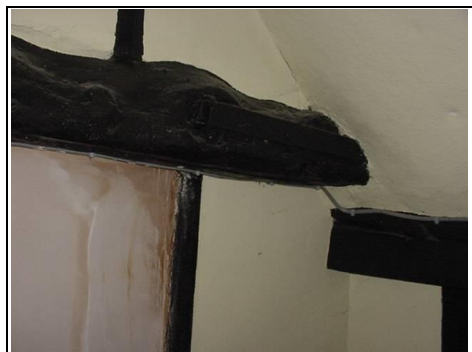
Hallway/Landing/Lobby before front right room

Dampness

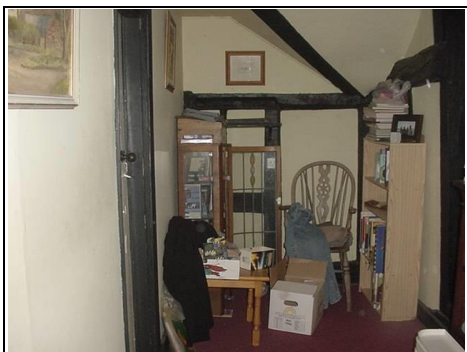
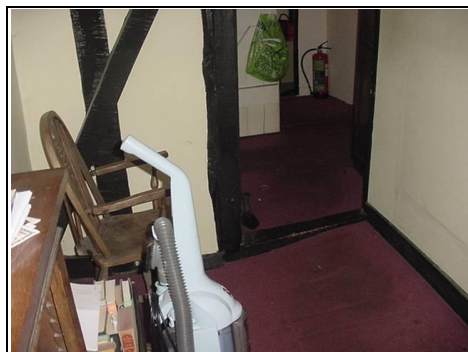
Hallway

DESCRIPTION	CONDITION	ACTION REQUIRED
Ceilings: Vaulted ceiling Fireboard type ceiling	Dated	Repair, prepare and redecorate
Walls: Feature timbers Wrought iron tie bars in corners of corridor	Dampness from valley gutter

Repair, prepare and redecorate
Floors: Carpet	Undulating floor

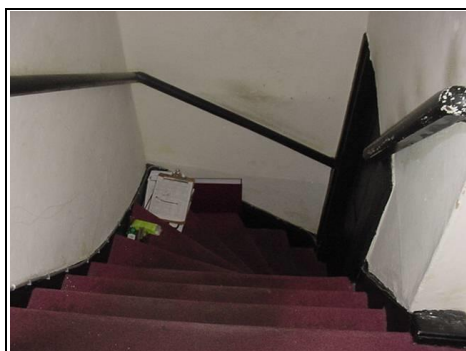
Main stairs to rear right

DESCRIPTION	CONDITION	ACTION REQUIRED
Ceilings: Vaulted	Dated	Repair, prepare and redecorate
Walls: Painted embossed wallpaper	Dated Requires one hour fire resistance lining	Repair, prepare and redecorate
Floors: Carpet	Dated Undulating/considerable drop	Deep clean or replace. Level
Detailing: Windows: Timber	Dated	Repair, prepare and redecorate.
Doors: Timber	Dated	Repair, prepare and redecorate

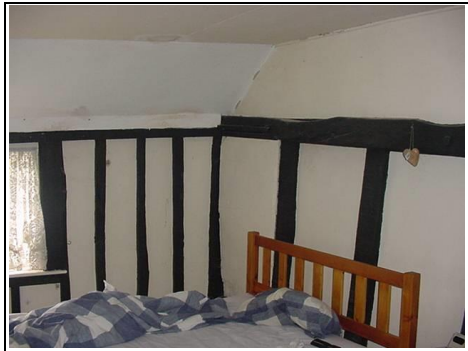
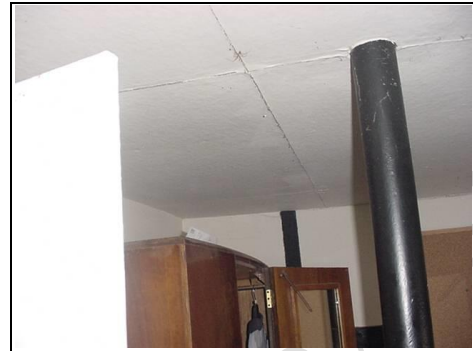
Master bedroom front left (Marked Number 2)

Support pole in master bedroom

DESCRIPTION	CONDITION	ACTION REQUIRED
Ceilings: Vaulted ceiling with fibreboard	Leak adjacent to the window Poorly clad fibreboard ceiling not finished	Resolve dampness Repair, prepare and redecorate
Walls: Feature timbers with paintwork between Wrought iron tie bars to corners Support pole behind door	Dated	Repair, prepare and redecorate
Floors: Carpet	Undulating	
Detailing: Windows: Timber casement window	Dated	Repair, prepare and

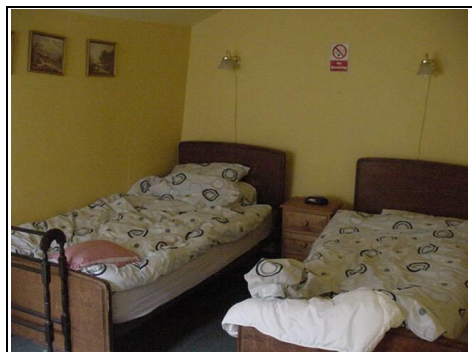
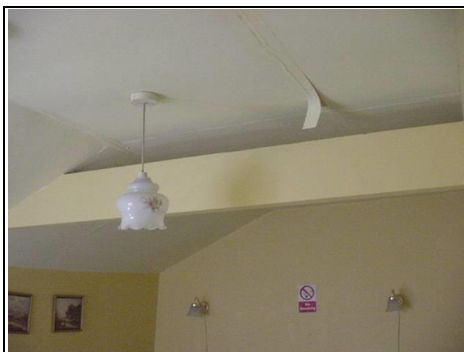
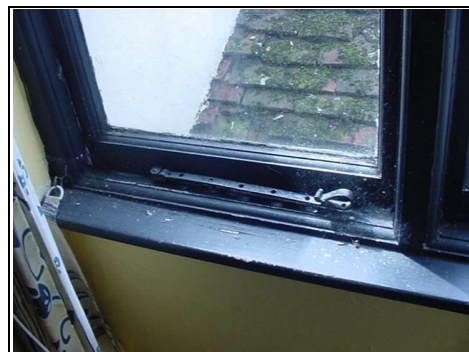
Bedroom two rear left (left extension)

Window to bedroom two

DESCRIPTION	CONDITION	ACTION REQUIRED
Ceilings: Vaulted Plasterboard taped One roof beam visible	Dated	Repair, prepare and redecorate
Walls: Painted	Dated	Repair, prepare and redecorate
Floors: Carpet	Undulating	
Detailing: Windows: Window to valley gutter Casement window	Dated and rotting	Repair, prepare and redecorate

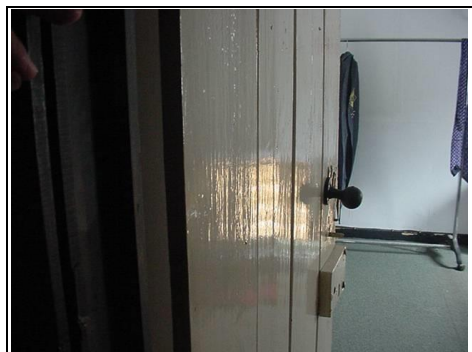
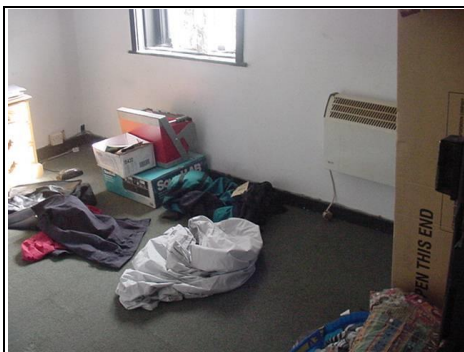
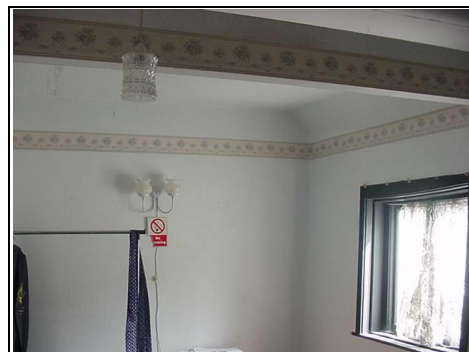
Bedroom three rear right (left extension)

DESCRIPTION	CONDITION	ACTION REQUIRED
Ceilings: Painted plasterboard	Dated	Repair, prepare and redecorate
Walls: Painted plasterboard dry lined with frieze	Dampness

Repair, prepare and redecorate
Floors: Carpet	Slight slope	
Detailing: Windows: Casement windows to right side	Dated	Repair, prepare and redecorate

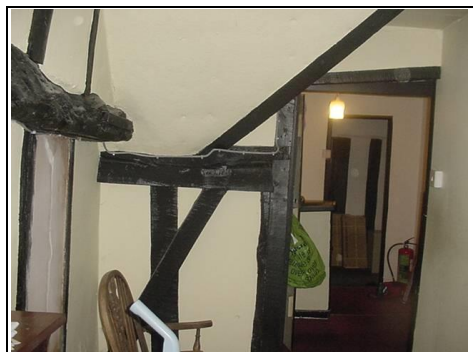
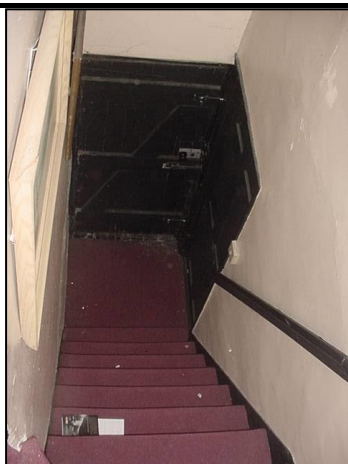
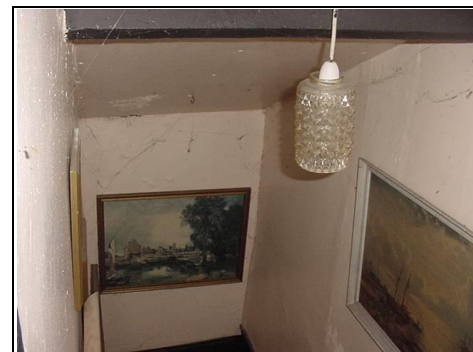
Second corridor/staircase left

Old style fire exit

DESCRIPTION	CONDITION	ACTION REQUIRED
Ceilings: Vaulted	Dated	Repair, prepare and redecorate
Walls: Painted	Dated Requires one hour fire resistance lining	Repair, prepare and redecorate
Floors: Carpet	Average	
Detailing: Doors: Timber	Dated	Repair, prepare and redecorate

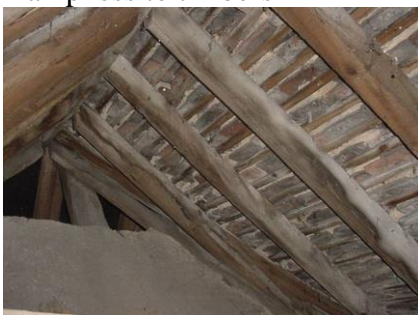
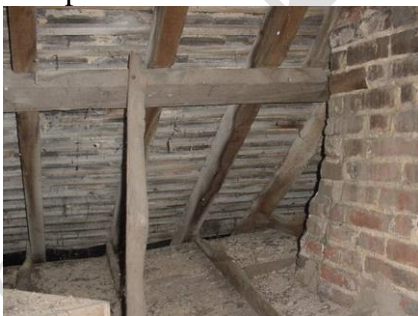
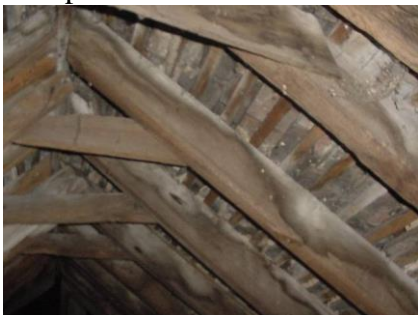
Main Roof – Internal (right)

DESCRIPTION	CONDITION	ACTION REQUIRED
Roof Access: Access from first floor corridor right hand side	No ladder, lights or floorboards, viewed by torchlight.	
Roof Structure: Cut timber roof with amendments		
Roof Timbers: Dampness to timbers

Dampness to timbers

Dampness in timbers

Make watertight Repair damaged and deteriorating timbers

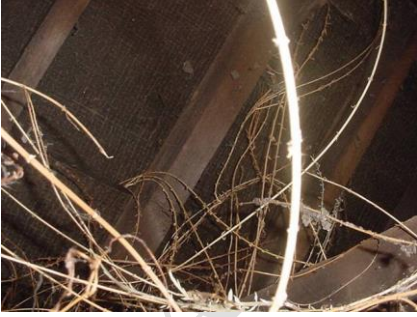
Plant growing within roof space Remove plants	
Protective Underlayer: Protective underlayer
