SCHEDULE OF CONDITION

Public House Surrey

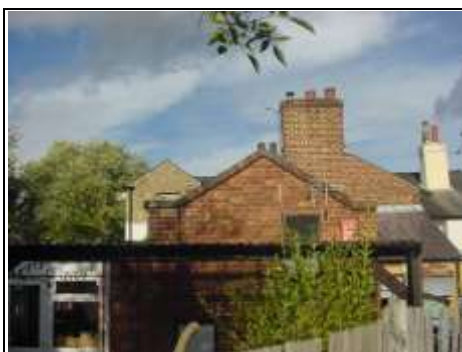
REAR ELEVATION

DESCRIPTION	CONDITION	ACTION REQUIRED
Chimneys: Rear view of left hand chimney with one flue and one chimney pot

Roof in poor condition Slate roof is in poor condition with deterioration and displaced slates. In need of a general overhaul and making watertight. Associated detailing such as the flashings need to be checked.

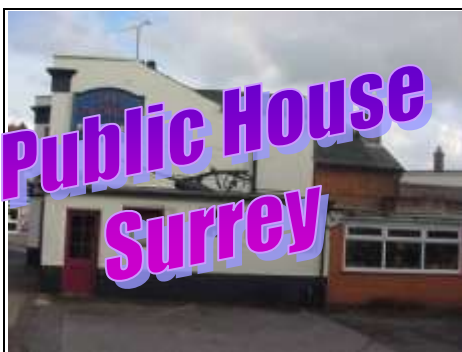
RIGHT HAND EXTERNAL ELEVATION

DESCRIPTION	CONDITION	ACTION REQUIRED
<p>Roofs:</p> <p>Main roof:</p> <p>Pitched, clad with slate</p> <p>Parapet walls:</p> <p>Rendered</p> <p>Slate roof over kitchen:</p>

<p>Slate roof over kitchen</p>	<p>Slate roof is in poor condition with deterioration and displaced slates. In need of a general overhaul and making watertight. Associated detailing such as the flashings need to be checked.</p>

<p>Running gulley allowing dampness to base of wall</p>	<p>Resolve dampness to walls Repair, prepare and redecorate.</p> <p>Resolve running gulley problems</p>
<p>External Detailing:</p> <p>Windows:</p> <p>Timber windows painted</p> <p>Metal windows painted,</p> <p>Plastic windows to conservatory</p>		<p>Repair, prepare and redecorate.</p>

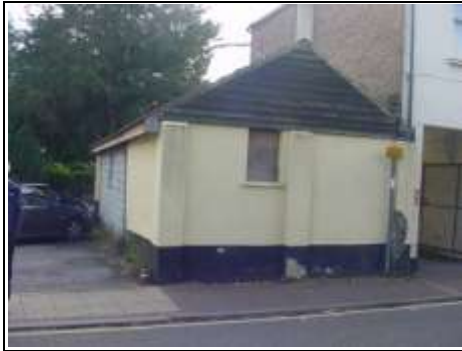
OUTBUILDING - EXTERNAL

DESCRIPTION	CONDITION	ACTION REQUIRED
Roofs: Pitched roof clad in concrete tiles Hidden valley gutter to right hand side causing dampness into adjoining property

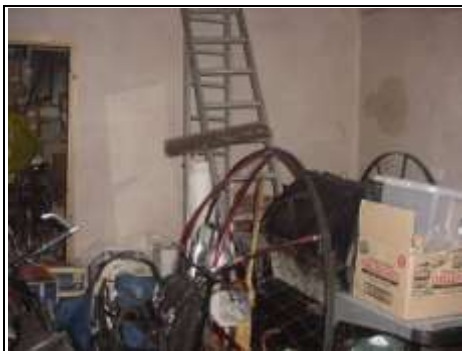
OUTBUILDING – INTERNAL
Generally stored items – limited view and rear not accessed

DESCRIPTION	CONDITION	ACTION REQUIRED
Ceilings: Modern gypsum plaster		Repair, prepare and redecorate.
Walls: Modern gypsum plaster Dry lined wall to left hand side

Dampness	Resolve dampness issues. Repair, prepare and redecorate.
Floors: Concrete		Carpet
Detailing: Windows:		Add windows
Services:	We are advised that no services have been installed.	
Stored Items: Full of stored items, owner advised were owned by third party.		Clear.

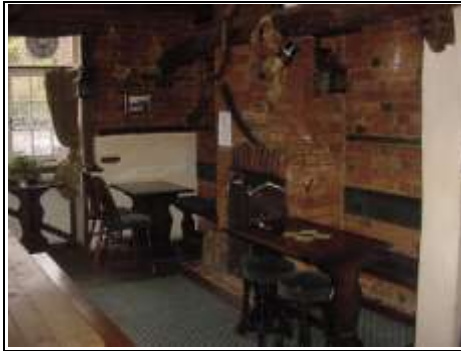
Left hand side of L shaped bar

DESCRIPTION	CONDITION	ACTION REQUIRED
Ceilings: Timber feature beams, painted panels between

Dated.	Repair, prepare and redecorate.
Walls: Exposed brickwork Painted render	Dated. Dampness found.	Resolve dampness. Repair, prepare and redecorate.
Floors: Carpet Wood block section to far left hand corner	Worn	Clean and/or replace. Sand and re-stain

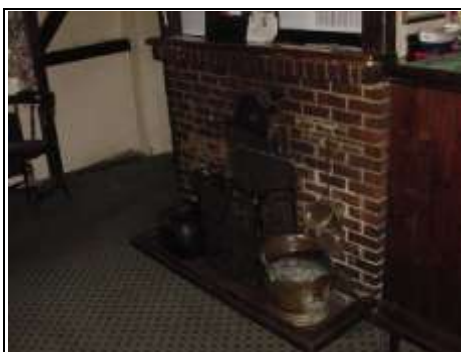
Bar right hand side near toilets

DESCRIPTION	CONDITION	ACTION REQUIRED
Ceilings: Timber feature beams, painted panels between

Dated.	Repair, prepare and redecorate
Walls: Painted render	Dated. Dampness found.	Resolve dampness. Repair, prepare and redecorate
Floors: Carpet	Worn	Clean or replace.

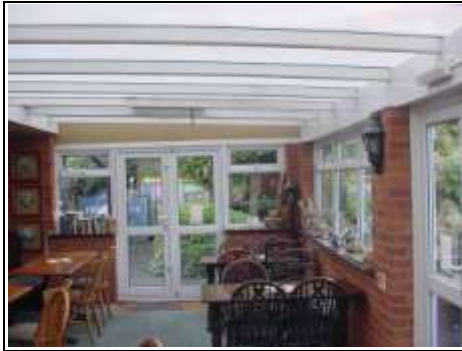
Conservatory

DESCRIPTION	CONDITION	ACTION REQUIRED
Ceilings: Polycarbonate (right hand side)

Polycarbonate roof	Clean
Walls: Exposed brickwork Our inspection was limited by bench seating		Resolve dampness.
Floors: Carpet	Worn	Clean or replace.
Joinery: Windows Plastic double glazed Doors: Plastic double glazed		Clean Clean
Services: See Services section

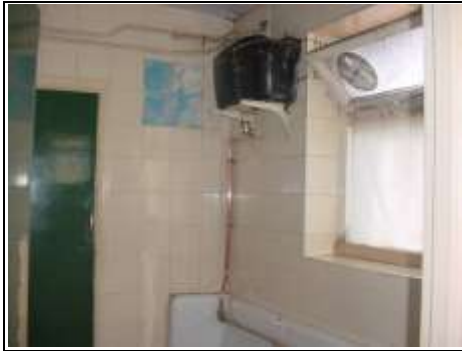
Gentlemen's Toilets

DESCRIPTION	CONDITION	ACTION REQUIRED
Ceiling: Painted	Pattern staining from flat roof above	Repair, prepare and redecorate.
Walls: Floor to ceiling tiles

Dampness found within walls. Tiles missing and blown tiles due to dampness to walls	Resolve dampness. Replace missing tiles, clean and re-grout. General deep clean.
Floors: Red quarry tiles

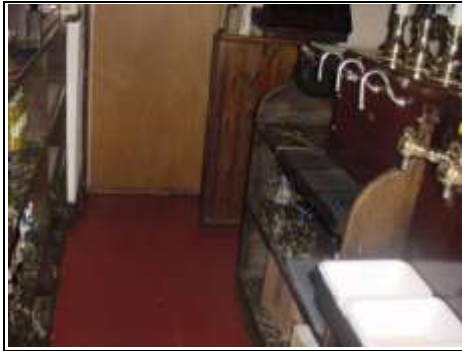
Bar Servery Area

DESCRIPTION	CONDITION	ACTION REQUIRED
Ceiling: Old sign with embossed paper behind		Clean sign and redecorate ceiling.
Walls: Painted	Dated	Repair, prepare and redecorate.
Floors: Altro style flooring

Worn	Replace or repair.
Detailing: Formica bar worn to right hand side

Shelving to bar worn	Replace shelving
Services: See Services Section.

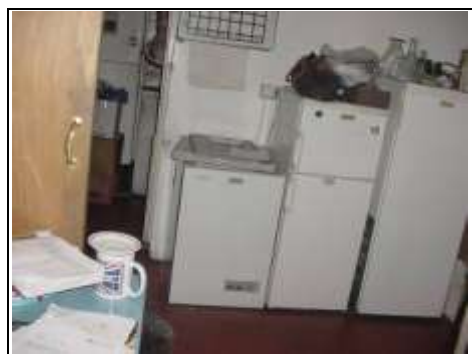
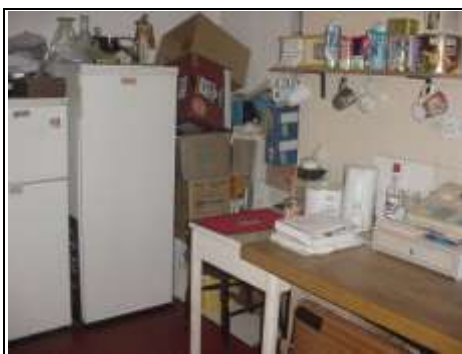
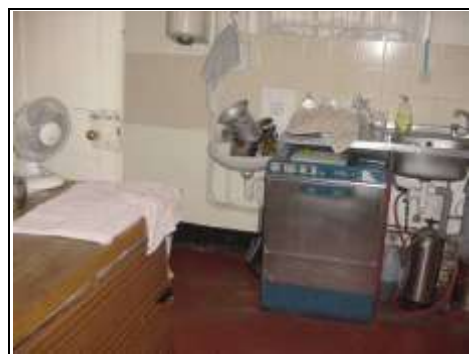
Preparation area behind bar (accessed from bar area)

DESCRIPTION	CONDITION	ACTION REQUIRED
Ceilings: Painted plaster	Dated.	Repair, prepare and redecorate
Walls: Painted	Dated.	Repair, prepare and redecorate
Floors: Altro style flooring	Worn in areas.	Repair and deep clean. Replace as necessary.
Joinery: Windows Doors: Two veneer doors Painted door leading to python store		Repair, prepare and redecorate Repair, prepare and redecorate
Kitchen Equipment: Wash hand basin Stainless steel sink with notice 'Designated for washing up' The catering equipment has not been inspected, you should seek expert advice. We have assumed that the catering equipment meets Local Authority approval and is appropriate for use. We would recommend a meeting with the Local Authority prior to taking over the lease.

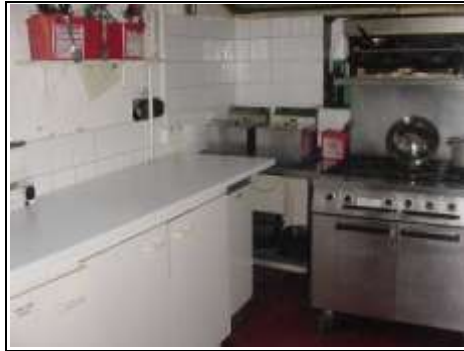
Catering kitchen cooking area

DESCRIPTION	CONDITION	ACTION REQUIRED
Ceilings: Textured paint

Part of ceiling paintwork coming down	Repair, prepare and redecorate
Walls: Floor to ceiling tiling Painted to left hand wall

Ingrained dirt and grease	Signs of movement noted and investigated by landlord.

Dampness coming through, generally greased and stained

Raking hairline crack to inner door	Resolve damp issues. Deep clean, clean grout and re-grout. Repair, prepare and redecorate.

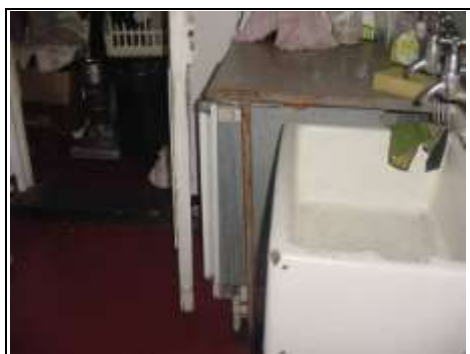
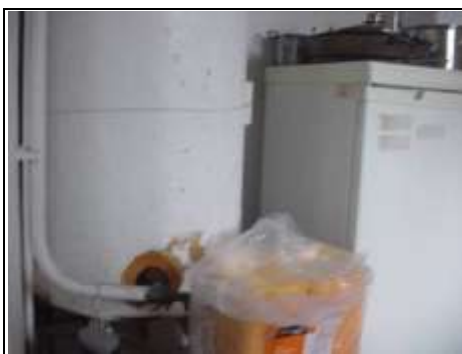
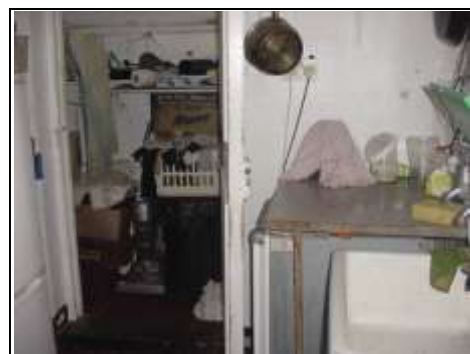
Food Store – fridges and hot water cylinder

DESCRIPTION	CONDITION	ACTION REQUIRED
Ceilings: Painted Exposed light	Stained, hairline cracking	Repair, prepare and redecorate
Walls: Painted Could not access	Dampness Hairline cracking	Resolve dampness. Repair, prepare and redecorate
Floors: Altro style flooring	Ingrained dirt	Clean and/or replace
Joinery: Windows: One metal window Doors		Repair, prepare and redecorate Repair, prepare and redecorate
Kitchen Equipment: Belfast sink		
Services: See Services section

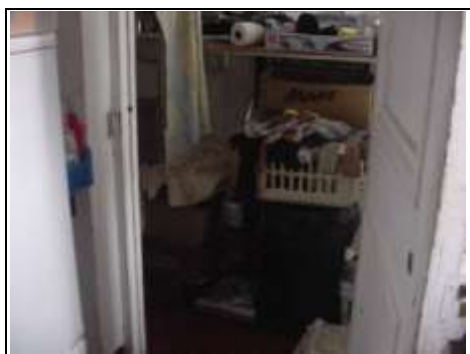
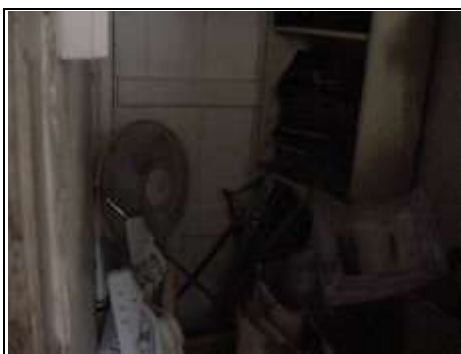
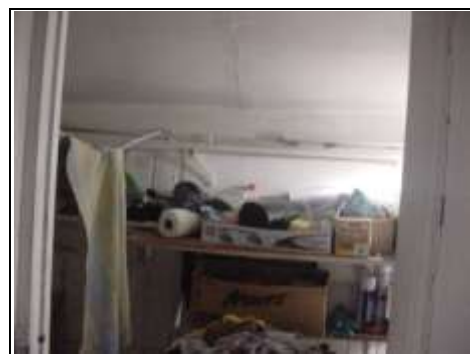
Laundry Room in lean-to

DESCRIPTION	CONDITION	ACTION REQUIRED
Ceilings: Painted	Dated	Repair, prepare and redecorate
Walls: One brick thickness Boarded walls to left, rear and front Painted brickwork to right hand side	Dampness Flaking	Resolve dampness. Repair, prepare and redecorate
Floors: Altro style flooring Tiled	Dated and damaged	Clean and/or replace Clean
Joinery: Windows: One timber window with Georgian wire polish plate glass Doors: Timber panel door		Repair, prepare and redecorate Repair, prepare and redecorate
Services: See Services section

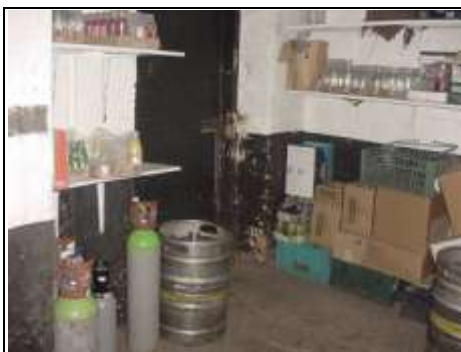
Cellar

DESCRIPTION	CONDITION	ACTION REQUIRED
Ceilings: Painted fibreboard

Dated, stained, dirty	Repair, prepare and redecorate.
Walls: Painted

Damp	Resolve dampness. Repair, prepare and redecorate.

<p>Floors:</p> <p>Concrete</p>   <p>Damaged floor</p>	  <p>Cracked and undulated Advised there is high water table level which does flood cellar</p>	<p>Level and screed, paint floor</p>
<p>Joinery:</p> <p>Doors</p>	  <p>Painted door to cellar</p>	<p>Repair, prepare and redecorate.</p>
<p>Services: See Services section</p>   <p>Electric fuse board – IEE test and report required.</p>   <p>Sump pump This has not been tested. We are aware from discussions that the property does flood.</p>   <p>Belfast sink</p>

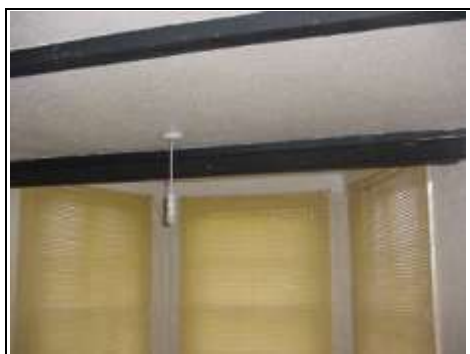
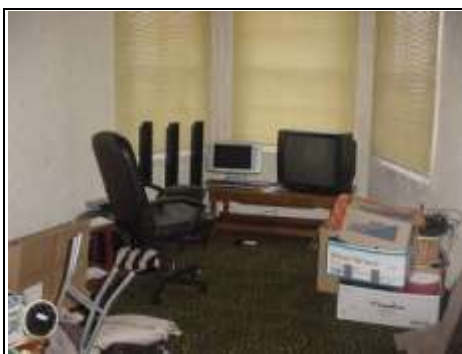
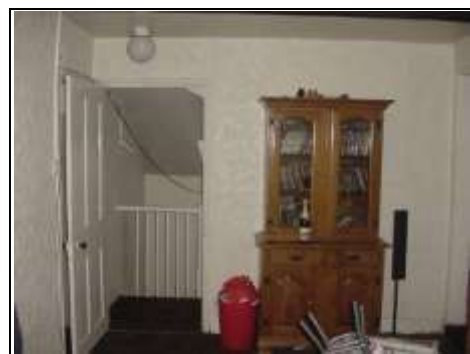
Lounge area

DESCRIPTION	CONDITION	ACTION REQUIRED
Ceilings: Timber feature beams, painted panels between	Dated.	Repair, prepare and redecorate.
Walls: Chipboard embossed paper	Dampness coming in via side of brick chimney	Repair, prepare and redecorate.
Floors: Carpet	Worn	Clean or replace.
Detailing: Windows: Bay window Doors:	Dated	Repair, prepare and redecorate.
Services: Brick exposed fireplace

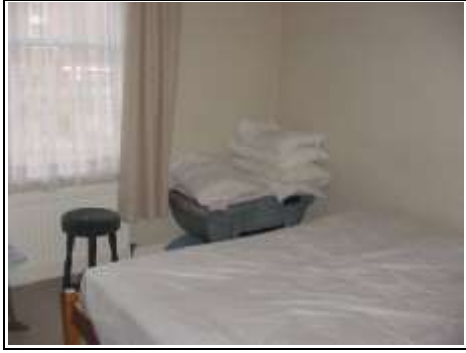
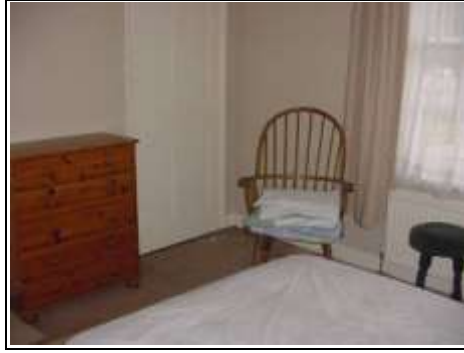
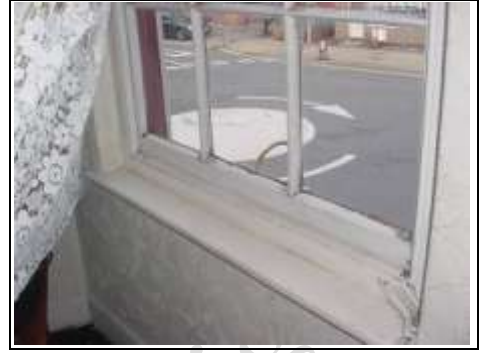
Bedroom front left

DESCRIPTION	CONDITION	ACTION REQUIRED
Ceilings: Papered cathedral ceiling	Average	
Walls: Papered	Average Crack around rear window approximately at flashing line, so assume flashing is leaking	Repair, prepare and redecorate.
Floors: Carpet	Areas of exposed floor boards which indicate joists go from front to back of property in this section	Clean or replace.
Detailing: Windows: Doors: Painted panel doors	One glass pane cracked Mould to window Dated.	Replace broken pane, repair, prepare and redecorate. Repair, prepare and redecorate and replace ironmongery
Services: Internal radiator with microbore pipes

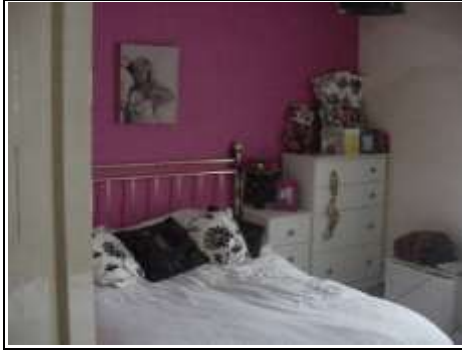
Bedroom rear right hand side (pink)

DESCRIPTION	CONDITION	ACTION REQUIRED
Ceilings: Painted

Dampness visible front right hand corner	Make roof watertight. Resolve dampness, repair, prepare and redecorate.
Walls: Painted	Dampness

Front corners obtaining readings over 100, should typically be 30-60	Resolve dampness. Repair, prepare and redecorate.
Floors: Carpet	Worn	Replace

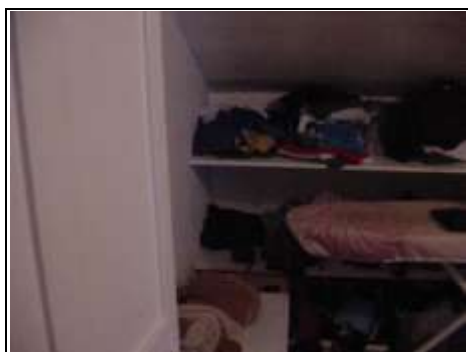
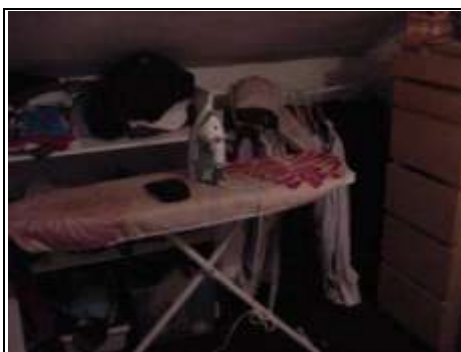
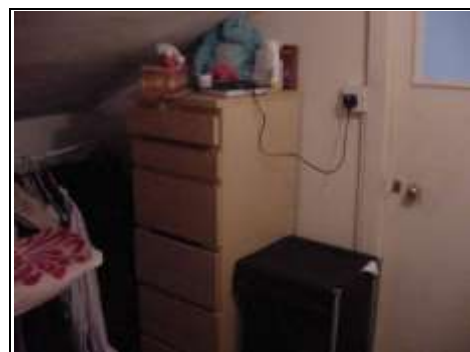
Ironing area

DESCRIPTION	CONDITION	ACTION REQUIRED
Ceilings: Cathedral ceiling	Dated.	Repair, prepare and redecorate
Walls: Painted	Dated.	Repair, prepare and redecorate
Floors: Carpet	Worn	Clean or replace.
Detailing: Doors: Painted panel door	Dated	Repair, prepare and redecorate.
Services: See Services Section.

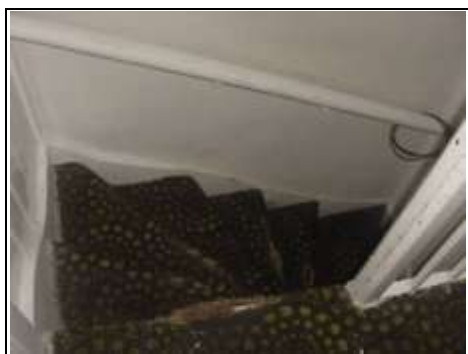
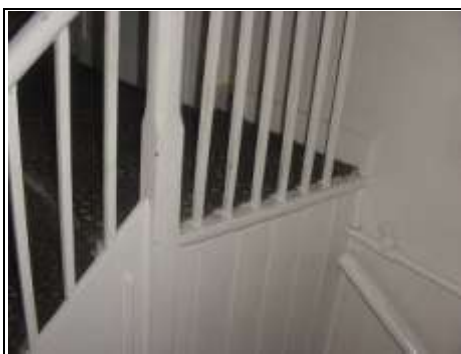
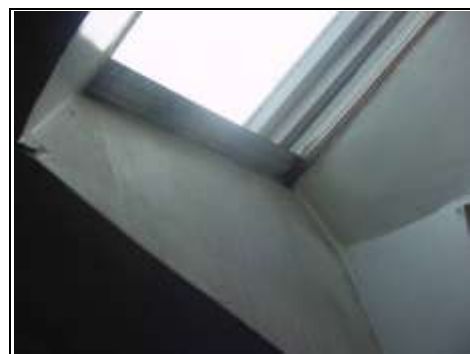
Stairs

DESCRIPTION	CONDITION	ACTION REQUIRED
Ceilings: Painted Roof window at top	Dated Average	Repair, prepare and redecorate
Walls: Wood chip wallpaper	Dated.	Repair, prepare and redecorate
Floors: Carpet	Worn	Clean or replace
